| <div><div>STELLANTIS</div><div>PARTS &amp; SERVICES</div></div> | | Technical Service Bulletin (TSB)<br>Air Bag Warning Lamp Illumination | | | |
| REFERENCE: | TSB: 10-001-23 REV. A<br>GROUP 10 - Restraints | Date: | November 9, 2023 | REVISION: | 10-001-23 |
| VEHICLES AFFECTED: | 2015 - 2022 (B1) Jeep Renegade<br>2015 - 2018 (BU) Jeep Renegade<br>2019 - 2022 (BV) Jeep Renegade<br>2019 - 2022 (FD) Fiat 500X<br>2015 - 2018 (FB) Fiat 500X | | | MARKET APPLICABILITY:<br><div><div><input type="checkbox"/> NA<input checked="" type="checkbox"/> MEA</div><div><input type="checkbox"/> SA<input checked="" type="checkbox"/> IAP</div><div><input checked="" type="checkbox"/> EE<input type="checkbox"/> CH</div></div> | |

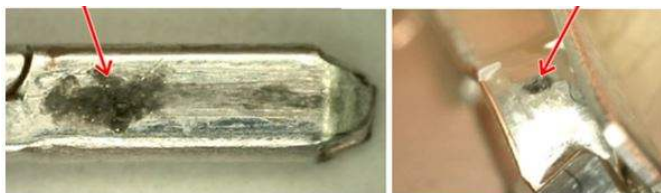
| CAUSE: | Micro vibrations between buckle and seat wiring connectors causing male and female terminal corrosion<br>Fig. 1. | | | | |

**Fig. 1**  
Terminal Corrosion

This bulletin involves replacing the inline seat connector.

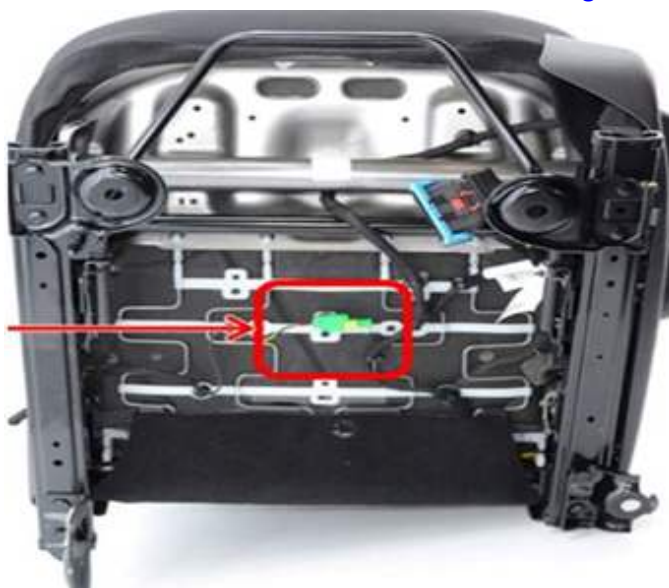
**Fig. 2**

Seat Belt Buckle In Line Connector Location

3. Remove the old seat belt buckle connector.
4. Splice in the new in line connector. Refer to the detailed service procedures available in DealerConnect>Service Library under: Service Info> 10 - Restraints / Standard Procedure Supplemental Restraint System Wiring Repairs.
