## Technical Service Bulletin (TSB)

### Throttle Blade Icing Service Fix

| REFERENCE: | TSB: 09-023-23<br>GROUP: 09 - Engine | Date: | November 28, 2023 | REVISION: | – |
| VEHICLES AFFECTED: | 2013 - 2023 (DS) RAM 1500 Pickup<br>This bulletin applies to vehicles equipped with a 3.6L V6 24V VVT Engine (Sales Code ERB). | | | MARKET APPLICABILITY:<br><div><input checked="" type="checkbox"/> NA<input type="checkbox"/> MEA<br/><input type="checkbox"/> SA<input type="checkbox"/> IAP<br/><input type="checkbox"/> EE<input type="checkbox"/> CH</div> | |

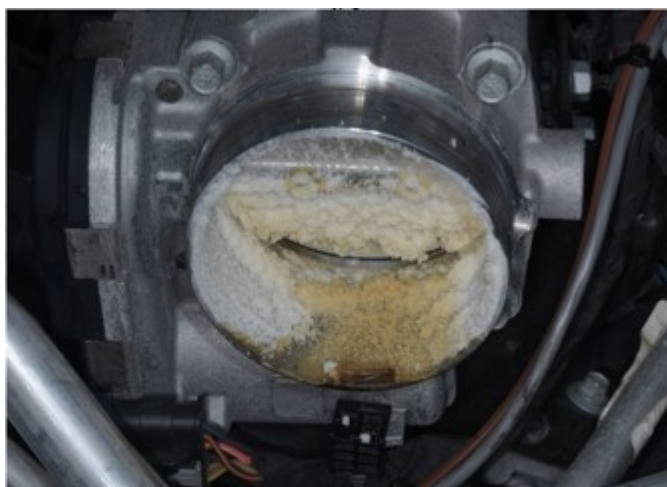
| CAUSE: | Throttle body blade icing up. | | | | |

**Fig. 1**  
Iced Throttle Body

3. Clean out and dry, any water or ice from the throttle body [Fig. 1](#).
