2019MY  
Optima (JFa),  
Sorento (UMa), and  
Sportage (QL)

PI1805Y/Z

January 2024

### ENGINE REPLACEMENT INSTRUCTIONS FOR DTC P1326 (PI1805Y/Z)

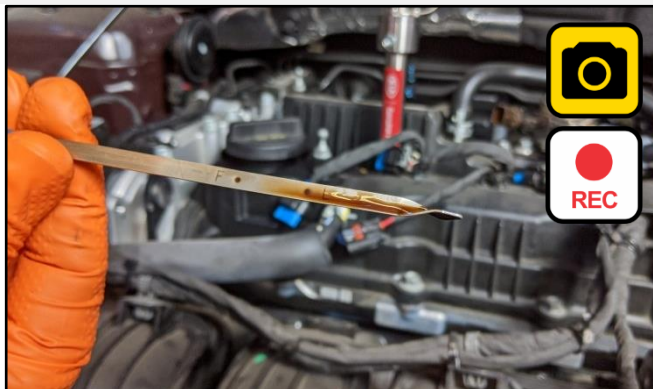
**Record/Note findings:** Oil sludge, varnish, burnt oil smell condition(s) found.

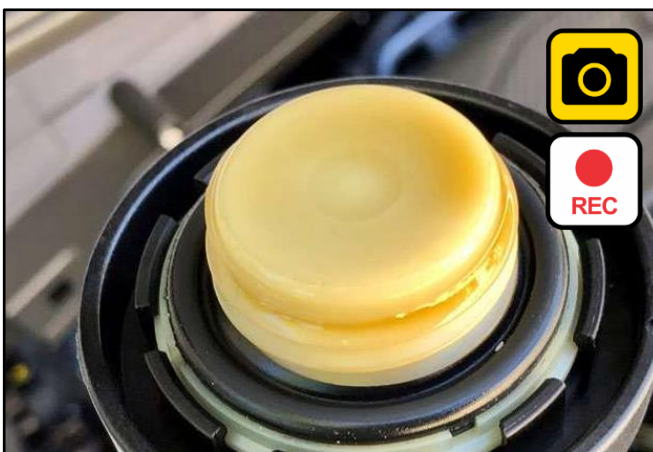
**Record/Note findings:** Oil sludge, varnish, burnt oil smell condition(s) found.

**If oil lacquering, oil sludge or oil varnish is present, then the engine is therefore suspect to maintenance neglect. Review of the vehicle's maintenance history is required.**

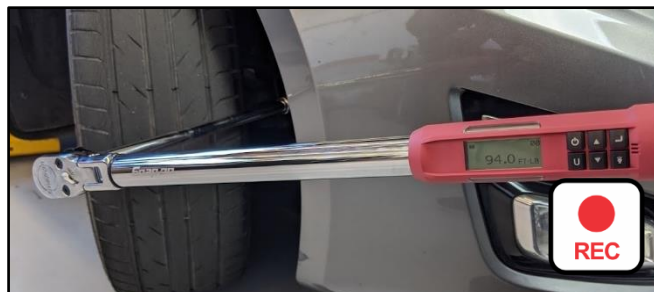
6. Show the engine being cranked and torque specification exceeding 94 lb.ft. torque.
