# Technical Service Bulletin

## 97 MIL on: DTC U064100 or U064000 for fuel tank breather - 2.0 ltr. TFSI EA888

97 24 05 2069123/2 January 18, 2024. Supersedes Technical Service Bulletin Group 97 number 23-90 dated January 17, 2023 for reasons listed below.

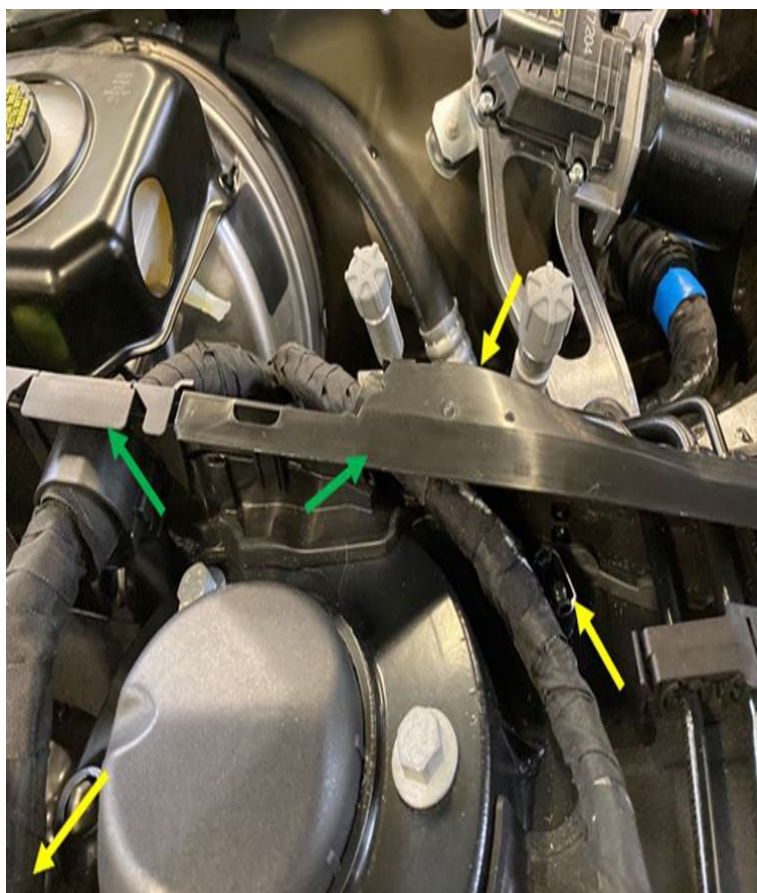
*Figure 1:* Plenum chamber covers (green arrows).

1. Remove plenum chamber covers (green arrows, Figure 1)

Release wiring harness securing clips (yellow arrows, Figure 1).

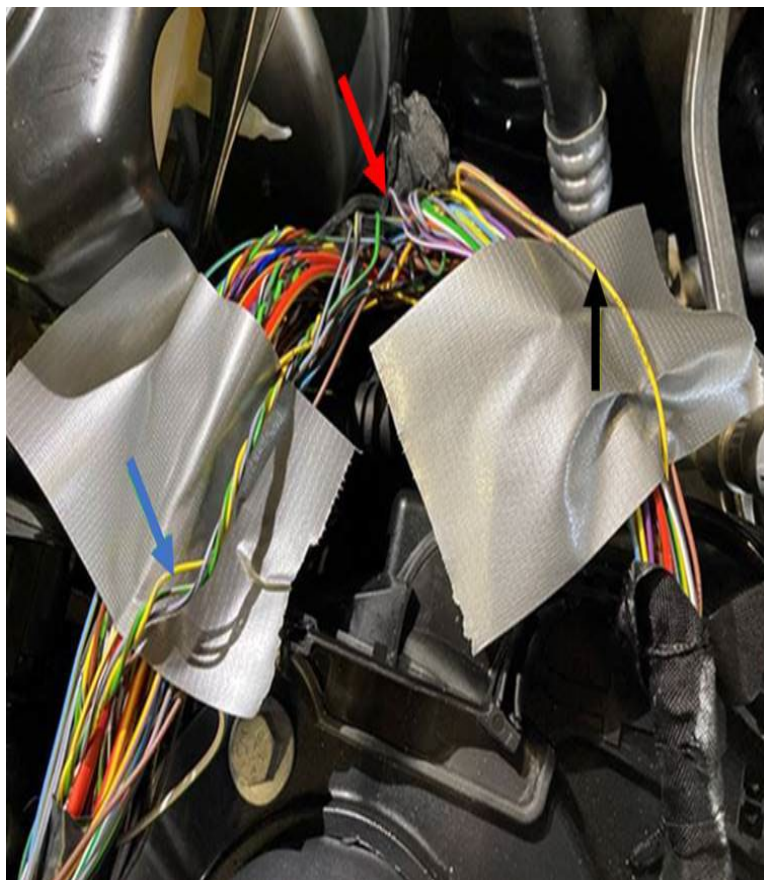
*Figure 2:* Wires isolated for modification.

2. Isolate the yellow/grey wire (triple twisted wire; blue arrow, figure 2) in the left bundle.

Isolate the yellow/purple wire in the right bundle (black arrow, Figure 2).

Cut the yellow/grey wire at the blue arrow and unravel it in the direction of the plenum chamber up to the red arrow.

Cut the yellow/purple wire at the black arrow.

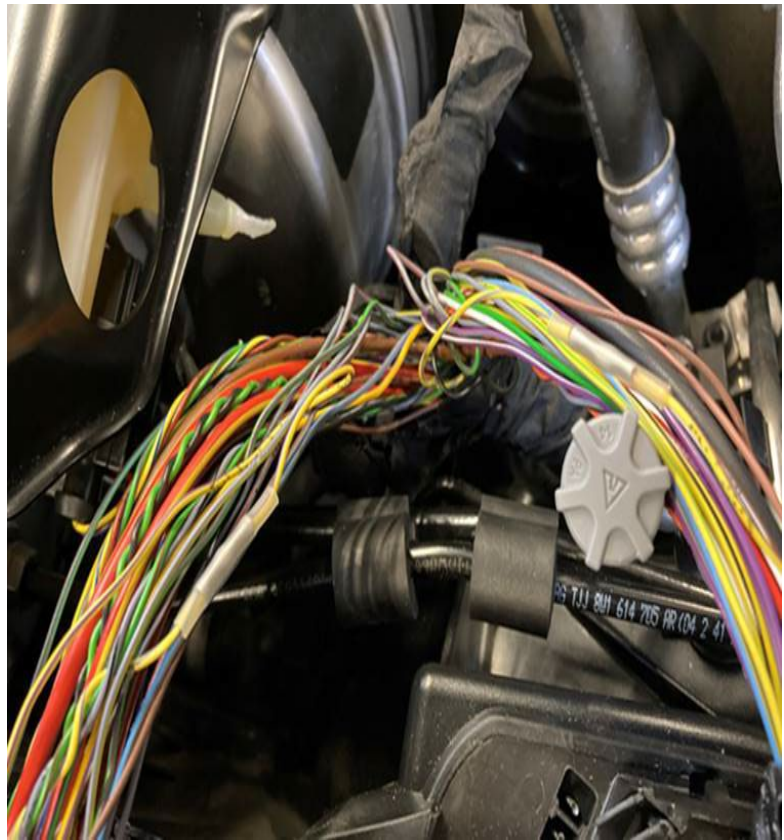
*Figure 3:* wire modification complete.

Connect the untwisted yellow/grey wire (plenum chamber side) from the left bundle to the yellow/purple wire in the right bundle (engine side).

Connect the remaining yellow/purple wire (plenum side) to the yellow/grey wire (engine side).
