# Technical Service Bulletin

## 27 48V vehicle electrical system warning, DTC U046900 stored in the ECM

27 24 65 2058831/12 January 18, 2024. Supersedes Technical Service Bulletin Group 27 number 23-64 dated December 22, 2023 for reasons listed below.

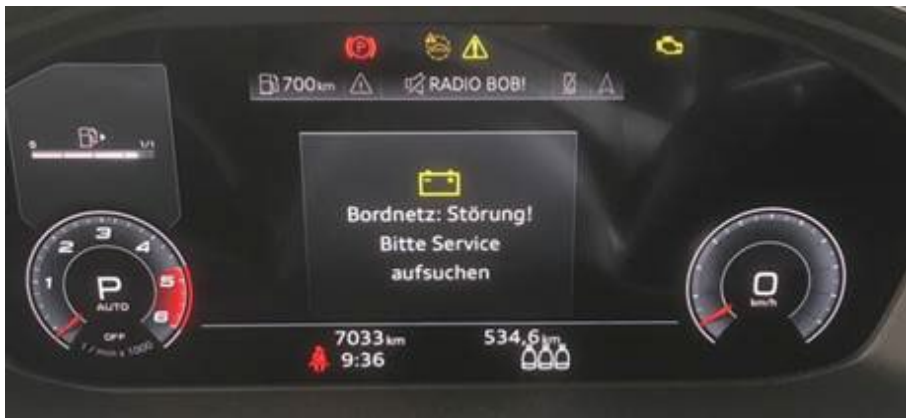
- The message “Electrical system: Malfunction. See owner’s manual” is displayed on the instrument cluster (Figure 1).
- A yellow or red battery warning symbol is displayed on the instrument cluster.

**Figure 1.** Cluster Warning Message.

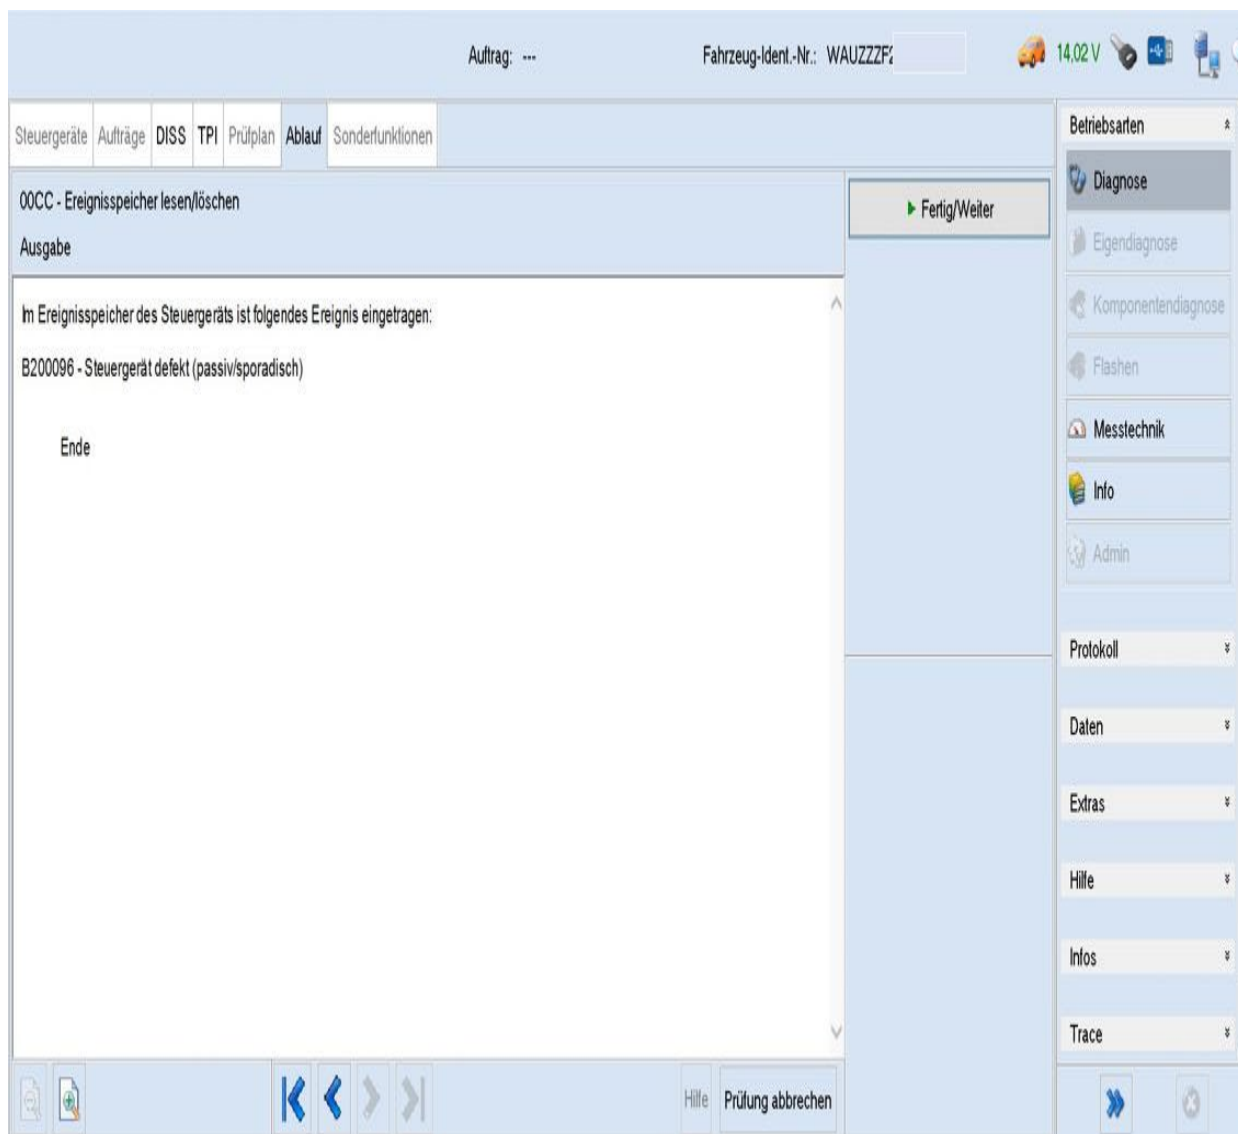
- **B200096** – Faulty control module (Figure 2).

Figure 2. ODIS tester screen.

If the following event memory entry is shown in ODIS, replace the starter-alternator according to ETKA and reevaluate the concern:
