# Request for Detailed Reporting of Oil Leaks from A25A Engines

Vehicles with A25A Engines

Engine Oil Leak between the Lower Oil Pan and Crank Case

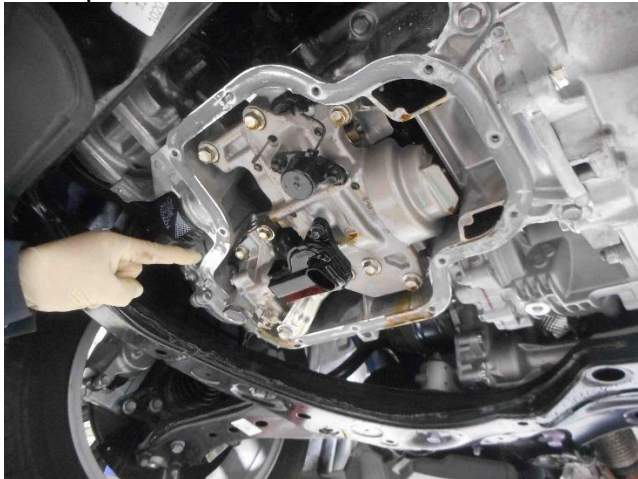
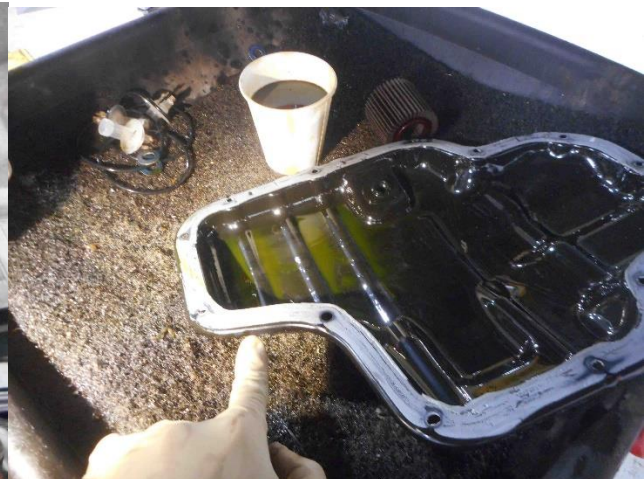
- Macro photos (far away) of both entire sides of the sealing surface (lower oil pan **and** crank case side)  
Examples:

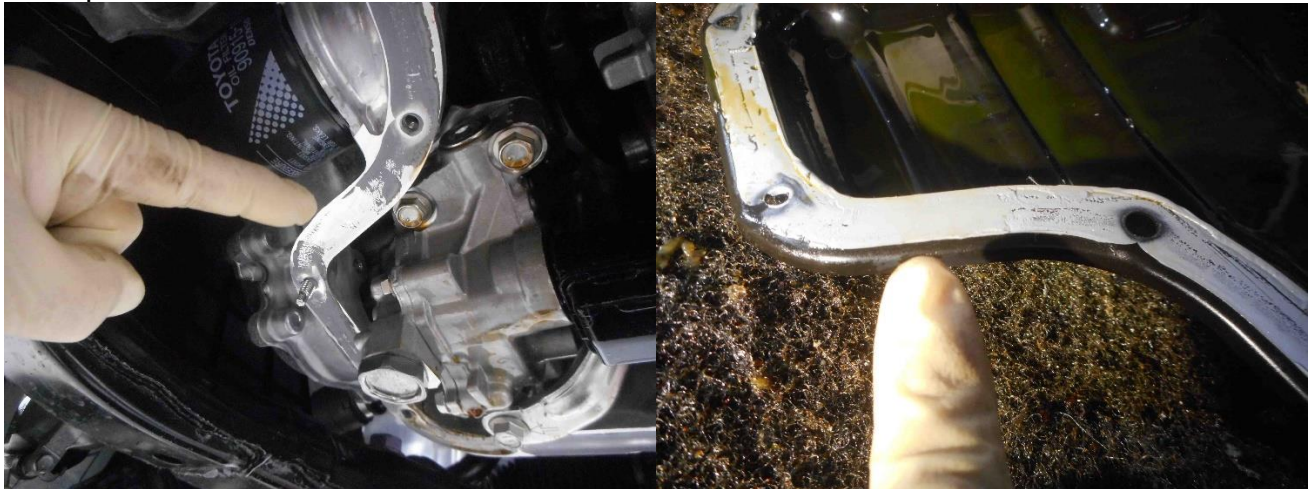
2. Micro photos (close up) of the suspected leak path in the FIPG  
Examples:

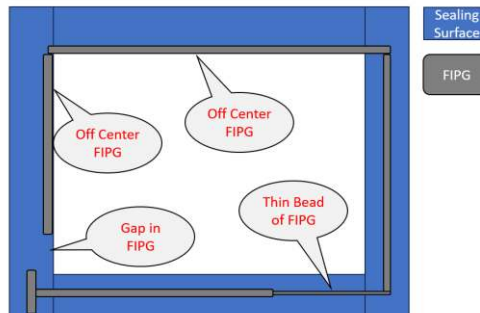
3. Notation if you suspect:
  - a. Insufficient or lack of FIPG (poor diameter of bead)
  - b. Mis-location of FIPG (off centered bead)
  - c. Any gaps in FIPG
  - d. Insufficient adherence of the FIPG (not sticking to one of the surfaces)

Example diagram of different application conditions:
