## SERVICE BULLETIN

**APPLICABILITY:** 2017-22MY Forester

**NUMBER:** 09-113-23

**SUBJECT:** DTC P2404 / Reprogramming Files

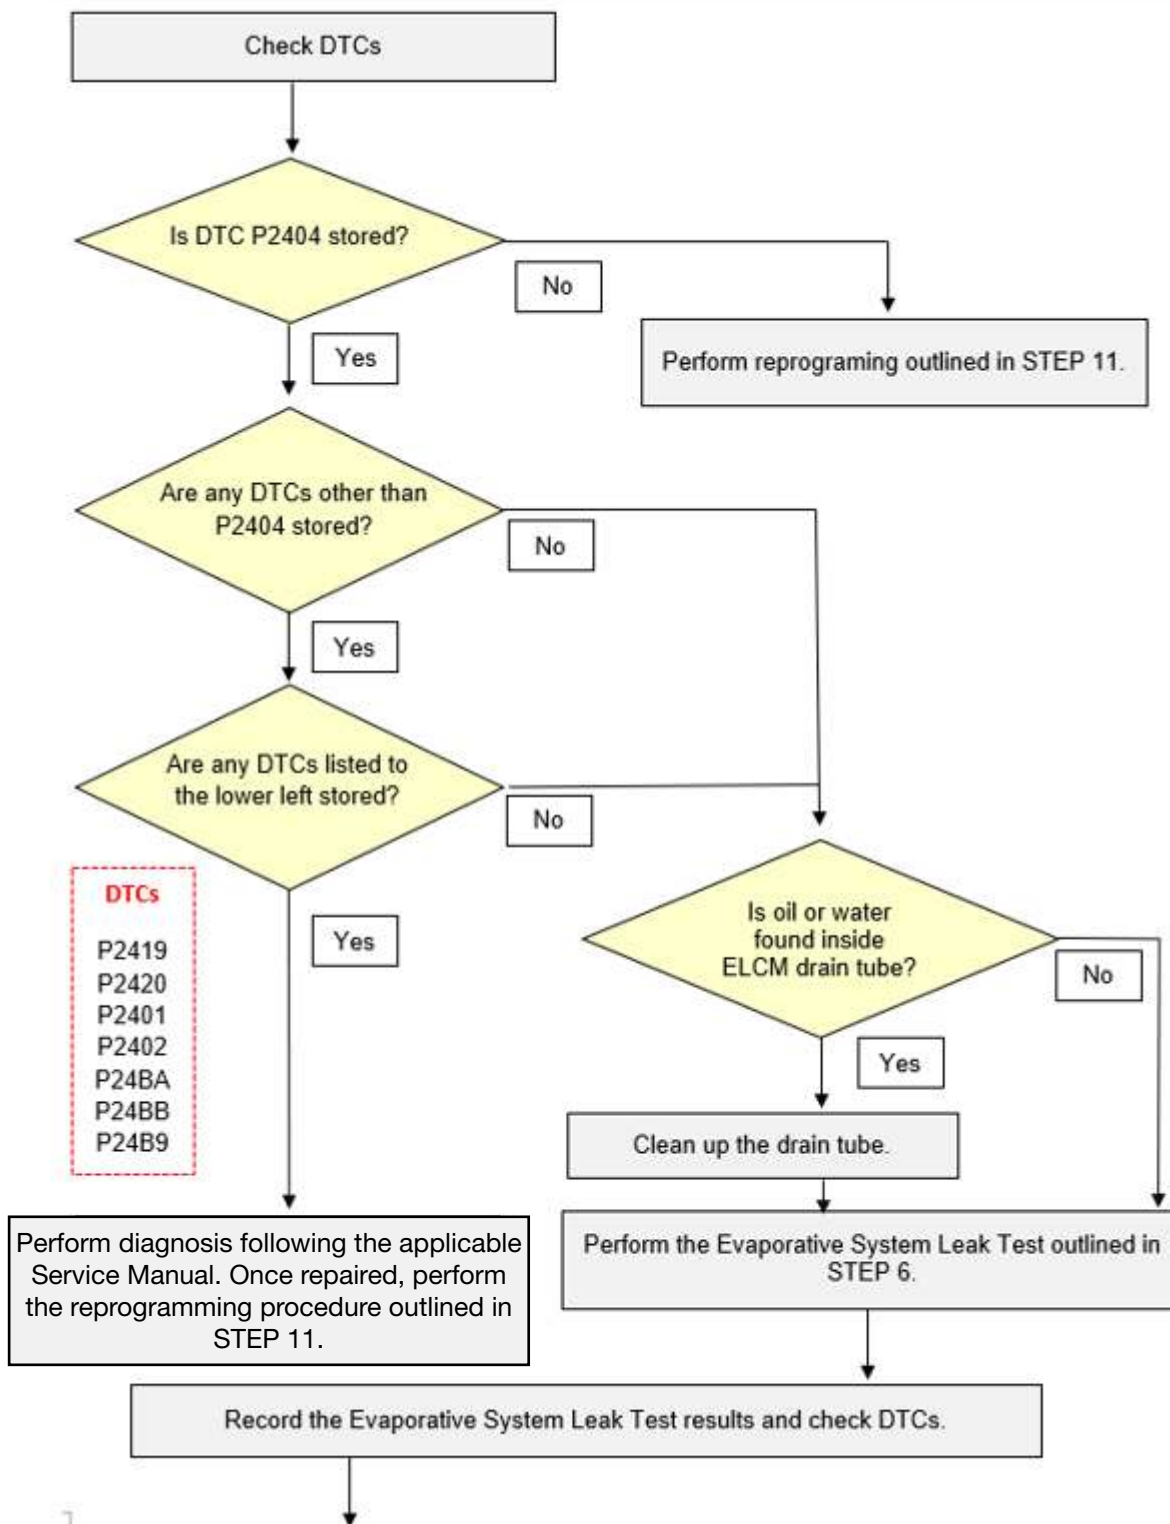
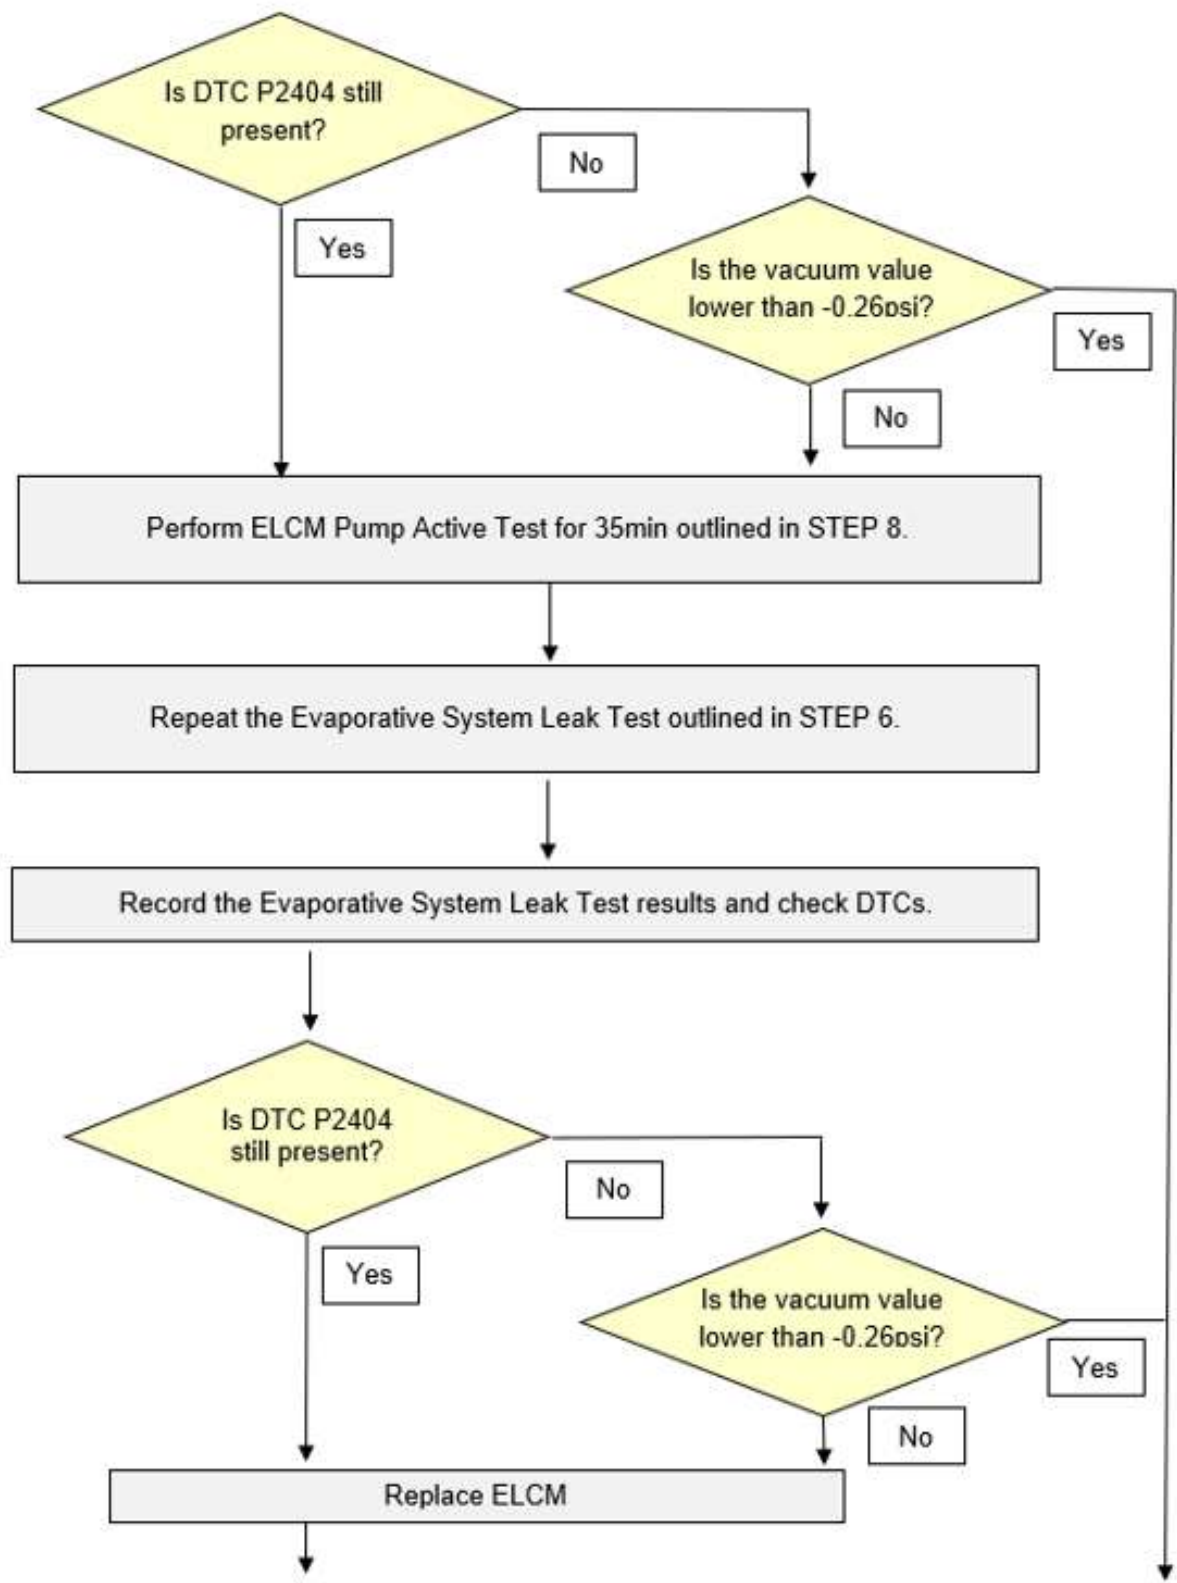
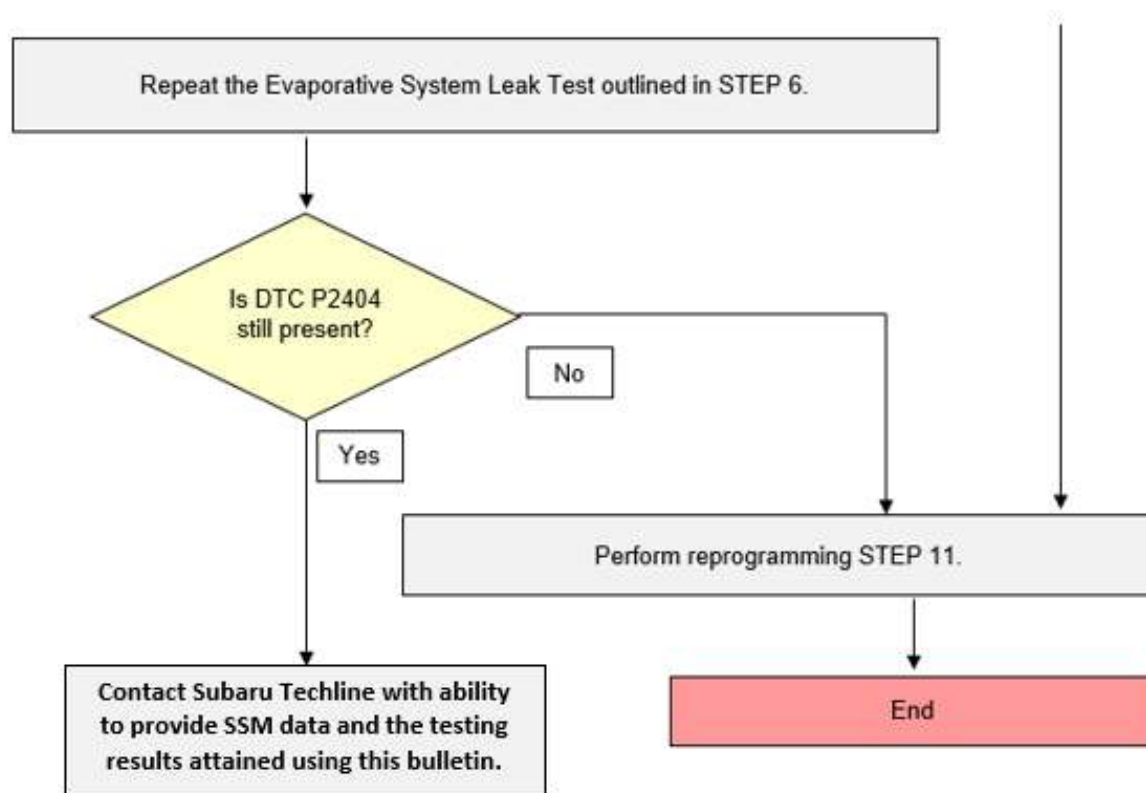
## SERVICE PROCEDURE FLOWCHART:

This bulletin announces diagnostic procedures and availability of new Engine Control Module (ECM) reprogramming files to address DTC P2404 (Evap System Leak Detection Pump Sense Circuit Range/Performance) detection. In rare cases, the internal pump for the Evaporative Leak Check Module (ELCM) system can seize temporarily. The new files contain enhanced logic to prevent the ELCM pump from seizing. If P2404 is found in the fault memory, follow the procedures outlined below.

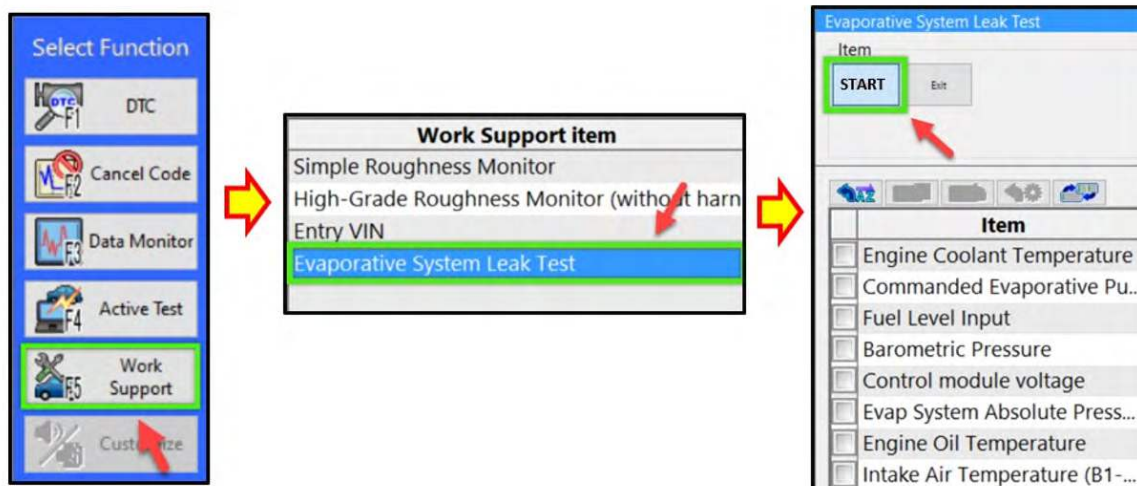
Once the evaporative system leak test is complete, check the DTCs and examine the vacuum value results. Record the value shown in the row labeled MID: \$3C, TID: \$C4, and Scaling ID: \$FE. This value should be lower than -0.26 PSI.

Value Must Be Lower Than -0.26 PSI

**STEP 6:** Connect the vehicle to a recommended power supply. See **APPENDIX A** for additional information regarding the power supply. Using SSM, perform the Evaporative System Leak Test. Collect and save all data.

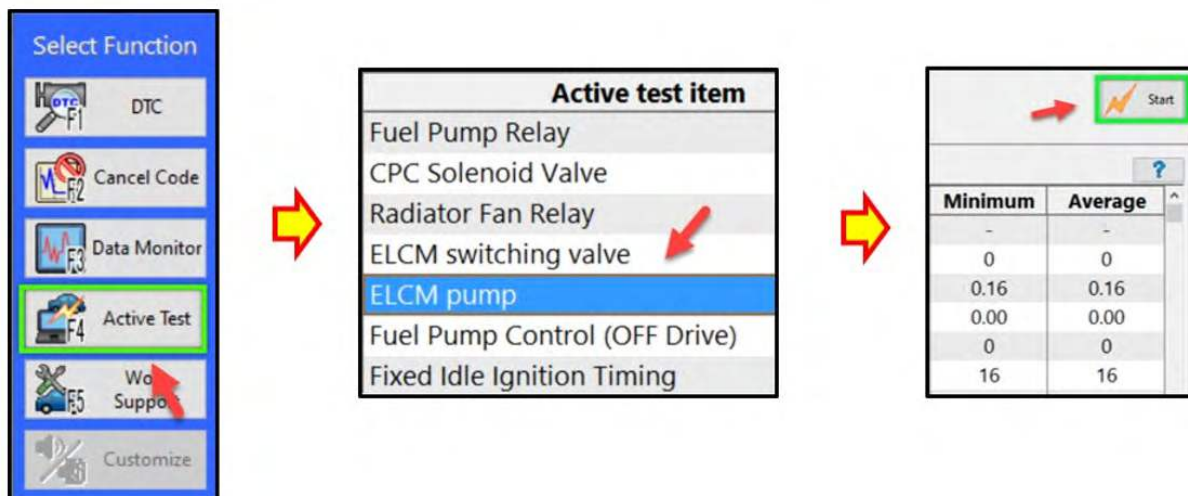
Once the ELCM Pump Active Test has been performed for a period of 35 minutes or more, repeat the Evaporative System Leak Test outlined in STEP 6. Check the DTCs and the vacuum value results.

**STEP 8:** Using SSM, perform the ELCM Pump Active Test for a period of 35 minutes or more. See **APPENDIX A** for additional information regarding power supply.
