## TECHNICAL SERVICE BULLETIN

### 400 Watt DC/AC Inverter System Inoperative With B1330:9A In The BCM

24-2020

Ford  
2021-2023 F-150

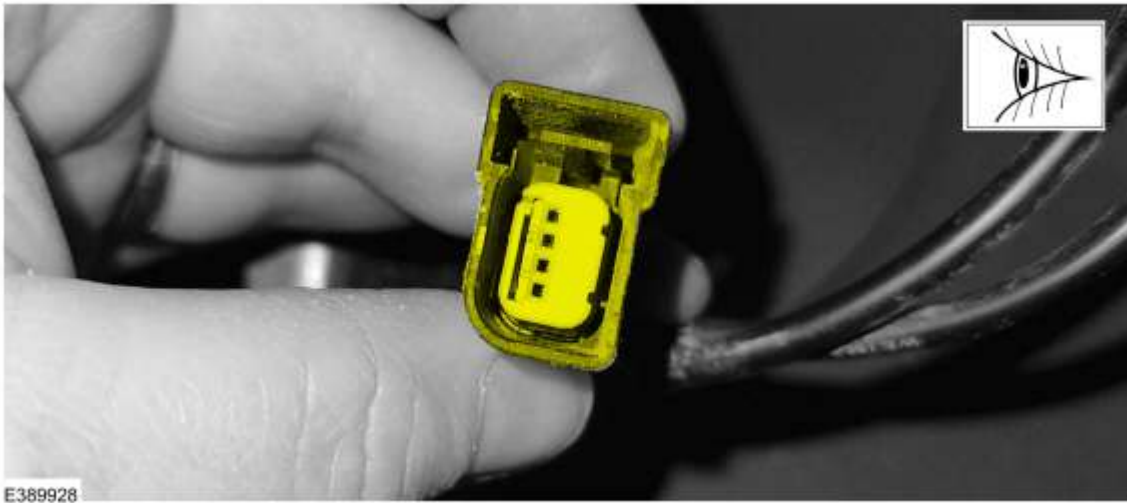
Figure 2

2. Using a suitable tool, carefully cut and remove the pickup bed AC power outlet socket harness retainer from the pickup bed AC power outlet socket harness. Discard the retainer.
3. Inspect connector C4628 for the presence of corrosion, dirt and/or damage. Is corrosion, dirt and/or damage present in connector C4628? (Figure 2)

- (1). Yes - replace the pickup bed AC power outlet socket assembly. Refer to WSM, Section 414-05. Replace the body side harness assembly (13A409) of connector C4628. Proceed to Step 4.
  - (2). No - proceed to Step 4.
4. Install a new pickup bed AC power outlet socket harness retainer 4.3 in. (110 mm) from the back of the pickup bed power outlet harness connector. If the pickup bed AC power outlet socket has been replaced, remove and discard the factory-installed harness retainer and install the new harness retainer. (Figure 3)

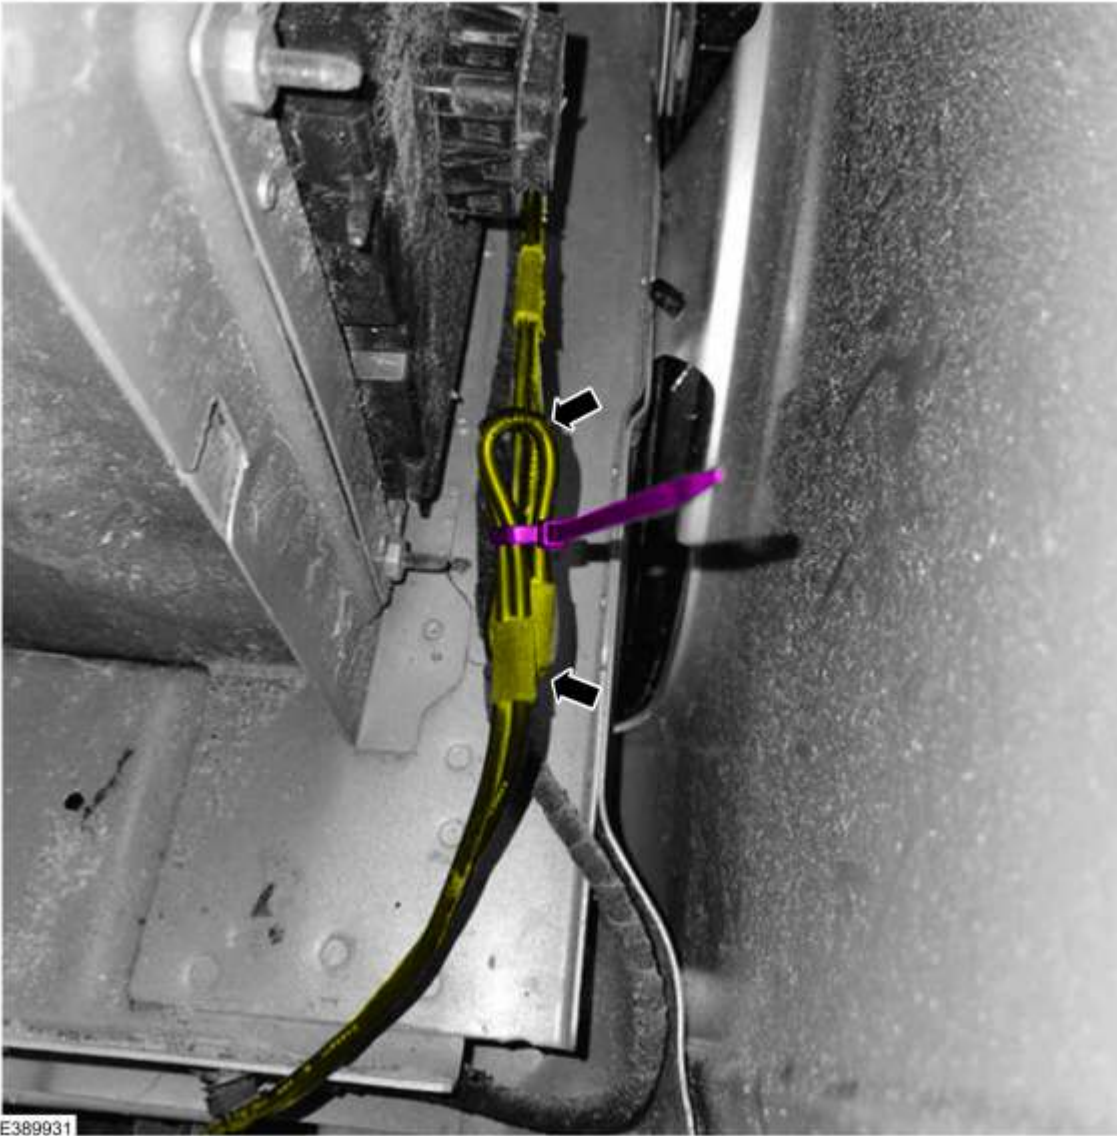
Figure 5

**CAUTION:** The bend radius of the pickup bed AC power outlet socket harness should be no less than 4 mm. Hard kinks and tight bends of the pickup bed AC power outlet socket harness can lead to wire damage.

6. Fold approximately 7 in. (185 mm) of the remaining/loose pickup bed AC power outlet socket harness in 2 bends just behind the pickup bed AC power outlet socket panel. Secure the folded wire with a wire tie. Inspect the routing of the harness to make sure it is not pulled too tight against the body sheet metal near the harness retainer and provides just enough length. (Figure 5)
