## 992 2WD – DME Fault P310B00 – ‘Fuel Low Pressure – Implausible’

Customer complains of a check-engine light resulting from fault “**P310B00- Fuel low pressure – implausible**” in the DME control unit.

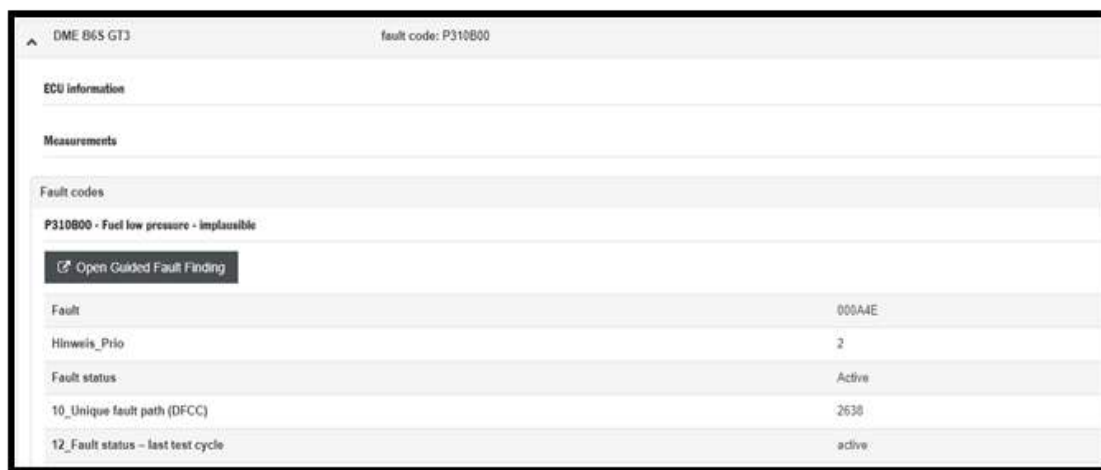
Figure 1

The diagnostic responsible for this fault monitors supply deviation within a finite time between the demanded or target low-pressure requested of the low-pressure fuel pump and that of the actual supplied quantity to meet the request, as correlated to pressure. In some instances, manufacturing tolerances for the low-pressure pump result in the actual supplied fuel quantity exceeding the DME's requested quantity, in other words, the pump's operation is 'too effective.' By consulting the Vehicle Analysis Log (VAL) containing the fault it is possible to see if the supplied fuel quantity exceeded the requested quantity in the low-pressure system to cause the fault.

In the example provided below of Figure 2, with imperial units provided, it is apparent the excess low-pressure fuel supply caused the fault. Specifically, the value "B220\_Fuel pressure actual value" of 10653.7 lbf/ft<sup>2</sup> exceeds "B221\_Fuel low pressure setpoint" of 10442.7 lbf/ft<sup>2</sup>. This deviation occurred despite the DME regulating the demand downwards (-) by 1948.6 lbf/ft<sup>2</sup> or 14.99% to compensate for the excess supply, but the regulation could not compensate enough to prevent the fault.

If the fault data is consistent with the condition exemplified in Figure 1, please replace the fuel pump, **NOT** the fuel pressure sensor.
