Preliminary Information

PIP5819B VT40 Transmission Setting DTC P2714

Models

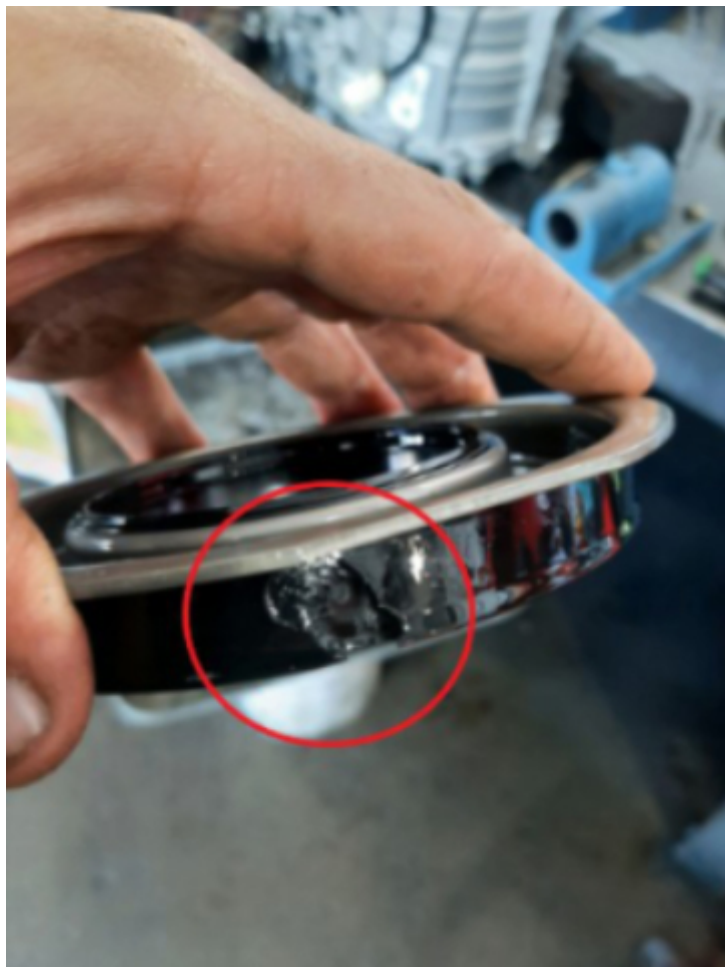
With the transmission disassembled, inspect the Forward Clutch Piston for damage along the side as shown.

If the Forward clutches are worn and there is damage seen to the Forward Clutch Piston then replace the Forward Clutch Piston and Housing and the applicable apply components as needed

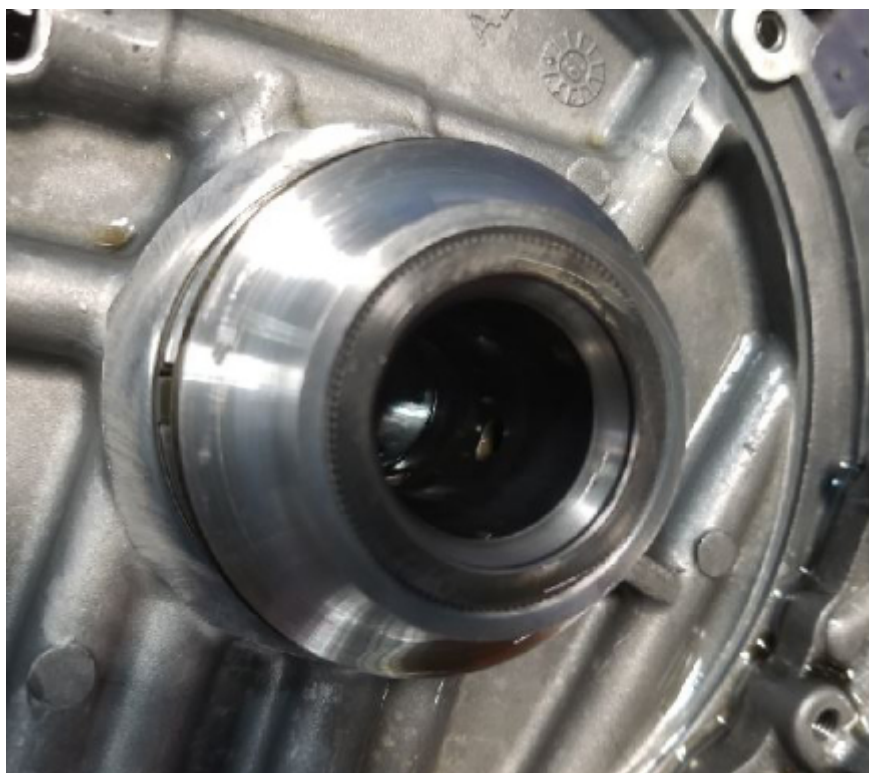
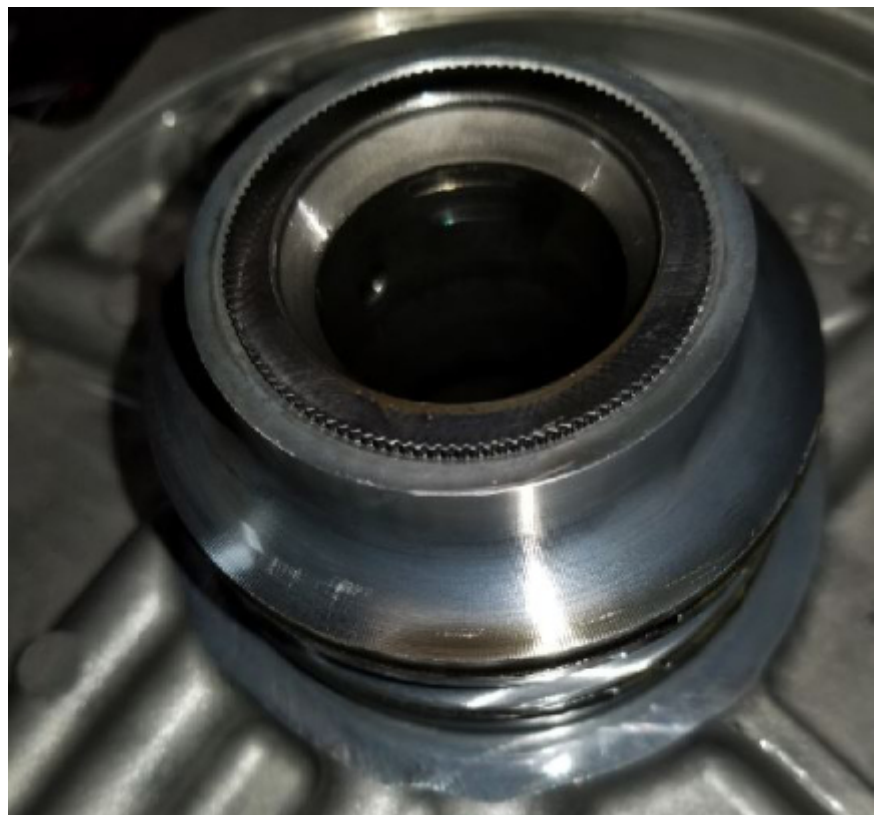
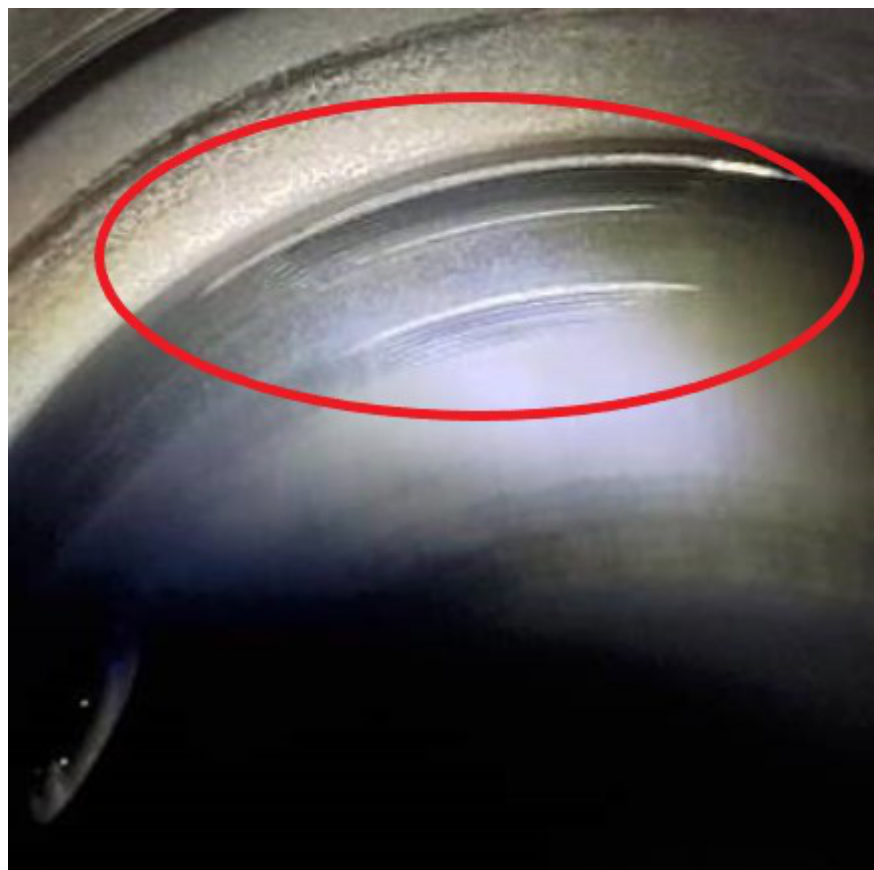
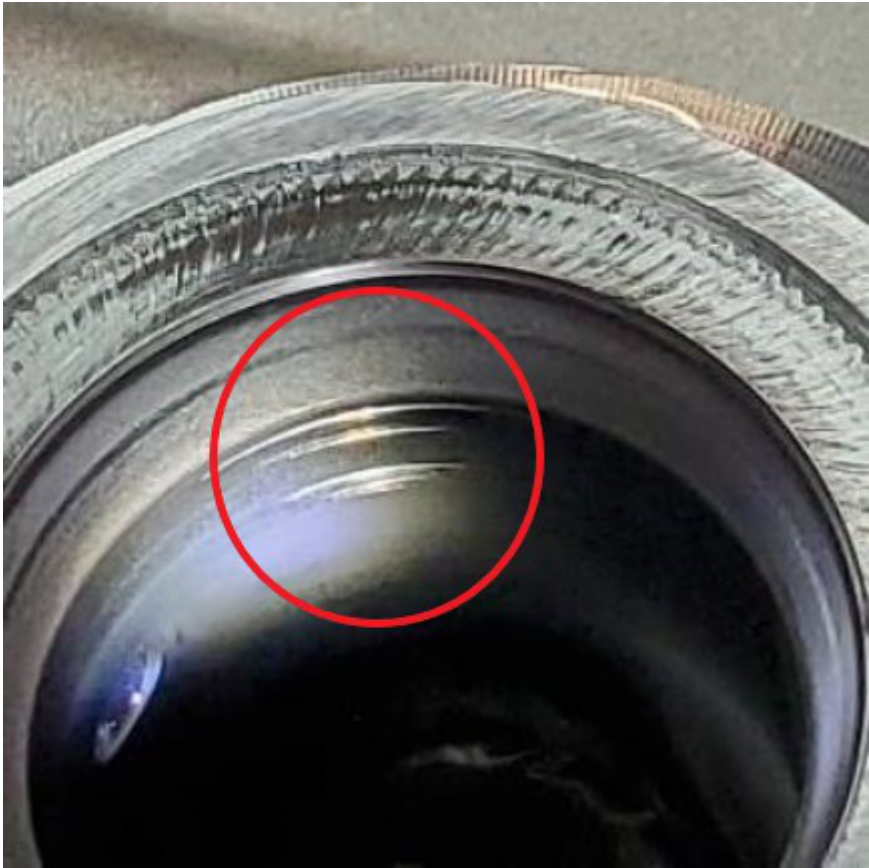
**Note:** The first 2 pictures show the outside of the pump, and the second 2 pictures show the wear that is found internal to the pump when wear to the Primary Pulley Bearing Bore is found .

If signs of wear are seen as shown, this indicates the Primary Pulley Bearing has spun in the bore and is allowing the Turbine Shaft to become off center. When this happens, it causes a pressure leak.

**Note:** The Primary Pulley Bearing is installed on the inside of the case on the primary pulley, this area of the transmission cannot be accessed for inspection, inspection of the pump for DTC P2714 and no concern found with the Forward Clutch Piston is critical.

If this concern is found, the transmission will need to be replaced.
