## Technical product information

| <b>Topic</b> | DTC P0B2500 logged within address 0021 (Battery Energy Control Module 2) - Dynamic ride system warning visible |
| <b>Transaction No.</b> | 2068946/5 |

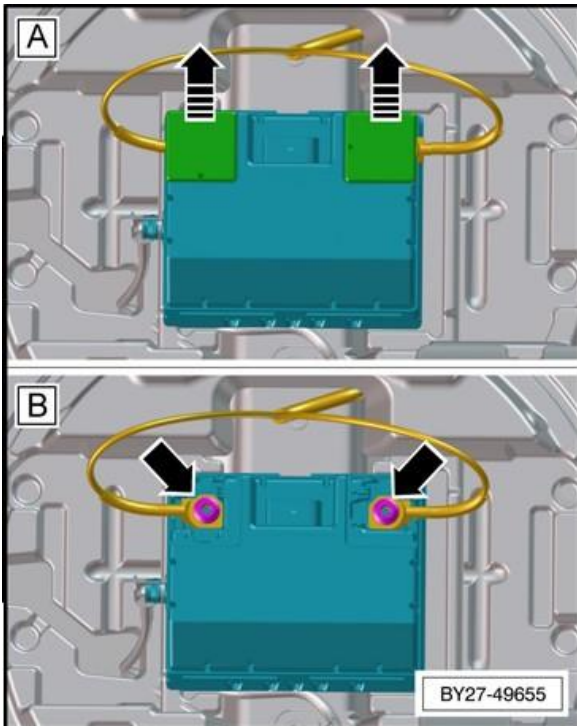
Figure 1

Possible internal fault with the super capacitor

- 1) Referring to Rep.Gr 27 - Deactivate the 48 volt system - Refer to 48 volt system - To activate and deactivate
- 2) Referring to Rep.Gr 27 - Check the security of the super capacitor positive and negative terminals (Figure 1) as follows:
  - Remove the caps (A) from the terminals
  - Check the security of the positive and negative terminals (B) are as described within Rep.Gr 27
  - In the event that one or both terminals are not secure the operative must secure the loose terminal(s) to the correct torque as detailed within Rep.Gr 27 - Super capacitor

**In the event one or both terminals were not secure please respond via the open DISS query or raise a new DISS query, in this scenario a response from Product Support is not required the operative should continue with the remaining instructions**
