# Technical Service Bulletin

## 87 Heat from rear vent insufficient - DTC B108911

97 24 06 2072931/1 February 9, 2024.

| Model(s) | Year | VIN Range | Vehicle-Specific Equipment |
|---|---|---|---|
| Q4 e-tron, and<br>Q4 Sportback e-tron | 2022 – 2024 | All | Not Applicable |

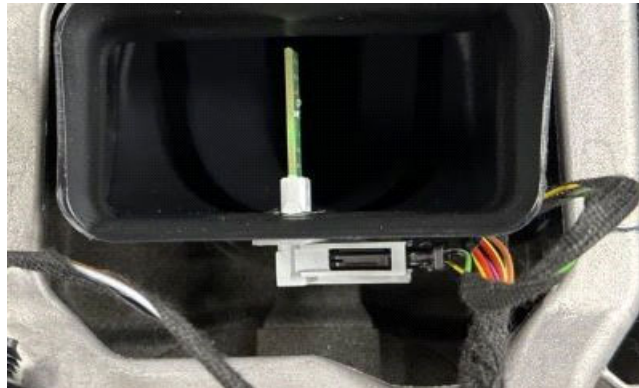
With the rear vent removed the rear vent temperature sensor G174 can be visually inspected. The G174 vent temperature sensor is found to be in place and undamaged. The electrical wiring to the rear sensor, however, is discovered pinched or chafed causing a short to ground against the center tunnel structure.

1. Remove the rear vent and inspect the wiring harness routing. Figure 1 shows the incorrect harness routing that can cause the wiring damage.

**Figure 1.** Harness routing prone to damage in assembly.

2. Rotate the rear vent temperature sensor 180° and route the harness wiring as shown in Figure 2. This will reduce the harness exposure and possible wiring damage when the rear vent is installed.

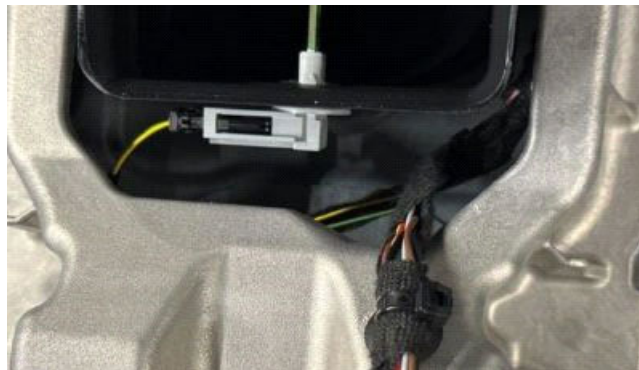
**Figure 2.** Corrected rear vent temperature sensor position and harness routing.

3. Repair any damaged wiring found using the VAS1978C Wiring Harness Repair Set and the wiring repair processes in ElsaPro.
