# Technical Service Bulletin

## 55 Power rear lid cannot be opened, DTC B113E07 and/or B113E29 are stored in the rear lid electronics module

55 24 90 2064020/2 February 15, 2024. Supersedes Technical Service Bulletin Group 55 number 21-58 dated July 16, 2021 for reasons listed below.

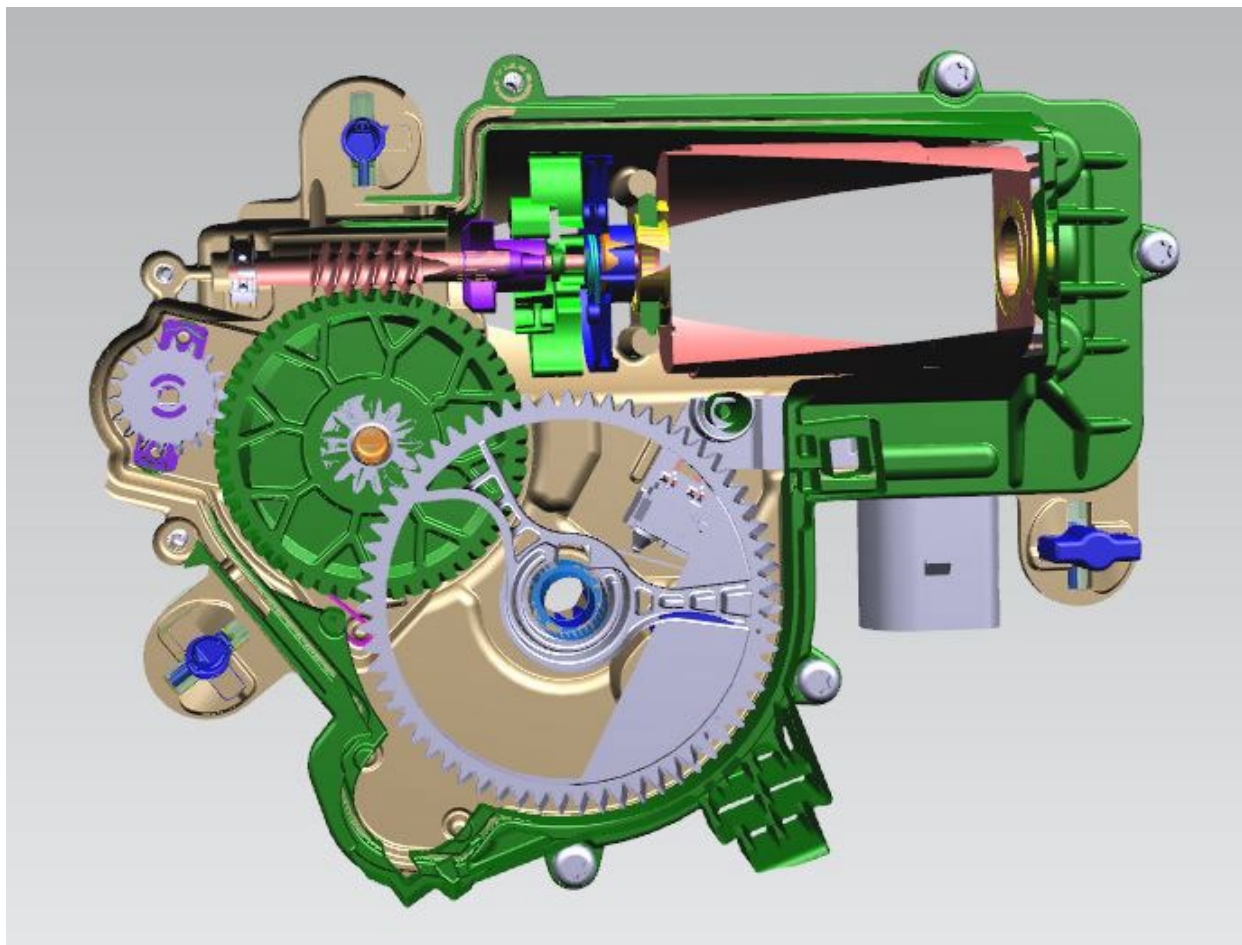
Due to component-related deviations of the rear lid closing assist motor, the closing assist motor can be internally blocked. Consequently, the power rear lid can no longer be opened as the rotary latch of the rear lid lock is not released by the closing assist motor (Figure 1).

**Figure 1.** Rear lid closing assist motor.

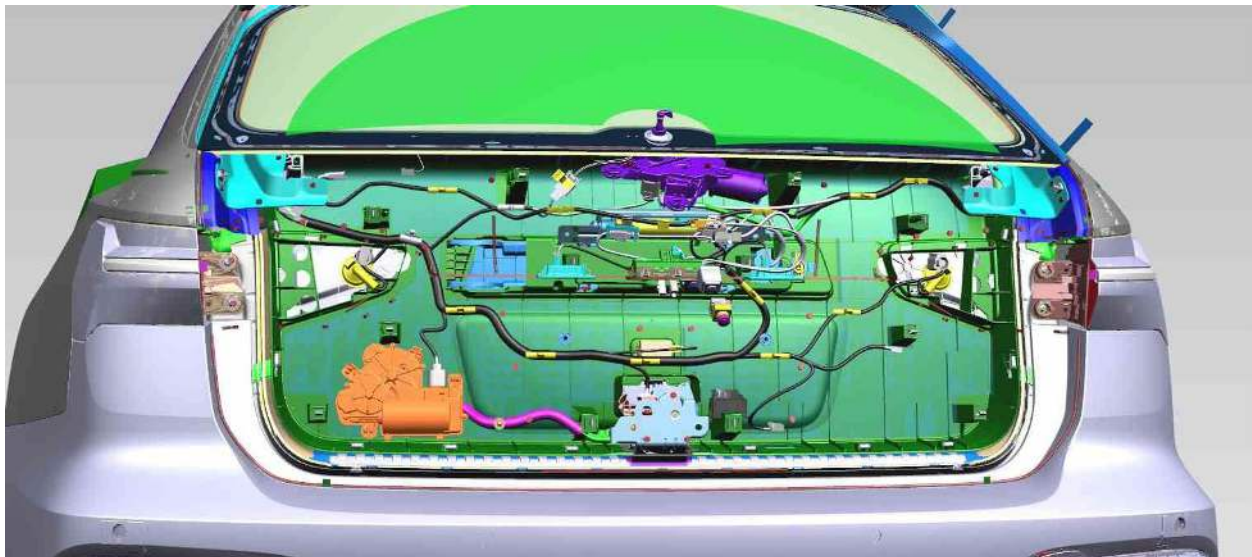
**Figure 2.** Carefully knock in the area of the closing assist motor. Its location varies and is model specific.

1. If it is not possible to open the power rear lid using the vehicle key, the interior/exterior buttons, or the emergency release, carefully knock with your hand on the rear lid in the area of the closing assist motor (Figure 2). The resulting vibrations should release the blockage within the closing assist motor.

2. If the blockage cannot be released and the rear lid cannot be opened, the rear lid trim must be removed from inside the vehicle using standard tools. On some models, it is not possible to remove the trim without damaging it irreparably. Please upload a photo of the damaged trim to Doc-It.
3. Open the rear lid and remove the rear lid lower trim panel according to the Elsa Repair Manual.
4. Replace the closing assist motor.
5. Check the operation of the closing assist motor and the power rear lid before reinstalling the rear lid lower trim panel.
6. Reinstall the rear lid lower trim panel and clear any relevant DTC(s).
