# Technical Service Bulletin

## 55 Power rear lid not closing fully, rear lid lock not engaging secondary latch position, DTC B113E29, B12E015, B113E07

55 24 91 2064476/3 February 19, 2024. Supersedes Technical Service Bulletin Group 55 number 21-60 dated September 30, 2021 for reasons listed below.

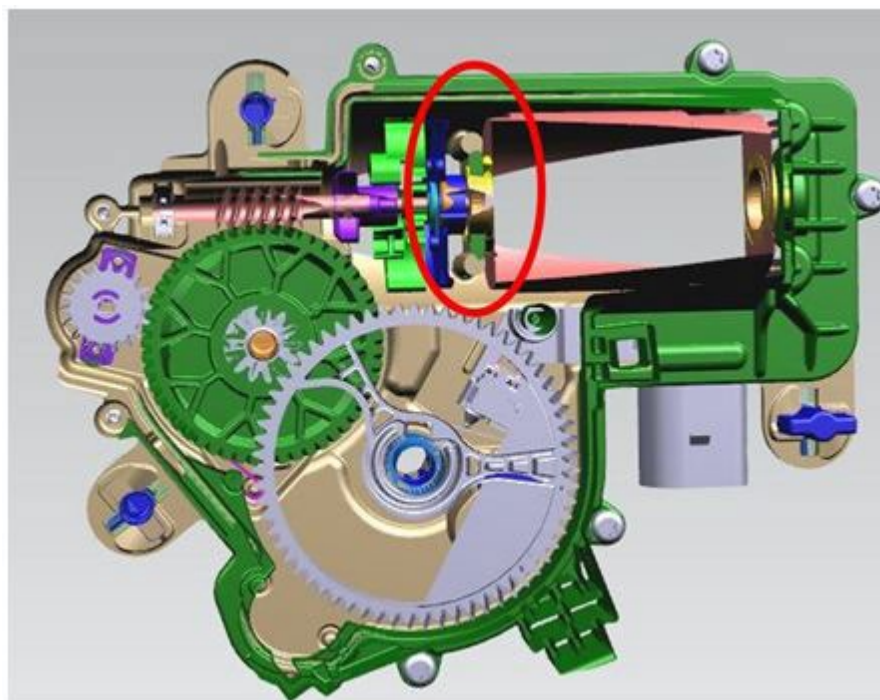
1. The internal clutch of the closing assist motor can be blocked due to a dimensional deviation. This failure mode could cause DTC B113E07 to store (Figure 1).

**Figure 1.** Blocked clutch due to a dimensional deviation.

Replace the rear lid closing assist motor according to the Elsa Repair Manual.

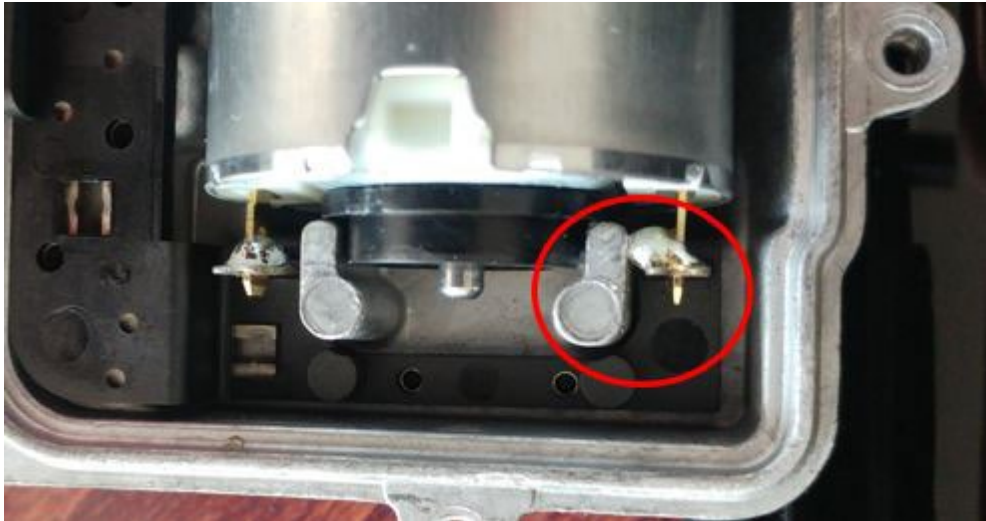
2. An improper solder joint inside the closing assist motor can cause a short circuit. This failure mode could cause DTC B12E015 to store (Figure 2).

**Figure 2.** Short circuit caused by solder joint.

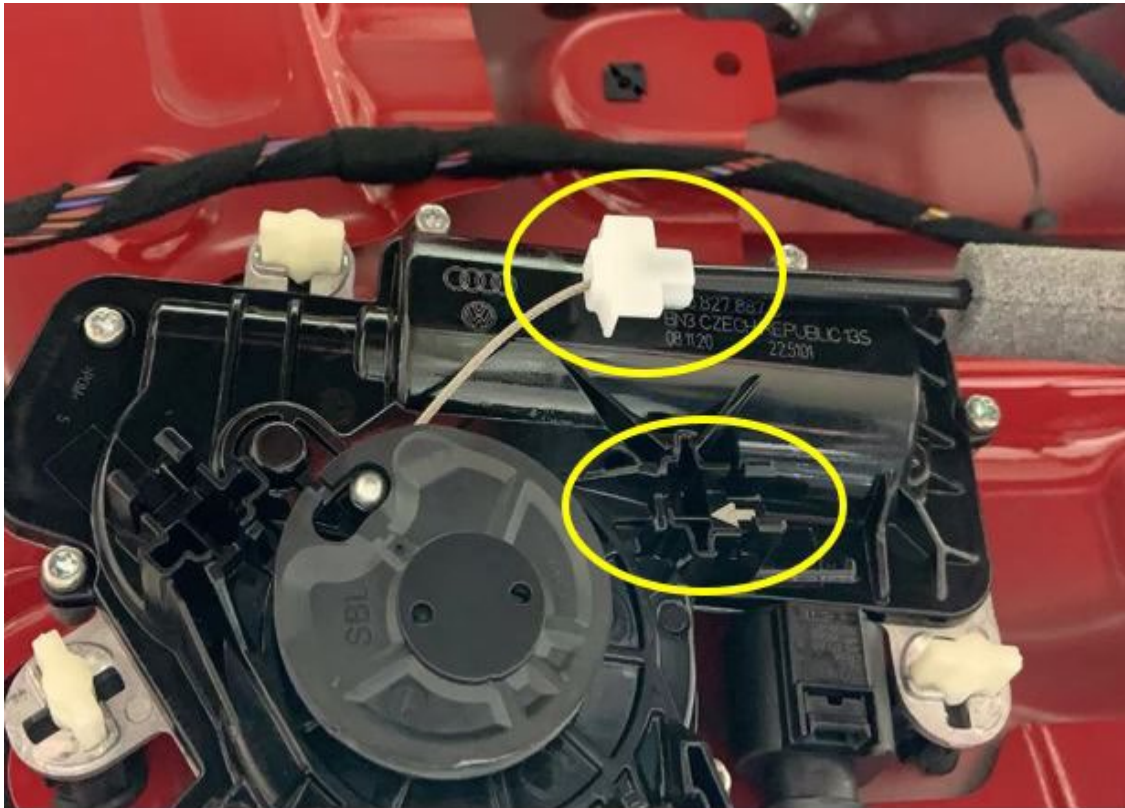
3. The Bowden cable clip has detached from the closing assist motor housing. This failure mode could also cause DTC B113E07 to store (Figure 3).

**Figure 3.** Detached Bowden cable clip.
