# Service Bulletin

Bulletin No.: 22-NA-007

**Subject:** Poor Engine Performance in Extremely Cold Weather Conditions for LE2 Engines, Charge Air Cooler (CAC) Icing - Malfunction Indicator Lamp (MIL) Illuminated, DTC P0299, P0234, P0236, P2227, P00C7 Set

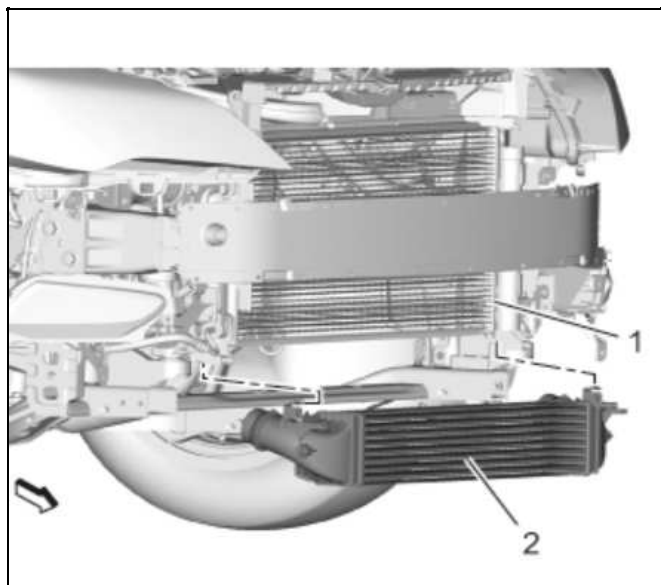
4171562

| Involved Region or Country | North America |
|---|---|
| Cause | <p>This condition may be caused by ice accumulation in the charge air cooler (CAC) or turbocharger wastegate regulator solenoid valve (TCV), causing improper boost pressures.</p> |

1. Remove the CAC (2) and drain any moisture built up. Refer to Charge Air Cooler Replacement in SI.
2. Perform an oil change. Refer to Engine Oil and Oil Filter Replacement in SI.

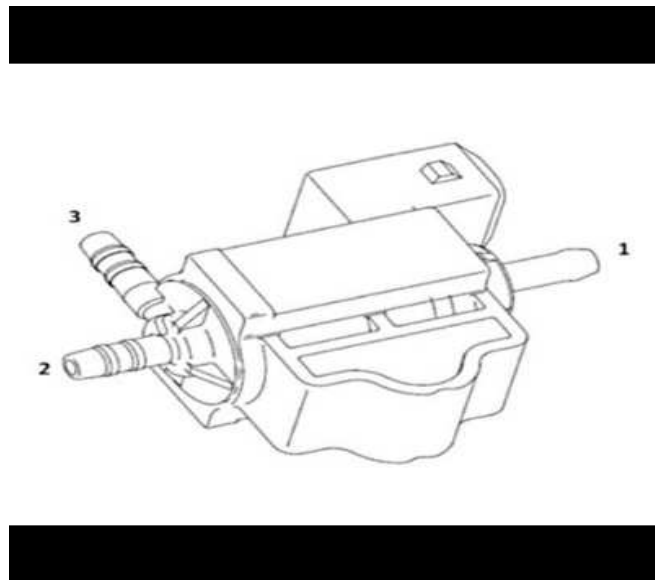
6055068

**Note:** Check port #2 to assure the spring gets lifted off the seat. This will be determined by the compressed air not dead heading when applied to port #2. When applying air to this port a small amount of air should be observed at port #3 and even less air will be noticed at port #1. If this does not happen, the TCV plunger may have hardened deposits from hot operating conditions

which will impede TCV plunger movement, and the turbocharger wastegate regulator solenoid valve should be replaced.

3. Using clean shop air regulated to 80-100 PSI, blow through all three ports (1, 2 & 3) for 5 seconds each.

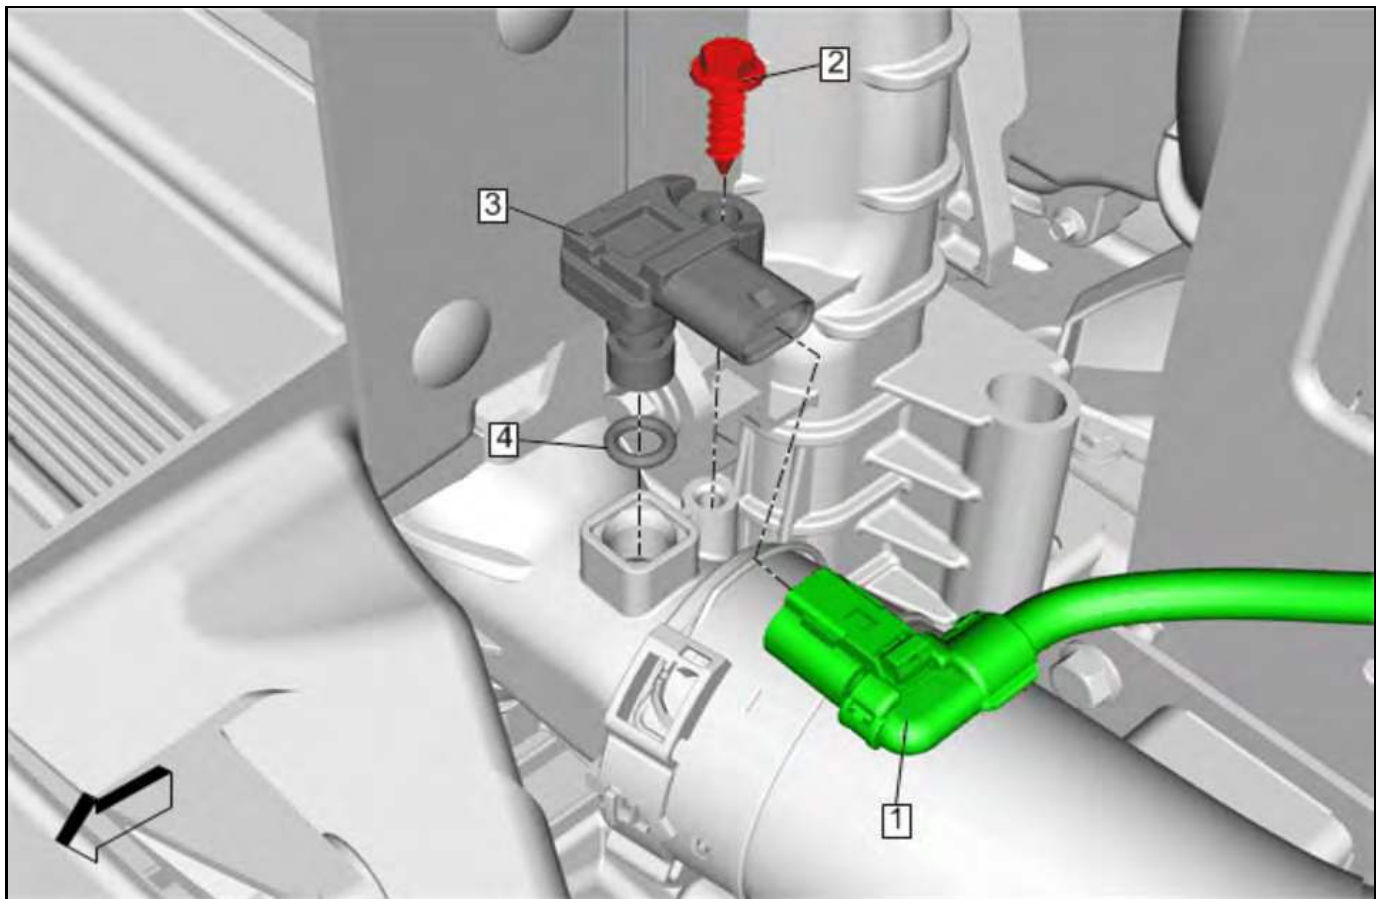
2. Inspect the sensor for any contaminates.

1. Remove the turbocharger air pressure sensor (3). Refer to Turbocharger/Supercharger Boost Pressure Sensor Replacement in SI.

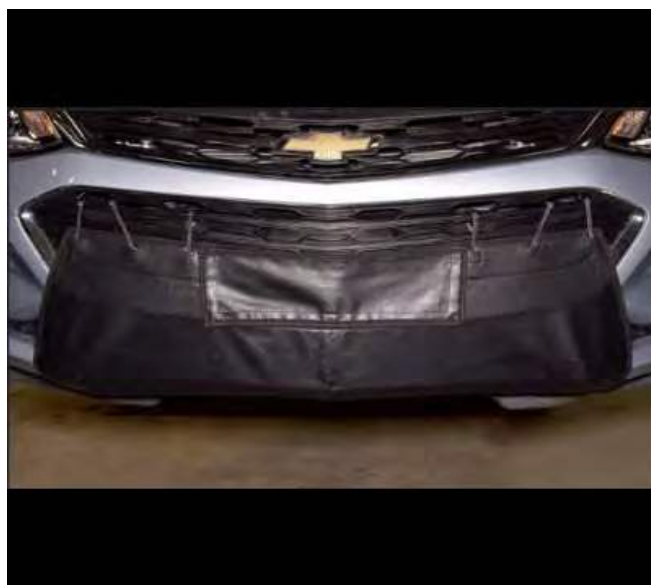
Warning: Remove grille cover during temperatures above 32 F/0 C to prevent engine and transmission overheating. Remove grille cover before towing a trailer of any size. Failure to do so will decrease transmission cooling efficiency and possibly cause damage to the drivetrain.

Install the service winter grille cover around the front bumper to prevent ice-build in the CAC. The installation instructions will be provided with the service part.
