**01-19-05TT - Engine Crank, No Start or No -J623- ECM Communication with DTC U0100 Stored in ECM Fault Memory**

2/22/2024

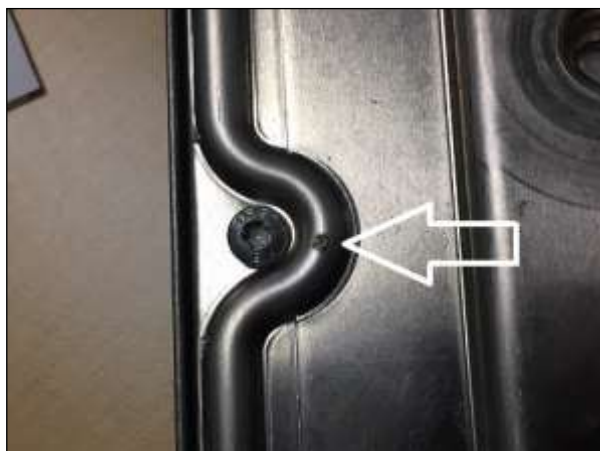
Figure 1

When disconnecting the Battery during service, the **-J623-** (ECM) may become internally shorted as a result of the Positive Battery Terminal grounding out on the ECM case. DTC U0100 may set, as well as an engine crank with no start condition.

When disconnecting or replacing a Battery, the Repair Manual procedure outlined in Elsa must be followed in its entirety. See Repair Manual Group 27. The Battery Ground Cable must always be disconnected prior to the Battery Positive Cable. Failure to do so may result in internal ECM damage.
