# Service Bulletin

Bulletin No.: 24-NA-020

**Subject:** Information on Service Emissions System Displayed on Drivers Information Center (DIC), Malfunction Indicator Lamp (MIL) Illuminated - DTC P249C and/or P20E8 Set

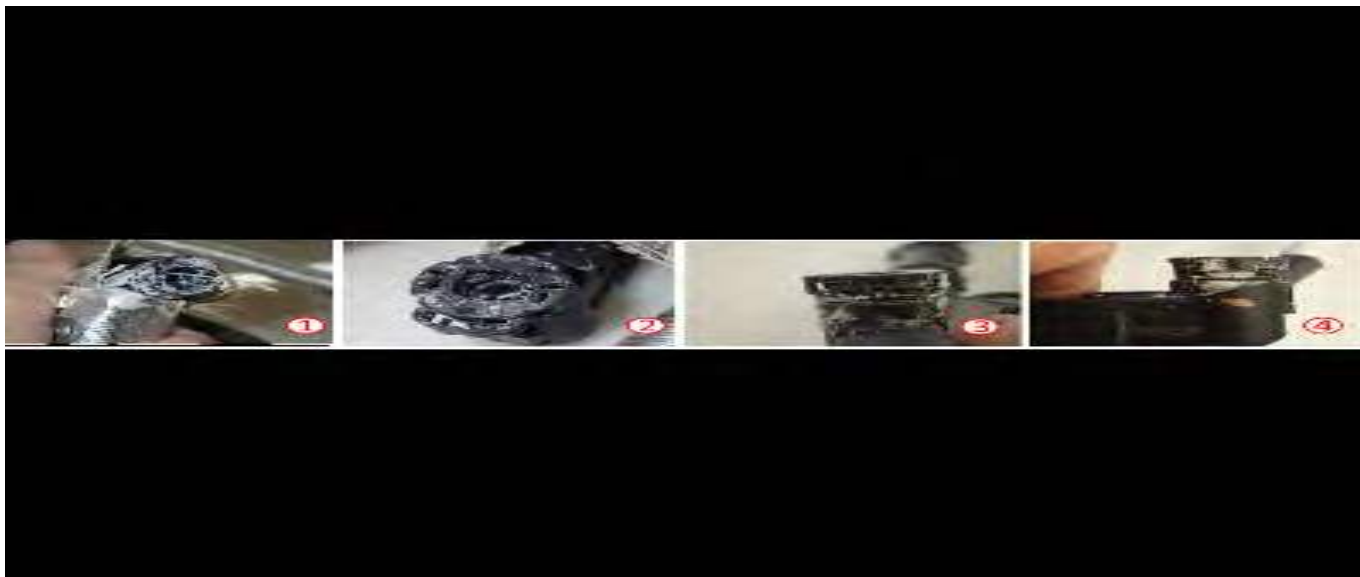
6531871

- Example of a DEF pipe with crystallized DEF. This can be cleaned using the procedure below.

The Emission Reduction Fluid Exhaust Front Pipe Injector Supply Pipe may be contaminated with crystallized DEF in or around the connector. This procedure outlines the correct cleaning procedure before attempting to re-connect the Emission Reduction Fluid Exhaust Front Pipe Injector Supply Pipe to the Reductant Fluid Injector or the Emission Reduction Fluid Pump Outlet Port.

1. Fill a clean container with fresh water.
2. Remove or pull back the heat protecting hood from the Emission Reduction Fluid Exhaust Front Pipe Injector Supply Pipe connector end if present.
3. Fully disconnect the Emission Reduction Fluid Exhaust Front Pipe Injector Supply Pipe connector from the Reductant Fluid Injector or the Emission Reduction Fluid Pump Outlet Port by following the

4. Submerge the Emission Reduction Fluid Exhaust Front Pipe Injector Supply Pipe connector end into the container filled with clean water, ensuring the open end of the connector is facing up and hold for 1 min. Swash around the connector while it is submerged in water for another minute to dislodge any crystals embedded inside the connector.

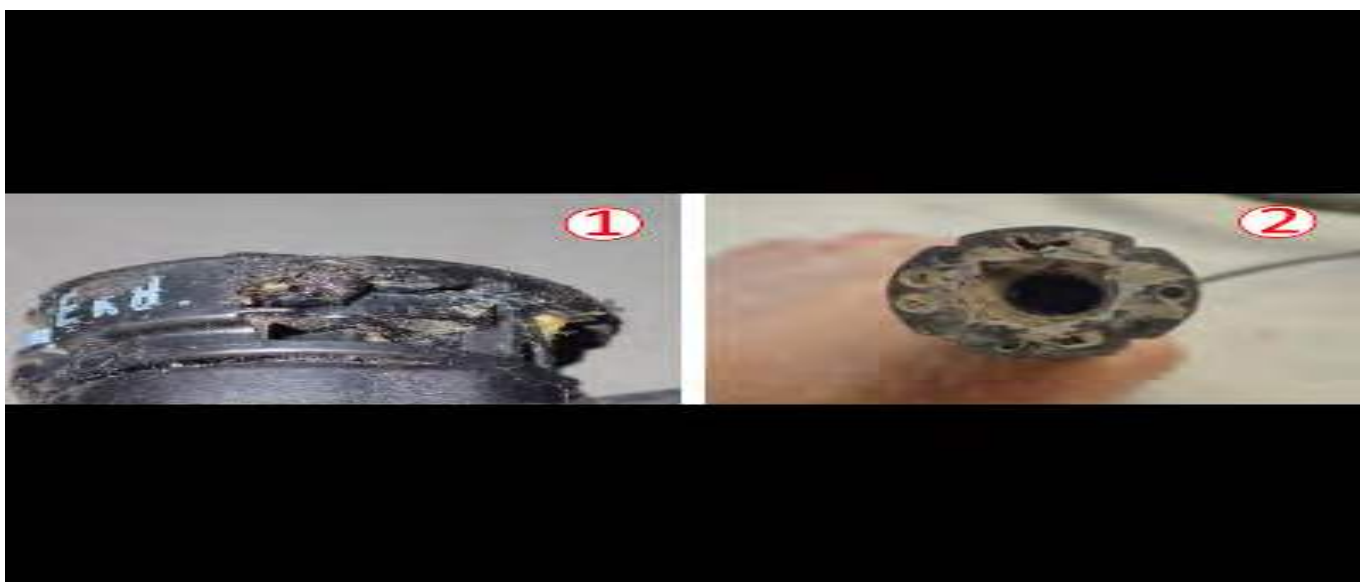
6531860

Note: This procedure cannot be performed if the Emission Reduction Fluid Exhaust Front Pipe Injector Supply Pipe connector is contaminated with other forms of contaminants such as frame wax or dirt inside the connector. If this is the case, do not perform the cleaning procedure as the Emission Reduction Fluid Exhaust Front Pipe Injector Supply Pipe will need to be replaced.
