## Technical product information

| Topic | Bentayga V8 Kovomo - DTC P227900 evident within the engine control unit 0001 |
| Brand | Bentley |
| Transaction No. | 2071575/2 |

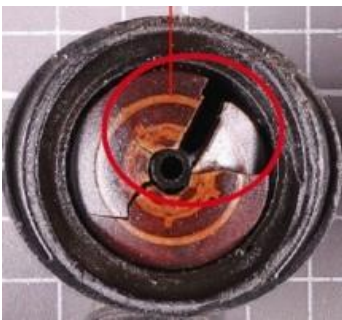
Figure 1

The issue described is due to a split breather diaphragm in one or both of the turbocharger full load pipes (Figure 1)

**The diaphragm of the bank 1 turbocharger full load pipe is located at the end of the pipe and can be easily located however the diaphragm of the bank 2 turbocharger full load pipe is installed within the pipe and therefore will not be visible**

Hint: the breather diaphragm could be split/damaged or missing

**Hint:** The diaphragm of the A,B and E suffix parts is orange (Figure 1)

1) Referring to Rep.Gr 21 - Replace the bank 1 (right) and bank 2 (left) turbocharger full load pipes

The operative should remove any debris belonging to the original diaphragm before fitting the new replacement pipes
