# Technical product information

| Topic | DTC P04F000 EVAP system high pressure purge line performance DTC logged |
| Brand | Bentley |

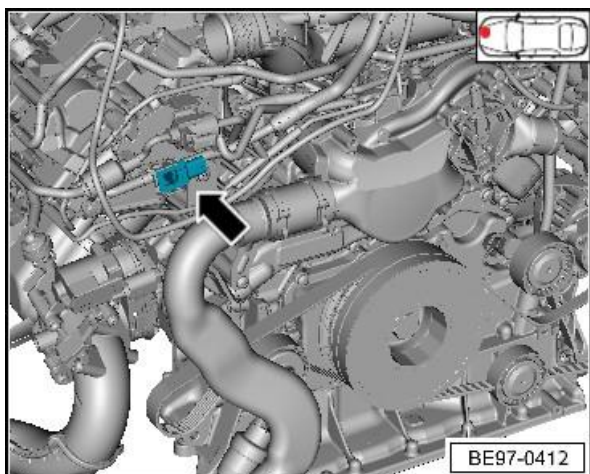
Figure 2

The DTC is related to mismatched terminal locations of the Pressure sensor for the activated charcoal filter system – G804 (Figure 2)

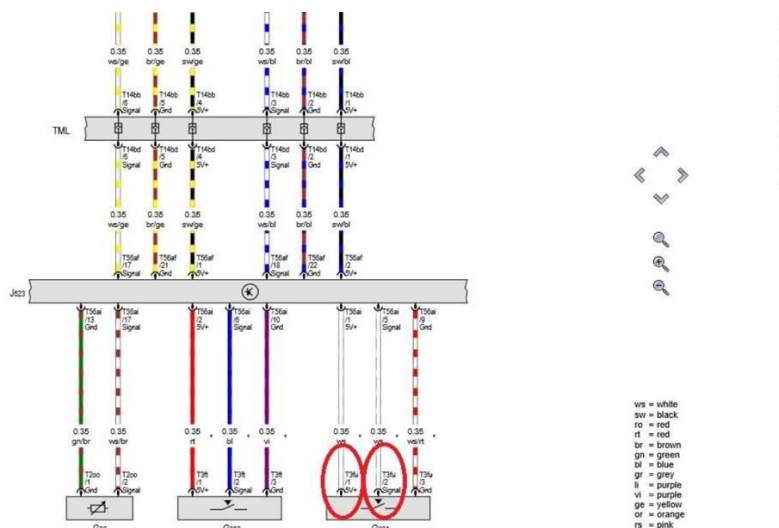
Figure 3

1) Refer to Wiring diagram 106/18 within Elsa pro (Figure 3)

2) Should the terminal locations **NOT** be as shown in Figure 3, the terminals should be reallocated within plug as per the wiring diagram

- Refer to Repair manual Rep.Gr 20 - Tank ventilation pressure sensors - To remove and fit to gain access to the sensor connection
- Reallocate the sensor terminals as per Elsa pro wiring diagram instruction
