# Technical product information

| Topic | V8 Kovomo - Engine MIL light on - DTC 'P04F000: EVAP system high pressure purge line performance' evident |

V8 Kovomo - Engine MIL light on - DTC 'P04F000: EVAP system high pressure purge line performance' evident

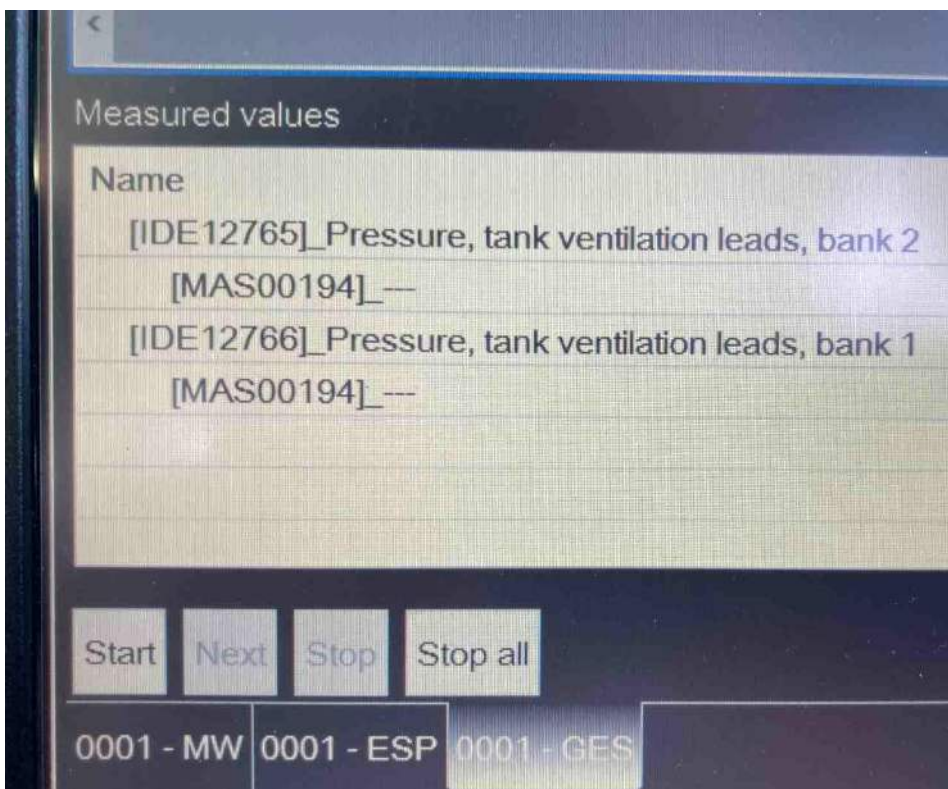
Figure 1

Referring to Figure 1:

IDE12765 (When monitored) fluctuates from the static value found (Ignition on/Engine Off)

With/without purge activation

IDE12766 (When monitored) DOES NOT fluctuate from the static value found (Ignition on/Engine Off)

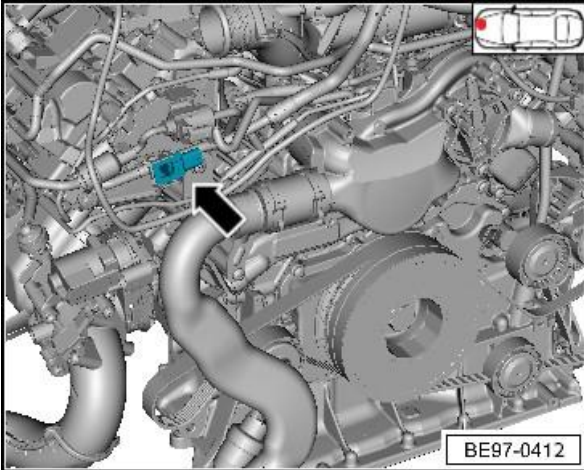
- Referring to Figure 2 - Locate the Pressure sensor connector (T3dd) for the activated charcoal filter system (G804)

- Disconnect T3dd
- Disconnect T56aj from the Engine control unit (J623)
- Referring to the applicable wiring diagram within in Elsa pro - Conduct a wiring integrity check

From T3dd (PIN's 1 and 2) - To Connector T56aj (PIN's 1 and 5)
