# Technical product information

| Topic | Engine overheating - Warning on the DIP - V8 Kovomo |
| Brand | Bentley |
| Transaction No. | 2061369/6 |

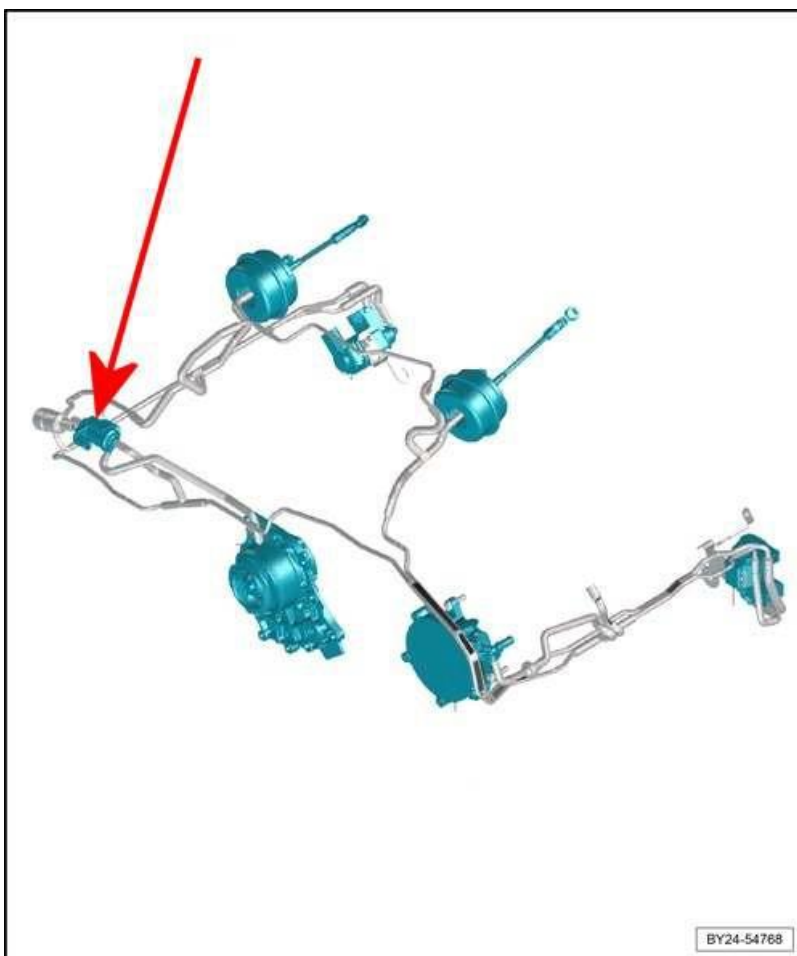
Figure 1 Shows Bentayga (Arrow)

- The switch valve for mechanical coolant pump N649 is designed to cut off the vacuum supply to the coolant pump when the engine reaches maximum temperature, the vacuum cut off allows the engine to start circulating coolant by retracting a sleeve which is situated around the coolant pump impeller

**TIP:** When the switch valve for mechanical coolant pump N649 is at fault (sticking open) the vacuum supply is constant, this allows the sleeve to stay in position around the impeller which leads to the symptoms described within the Customer statement/Workshop findings section of this TPI

1) Referring to Figures 1,2 and 3 - With care (visually monitor for any traces of coolant) disconnect each vacuum hose from the switch valve for mechanical coolant pump N649

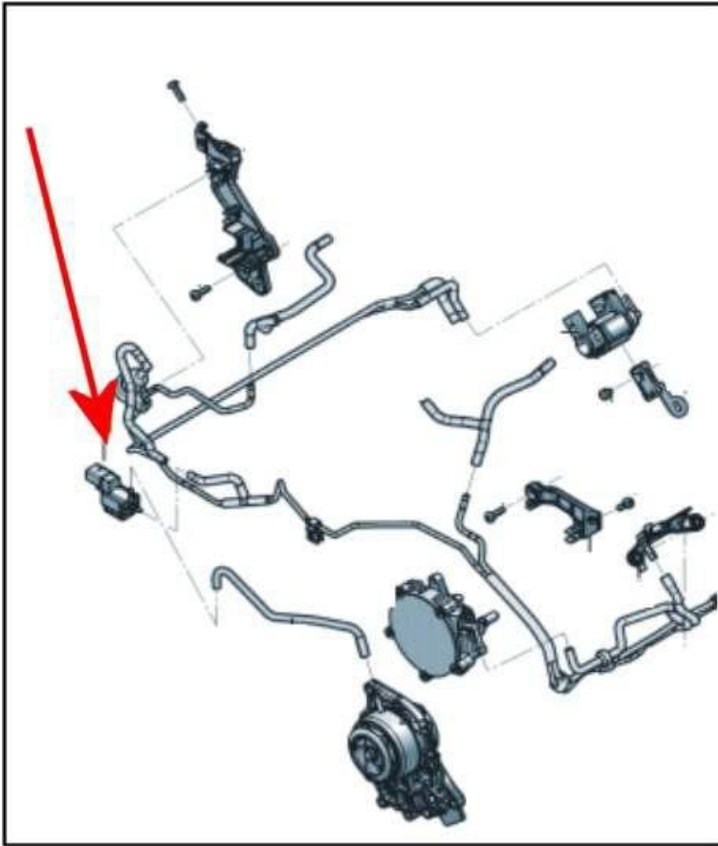
Figure 2 Shows New Continental GT/ GTC and Flying Spur (Arrow)

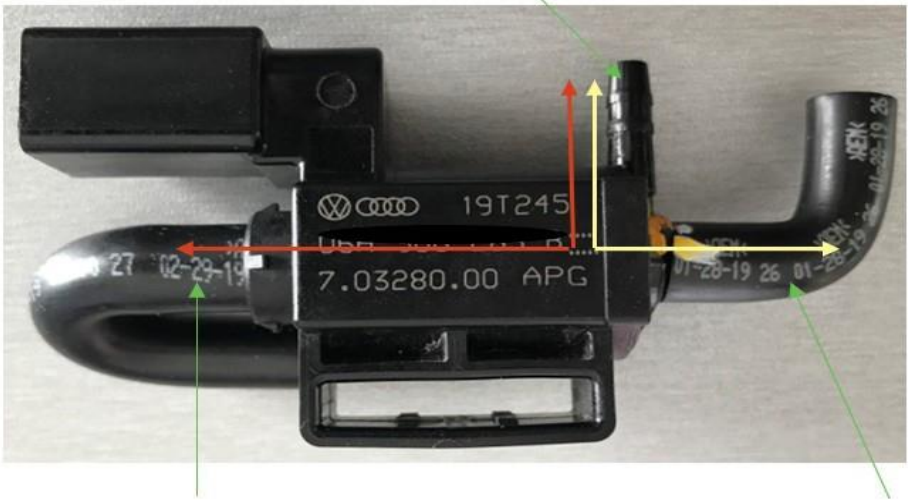
- Referring to Figure 3 the standard operation of N649 (with no operational issues) is as follows:
- Un-energised state (Ignition off) = coolant pump connected to vent connection (red arrows)
- Energised state (Ignition on) = engine vacuum connection to coolant pump (yellow arrows)

**IMPORTANT:** The switch valve for mechanical coolant pump N649 fails due to an internal leak from coolant pump causing corrosion within the unit from coolant migration

- Coolant pump
- Coolant regulator (Thermostat)
- Switch valve for mechanical coolant pump N649
