## Ignition Lock Error B143C29

### Vehicles Affected

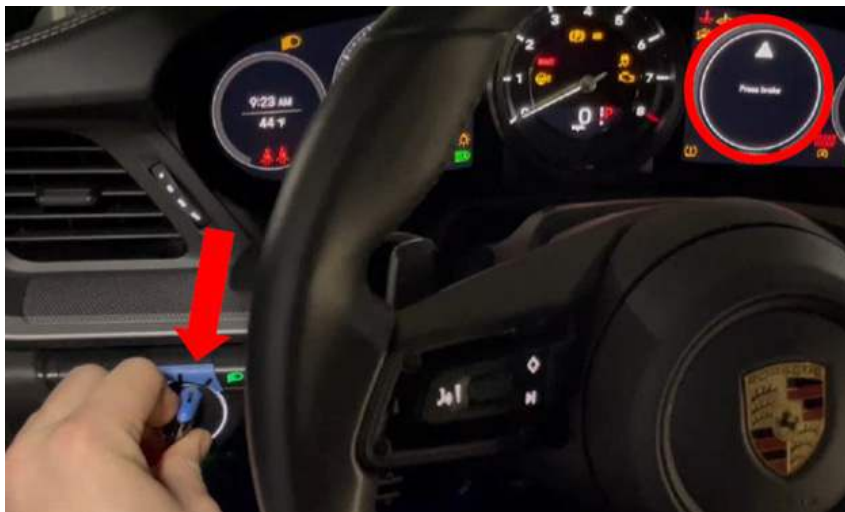
**Figure 1**

If the ignition switch is not fully engaged to start the engine, one of the four signals will not be switched (open line). However, due to the design of the redundant system, the engine will still start. If the diagnostic for this signal continuously sees an open line, the fault will eventually be set in the BCM2.

Please advise the customer to fully engage the ignition switch to start the engine each time to ensure the system functions as designed and a real fault can be diagnosed. The image below shows a partial switch engagement, which will lead to this fault after enough occurrences. Since this is a redundant system, the engine will start and there will be no warning that it is being misused until the diagnostics eventually sets the fault after the threshold is reached.
