## Subject: DTC U3000 Setting in Automated Map Module (HDLM) - SuperCruise Unavailable

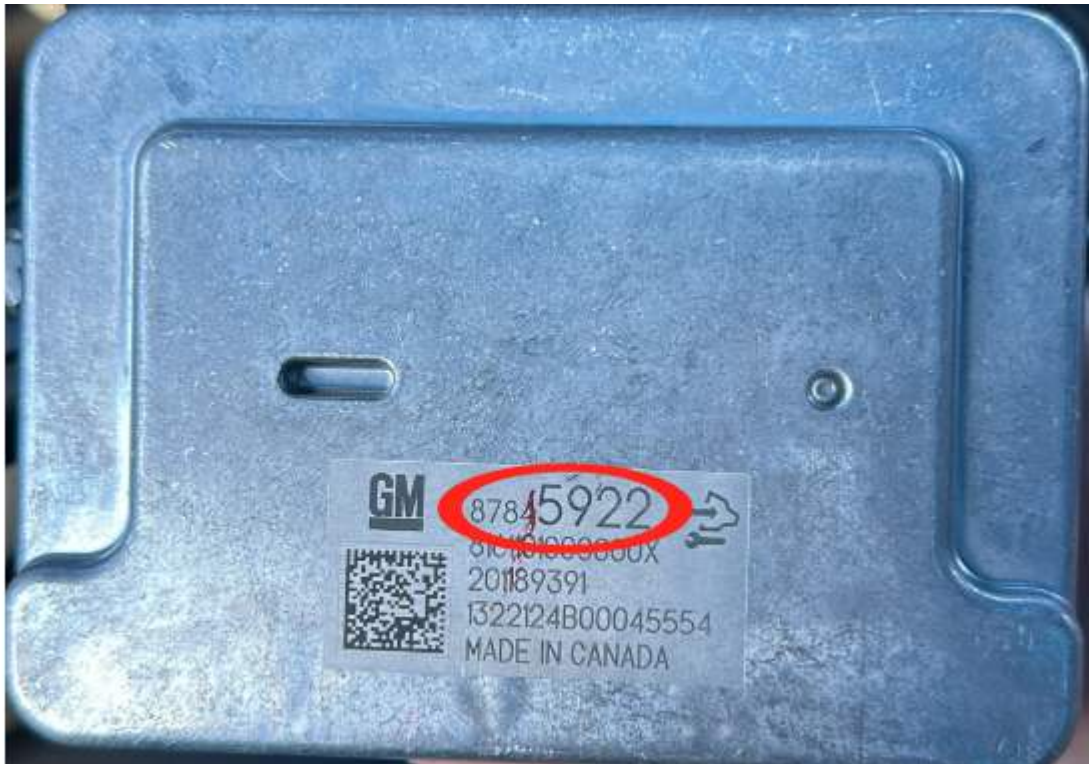
6553204

If one of these Map module part numbers listed in Parts Information is not installed in the vehicle, and the map module is setting the U3000 DTC with SuperCruise being unavailable, do not replace the module until additional diagnostics through SI are completed.

| <b>Correction</b> | Technicians are asked to verify the condition by driving on 2 different verified SuperCruise roads. Replace the HDLM module if, and only if, the part number of the HDLM in the vehicle is listed in Parts Information.<br><br><b>Important:</b> Please refer to the Electronic Parts Catalog (EPC) to order the latest release part number for this module. |
