## TECHNICAL SERVICE BULLETIN

### Equipped With Minor Feature Code HUKAJ - 400 Watt DC/AC Inverter System Inoperative With B1330:9A In The BCM

24-2039

Ford  
2021-2023 F-150

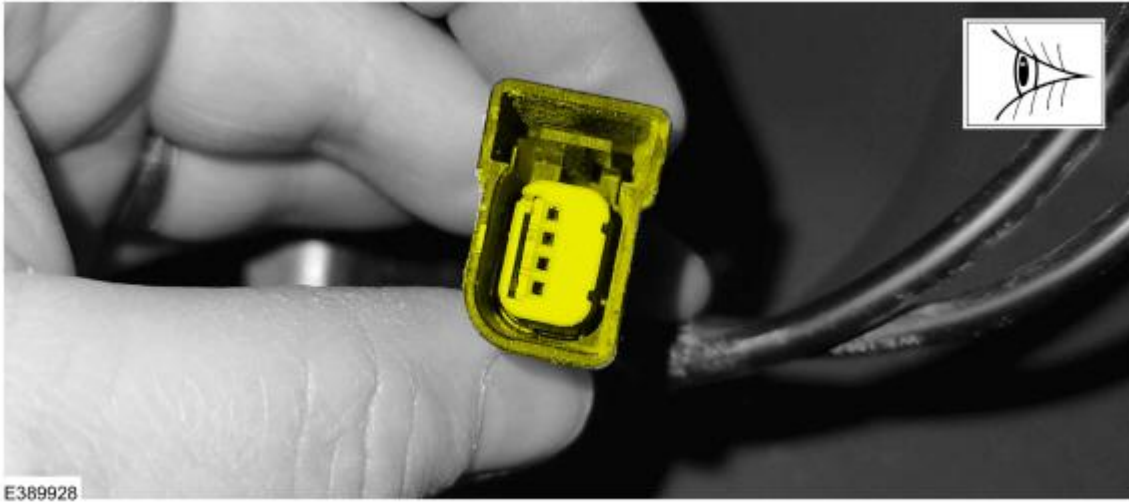
Figure 2

3. Inspect connector C4628 for the presence of corrosion, dirt and/or damage. Is corrosion, dirt and/or damage present in connector C4628? (Figure 2)

- (1). Yes - replace the pickup bed AC power outlet socket assembly. Refer to WSM, Section 414-05. Replace the body side harness assembly (13A409) of connector C4628. Proceed to Step 4.
- (2). No - proceed to Step 4.
4. Install a new pickup bed AC power outlet socket harness retainer 4.3 in. (110 mm) from the back of the pickup bed power outlet harness connector. If the pickup bed AC power outlet socket has been replaced, remove and discard the factory-installed harness retainer and install the new harness retainer. (Figure 3)

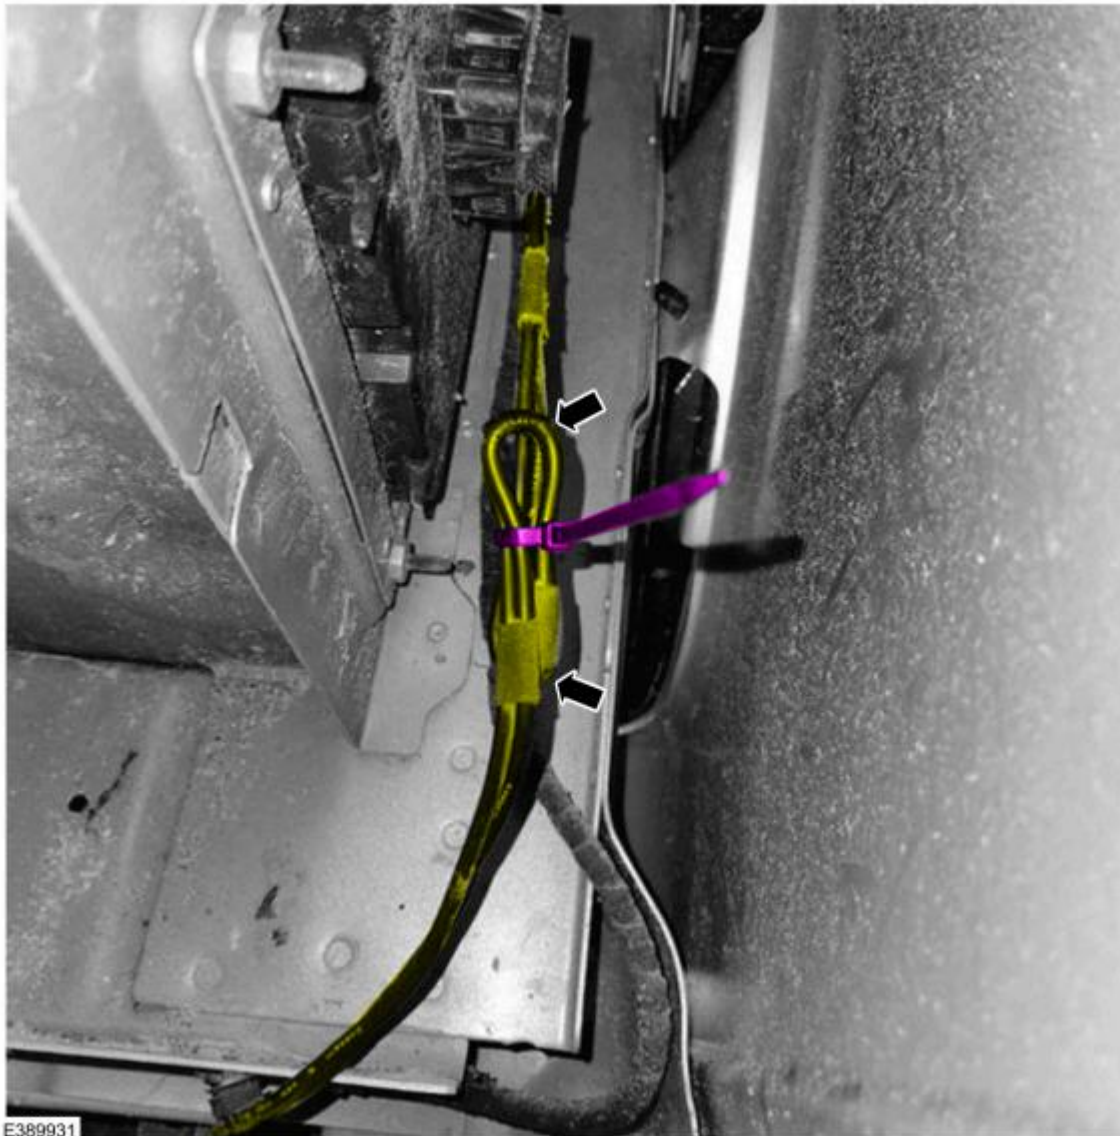
Figure 5

**CAUTION:** The bend radius of the pickup bed AC power outlet socket harness should be no less than 4 mm. Hard kinks and tight bends of the pickup bed AC power outlet socket harness can lead to wire damage.

6. Fold approximately 7 in. (185 mm) of the remaining/loose pickup bed AC power outlet socket harness in 2 bends just behind the pickup bed AC power outlet socket panel. Secure the folded wire with a wire tie. Inspect the routing of the harness to make sure it is not pulled too tight against the body sheet metal near the harness retainer and provides just enough length. (Figure 5)
