# Technical Service Bulletin

**01 Car jerks/bucks or hesitates while driving DTCs P023600 and/or P010600 are stored in the ECM**  
01 24 11 2062323/3 March 4, 2024. Supersedes Technical Service Bulletin Group 01 number 21-13 dated October 20, 2021 for reasons listed below.

| Model(s) | Year | VIN Range | Vehicle-Specific Equipment |
|---|---|---|---|
| A6 | 2019 – 2022 | All | 2.0l engine |

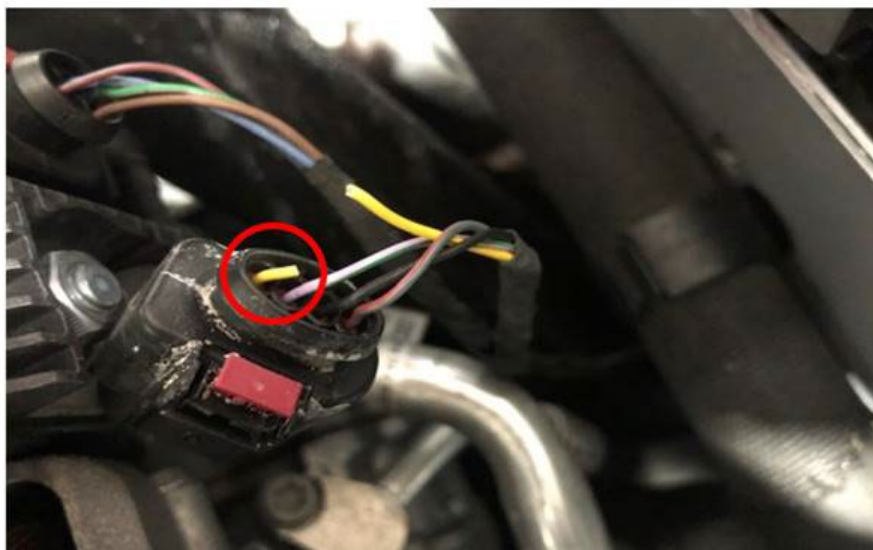
- The yellow wire on the electrical connector of the charge pressure sender is damaged.

Due to the routing of the wiring and the length of wiring that is uncovered, the wiring may become damaged due to vibrations.

*Figure 1. Wire is broken at G31 sensor.*

1. If damage is found to the pins or wire at the G31 boost pressure sensor, repair the harness using VAS 1978B (Figure 1).

Please use gold-plated contacts to repair the damaged wire(s) (000 979 025 EA).

Ensure there is sufficient slack in the harness to prevent future issues.

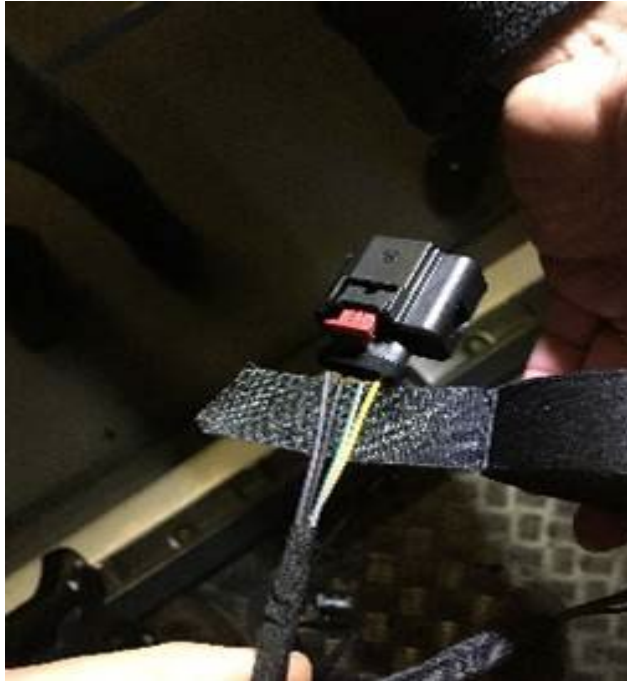
*Figure 2. Harness is wrapped using textile tape 105 920 02.*

2. Following repairs, the harness must be wrapped with textile tape **N 105 920 02**.

Apply the textile tape starting at the wiring below the connector. Ensure the wires are kept flat to avoid over stressing the pins (Figure 2).

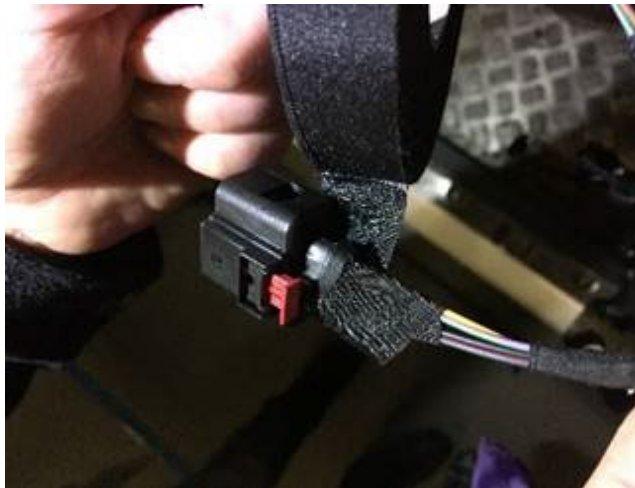
*Figure 3. Wrapping the connector base.*

3. Wrap the tape in the direction of the connector keeping it **flat** (Figure 3).
