## Technical product information

| <b>Topic</b> | New Continental GT and GTC - Window drop glass operation |
| <b>Transaction No.</b> | 2070497/7 |

Retailer glass reset procedure for GT/GTC

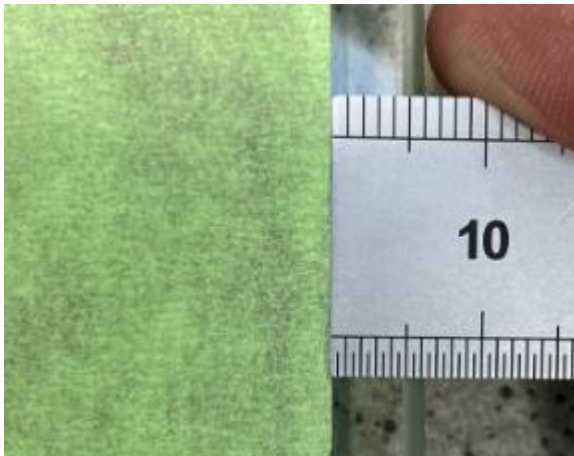
Example of incorrect fitment:  
10mm intrusion into division bar seal not achieved. Only 6mm seen, front and rear side glasses will be too far rearwards, potentially clash condition between rear of rear glass and cant rail/roof seals

When reinstalling front drop glass ensure tape is applied at 10mm from front edge and align this with the previously set quarter glass division bar.
