# Technical Service Bulletin

## 94 Warning for 3rd brake light: DTC B12C615

94 24 75 2073316/1 March 12, 2024.

| Model(s) | Year | VIN Range | Vehicle-Specific Equipment |
|---|---|---|---|
| A3, S3, and RS 3 | 2020 - 2024 | All | Not Applicable |

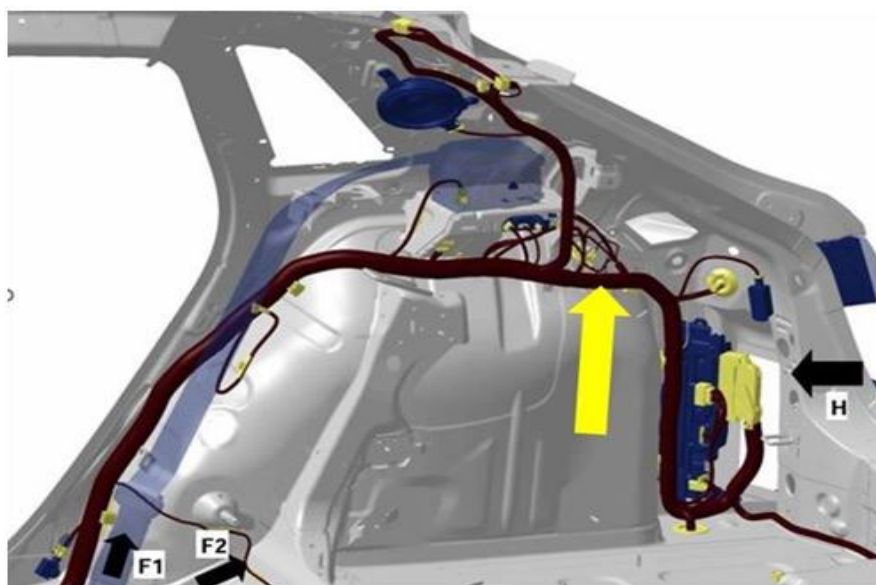
The suppression capacitor C24 is located near the yellow arrow on the right side of the luggage compartment. (Figure 1).

**Figure 1:** C24 location near the ground stud 22.

5. Remove the suppression capacitor C24 using the steps below:

- Gain access to the C24 suppression filter.

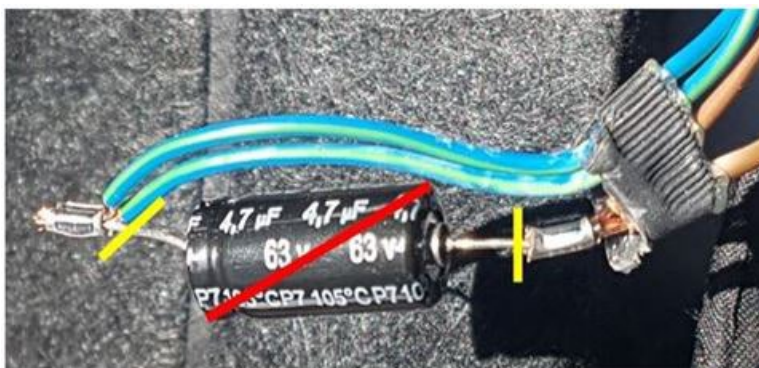
**Figure 2:** Suppression capacitor C24.

- Remove the heat-shrink from around the capacitor.
- At the yellow highlighted area, cut and remove the capacitor from the wiring harness (Figure 2).

- Insulate the exposed crimps using heat-shrink hose from **VAS 1978B** wire harness repair set and then wrap the wiring harness in fabric adhesive tape **N 10592002**
