# Preliminary Information

## PIT6128 Side Blind Zone Not Working / Super Cruise Does Not Perform Lane Changes / U3000 SYM76 Set in Rear Short Range Radar

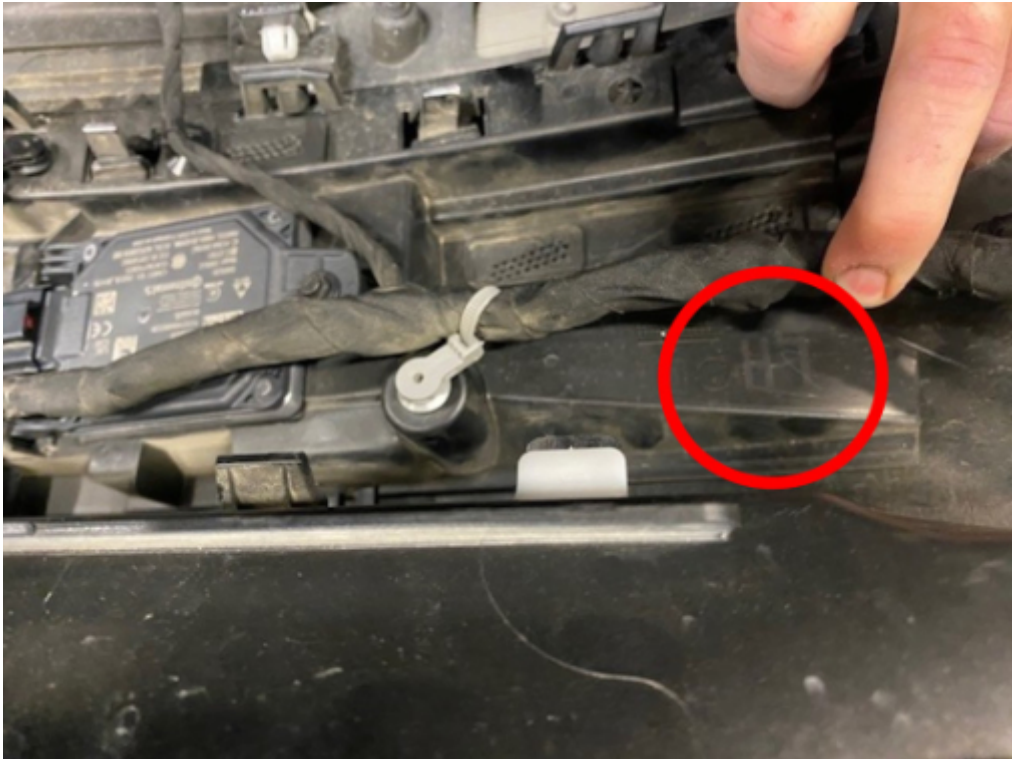
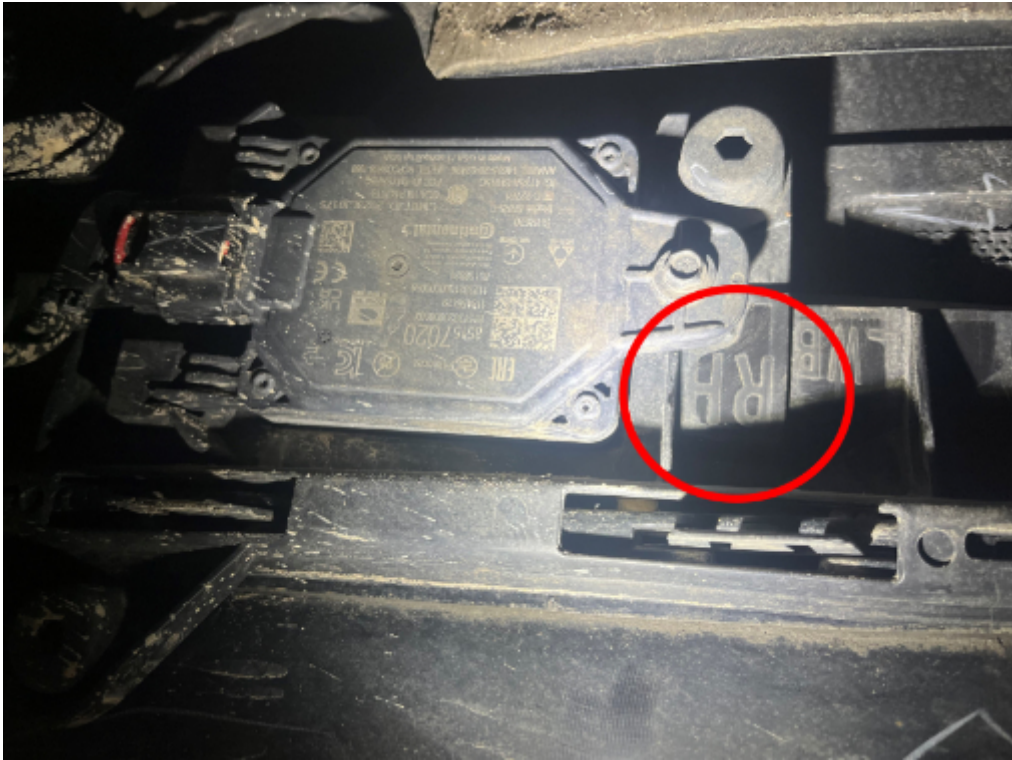
| Condition | Some customers may comment that the Side Blind Zone is not operating and/or when Super Cruise is engaged it will not change lanes as expected. Technician will find U3000 SYM76 set in one or both Rear Short Range Radar Modules. |
| Cause | The Rear Short Range Radar Brackets may be installed on the incorrect sides or two of the same brackets may be installed on the rear fascia. The brackets are heat staked to the rear fascia and cannot be replaced. |

Inspect the Rear Short Range Radar Brackets for being installed on the incorrect side by looking for "LH" / "RH" markings as shown below. If a bracket is found to be installed on incorrect side, replace the rear fascia. After replacing the rear fascia, the vehicle may need to be driven for several hours for the system to complete the automatic radar alignment procedure as referenced in Side Blind Zone Alert Description and Operation in SI. If brackets are found to be in the correct location, follow SI Diagnostics for the DTC.
