## Technical Service Bulletin (TSB)

### Radio Over The Air Update to U29.42 Software Version

| REFERENCE: | TSB: 08-008-24<br>GROUP: 08 - Electrical | Date: | January 6, 2024 | REVISION: | - |
| VEHICLES AFFECTED: | 2024 (WS) Grand Wagoneer/Wagoneer<br>This bulletin applies to vehicles built on or before November 15, 2023 (MDH 1115XX) equipped with a Global Telematics Box Module (TBM) (Sales Code RDG) and one of the following radios: <ul style="list-style-type: none"><li>Uconnect 5 NAV W 8.4" Display (Sales Codes UBL or UEL).</li><li>Uconnect 5 NAV W 10.1" Display (Sales Codes UBN or UEN).</li></ul> | | | MARKET APPLICABILITY:<br><div><input checked="" type="checkbox"/> NA<input type="checkbox"/> MEA<br/><input type="checkbox"/> SA<input type="checkbox"/> IAP<br/><input type="checkbox"/> EE<input type="checkbox"/> CH</div> | |

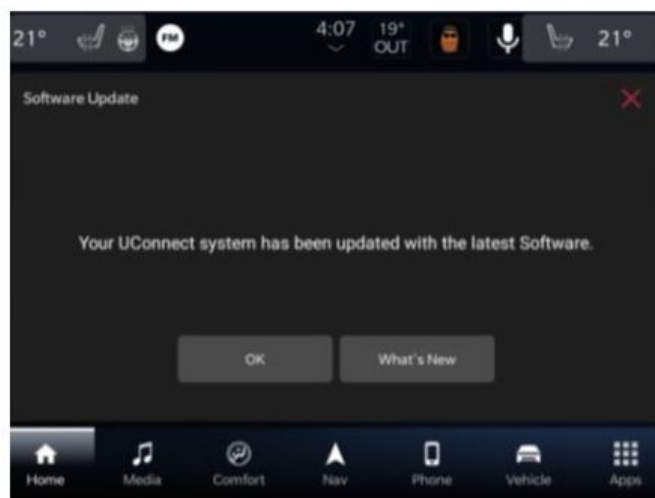
**Fig. 2**

Software Update Confirmation Screen

3. Upon completion of update, the radio will display a confirmation message [Fig. 2](#).
