## Technical Service Bulletin (TSB)

### Flash: Powertrain Control Module (PCM) Updates

| REFERENCE: | TSB: 18-007-24<br>GROUP: 18 - Vehicle Performance | Date: | January 25, 2024 | REVISION: | 18-056-22 REV. A |
| VEHICLES AFFECTED: | 2019 (DD) RAM 3500 Cab Chassis<br>2019 (DP) RAM 4500/5500 Cab Chassis<br>This bulletin applies to vehicles equipped with a 6.7L I6 Cummins Turbo Diesel Engine (Sales Code ETN). | | | MARKET APPLICABILITY:<br><input checked="" type="checkbox"/> NA<br><input type="checkbox"/> SA<br><input type="checkbox"/> EE<br><input type="checkbox"/> MEA<br><input type="checkbox"/> IAP<br><input type="checkbox"/> CH | |

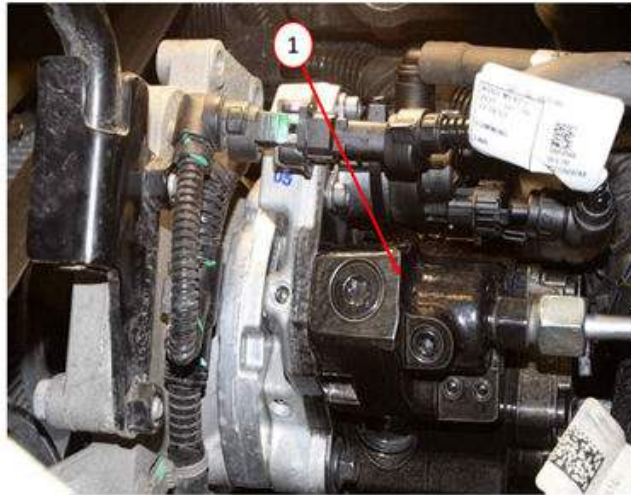
**Fig. 1**

**NOTE:** The only calibration available will be for the updated CP3.3 design high-pressure fuel injection pump [Fig. 1](#). Please ensure that recall Y78 has been completed first before proceeding with this update.

New Design CP3.3 Design Fuel Injection Pump

1 - New ICP3.3 Design High-Pressure Fuel Injection Pump From Top View

1. Inspect the high-pressure fuel injection pump [Fig. 1](#) to verify which pump is currently installed on the vehicle. **Also review the vehicle VIP report to see if campaign Y78 has been performed.**
