# Technical Service Bulletin

## 48 DTC B116831 is stored in the ABS control module

48 24 65 2063526/3 March 21, 2024. Supersedes Technical Service Bulletin Group 48 number 22-32 dated April 28, 2022 for reasons listed below.

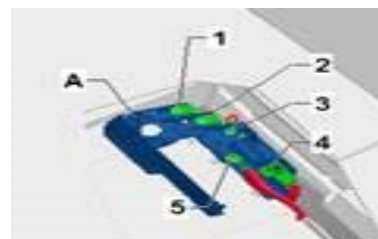
There is a voltage drop in power steering control module, J500 (address word 0044).

- This DTC is logged in the power steering control module, J500 (address word 0044) briefly, because it does not participate in the data bus communication during the start procedure.
  - This can be caused by a voltage drop in the power steering control module, J500 (address word 0044).
1. When the vehicle is started, the voltage should not drop by more than 1 Volt at contact 4 on the fuse carrier. This is the power supply to the power steering control module, J500 (address word 0044) (Figure 1).

**Figure 1.** Fuse carrier's power supply to the power steering control module, J500 (address word 0044).

2. If the voltage drops more than 1 Volt then the fuse carrier must be replaced. Replace the fuse carrier according to the instructions in the Elsa Repair Manual.

3. If this procedure does not lead to an improvement, continue the diagnosis on other components of the power supply for the power steering. Review the battery history data to help find the voltage drop.
