NUMBER  
PI1802Y/Z (Rev 7, 03/22/2024)

### ENGINE REPLACEMENT INSTRUCTIONS FOR DTC P1326 (PI1802Y/Z)

This bulletin provides information related to the Technical Service Bulletin previously published [PI1802](#) titled "Knock Sensor Detection System - ECU Logic Improvement" equipped w/THETA II engine. Specifically, this bulletin provides instructions on which procedures to follow if, after installation of the KSDS, any one of the subject vehicles below returns to the dealer with Diagnostic Trouble Code (DTC) P1326 (Knock Signal Range/Performance).

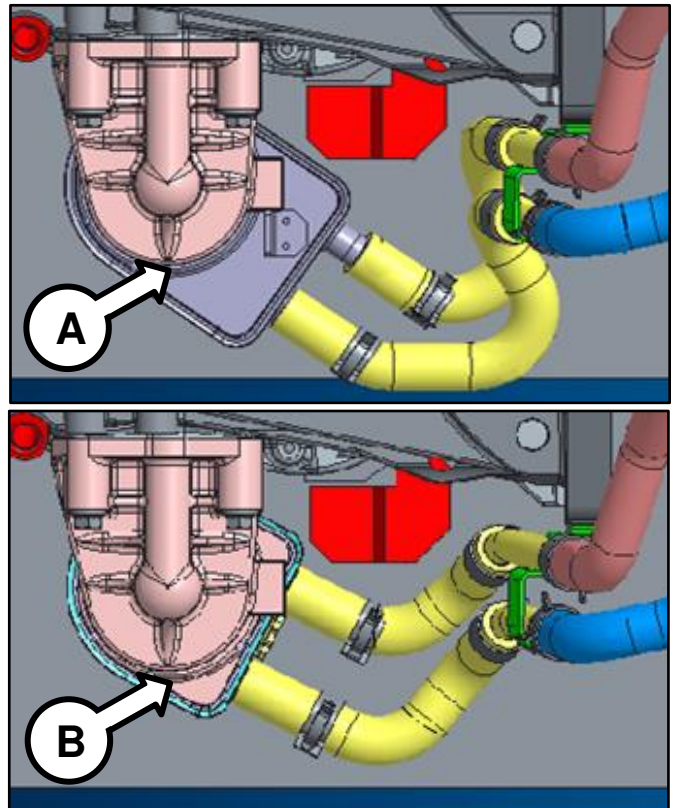
New engines may be supplied with a different oil cooler. Use steps below to determine the need for a replacement oil cooler tube assembly.

- If the new engine's (bigger) oil cooler (A) does not match the old engine's (smaller) oil cooler (B), replace the oil cooler tube assembly with the improved part. See parts table on page 16.
- If the new engine's (bigger) oil cooler (A) matches the old engine's (bigger) oil cooler (A), reuse the old engine's oil cooler tube assembly.
- If the new engine's (smaller) oil cooler (B) matches the old engine's (smaller) oil cooler (B), reuse the old engine's oil cooler tube assembly.

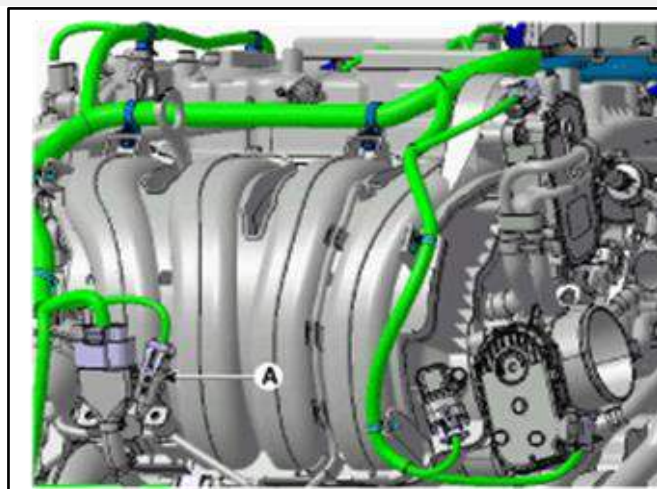
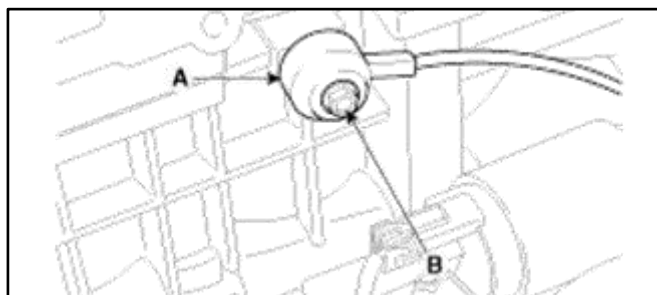
### Knock Sensor Replacement:

- Ensure the ignition is 'OFF'.
- Disconnect the battery negative (-) terminal.
- Disconnect the knock sensor (A) connector.
- Remove the intake manifold by referring to the "Engine Mechanical System → Intake Manifold → Repair Procedure" chapter in the applicable Shop Manual on KGIS.
- Loosen the knock sensor (A) retaining bolt (B) and replace the knock sensor.

### Torque Specification for bolt (B):

13.7 – 17.4 lb. ft. (18.6 - 23.5 N.m,  
1.9 - 2.4 kgf.m)

Reinstall all removed parts in the reverse order of removal and confirm normal engine operation and no DTC's.
