NUMBER  
PI1803Y/Z (Rev 7, 03/22/2024)

## PRODUCT IMPROVEMENT CAMPAIGN

### ENGINE REPLACEMENT INSTRUCTIONS FOR DTC P1326 (PI1803Y/Z)

This bulletin provides information related to the Technical Service Bulletin previously published [PI1803](#) titled "Knock Sensor Detection System - ECU Logic Improvement" equipped w/THETA II engine. Specifically, this bulletin provides instructions on which procedures to follow if, after installation of the KSDS, any one of the subject vehicles below returns to the dealer with Diagnostic Trouble Code (DTC) P1326 (Knock Signal Range/Performance).

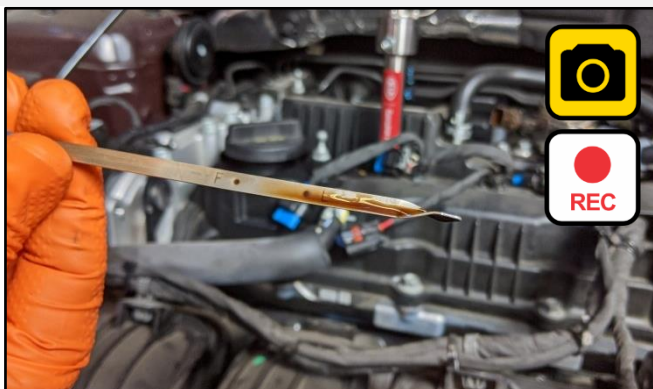
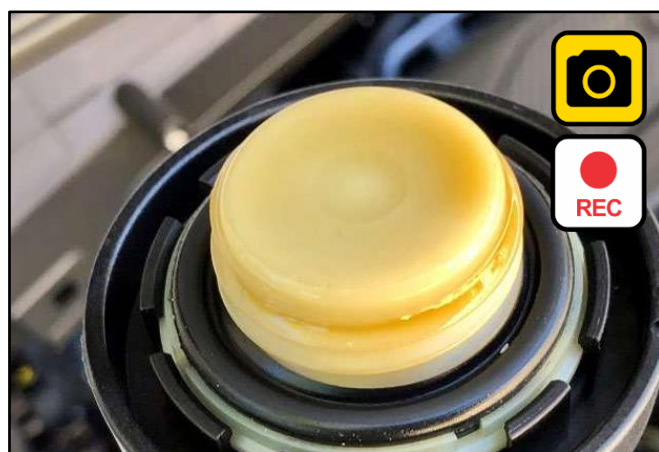
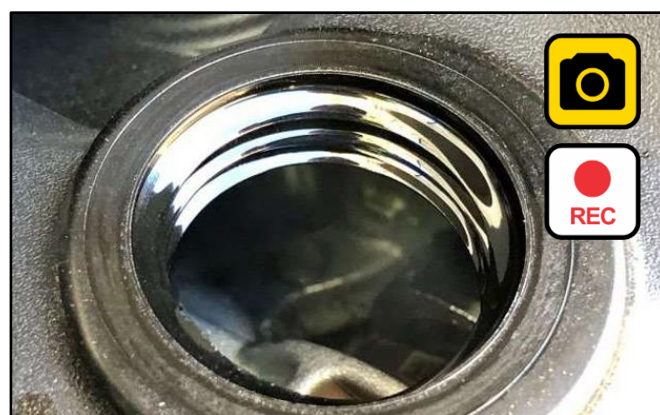
**Record/Note findings:** No oil, oil sludge, varnish, burnt oil smell condition(s) found.

If NO oil is registered on the dipstick, or oil lacquering, oil sludge and/or oil varnish is present (NG), then the engine is therefore suspect to maintenance neglect. Review of the vehicle's maintenance history is required.

If suspect, proceed to the 'Oil Level Measurement' instructions below and submit with the Techline case.

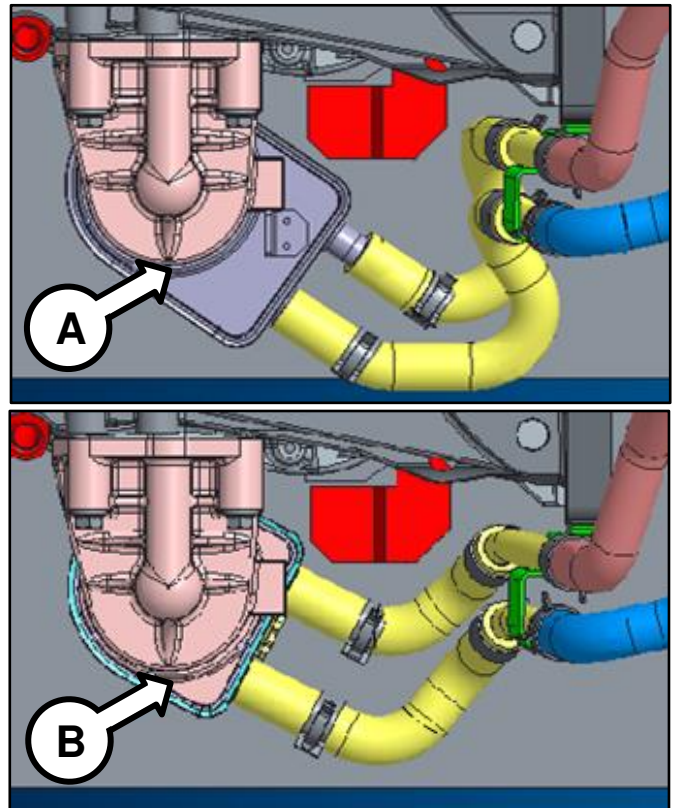
New engines may be supplied with a different oil cooler. Use steps below to determine the need for a replacement oil cooler tube assembly.

- If the new engine's (bigger) oil cooler (A) does not match the old engine's (smaller) oil cooler (B), replace the oil cooler tube assembly with the improved part. See parts table on page 23.
- If the new engine's (bigger) oil cooler (A) matches the old engine's (bigger) oil cooler (A), reuse the old engine's oil cooler tube assembly.
- If the new engine's (smaller) oil cooler (B) matches the old engine's (smaller) oil cooler (B), reuse the old engine's oil cooler tube assembly.
