# Technical Service Bulletin

## 55 Power rear lid not closing fully, rear lid lock not engaging secondary latch position, DTC B113E29, B12E015

55 24 95 2064476/4 March 22, 2024. Supersedes Technical Service Bulletin Group 55 number 24-91 dated February 19, 2024 for reasons listed below.

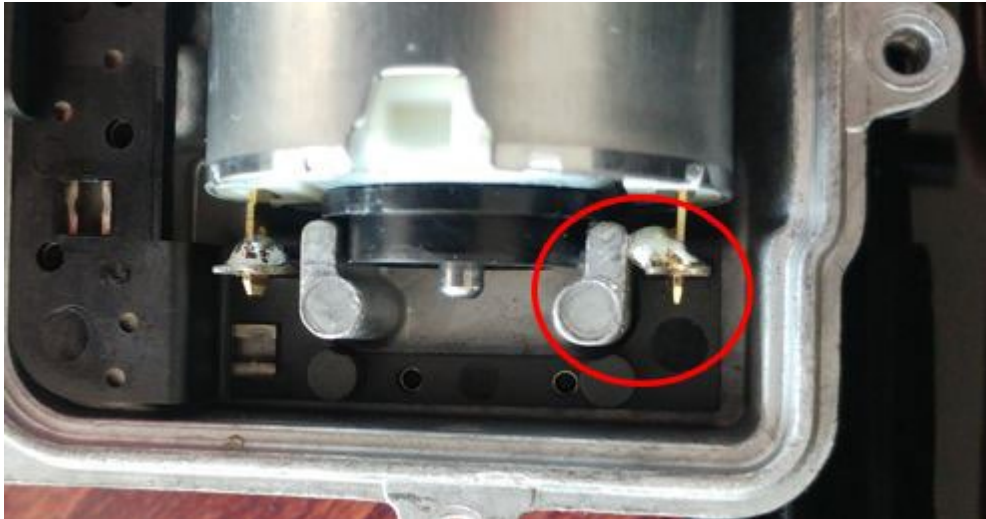
2. An improper solder joint inside the closing assist motor can cause a short circuit. This failure mode could cause DTC B12E015 to store (Figure 2).

**Figure 2.** Short circuit caused by solder joint.

Replace the rear lid closing assist motor according to the Elsa Repair Manual.

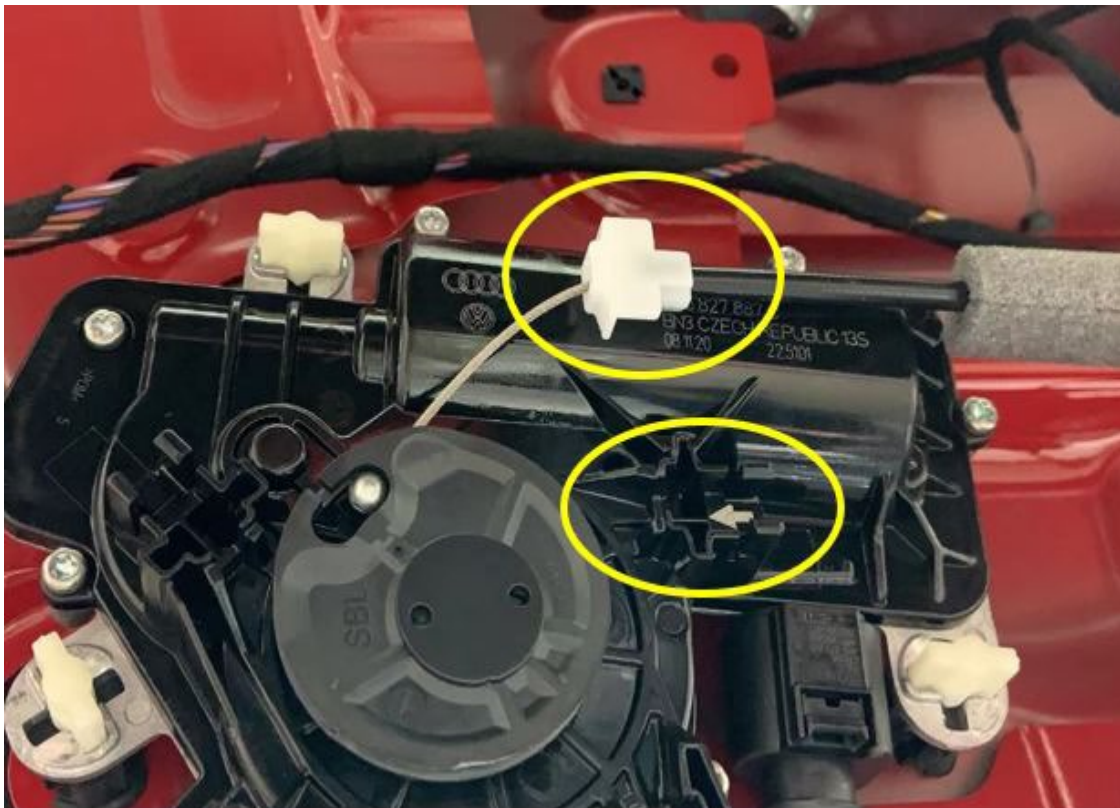
3. The Bowden cable clip has detached from the closing assist motor housing (Figure 3).

**Figure 3.** Detached Bowden cable clip.
