## Technical product information

| <b>Topic</b> | DTC P0B2500 logged within address 0021 (Battery Energy Control Module 2) - Dynamic ride system warning visible |

DTC P0B2500 logged within address 0021 (Battery Energy Control Module 2) - Dynamic ride system warning visible

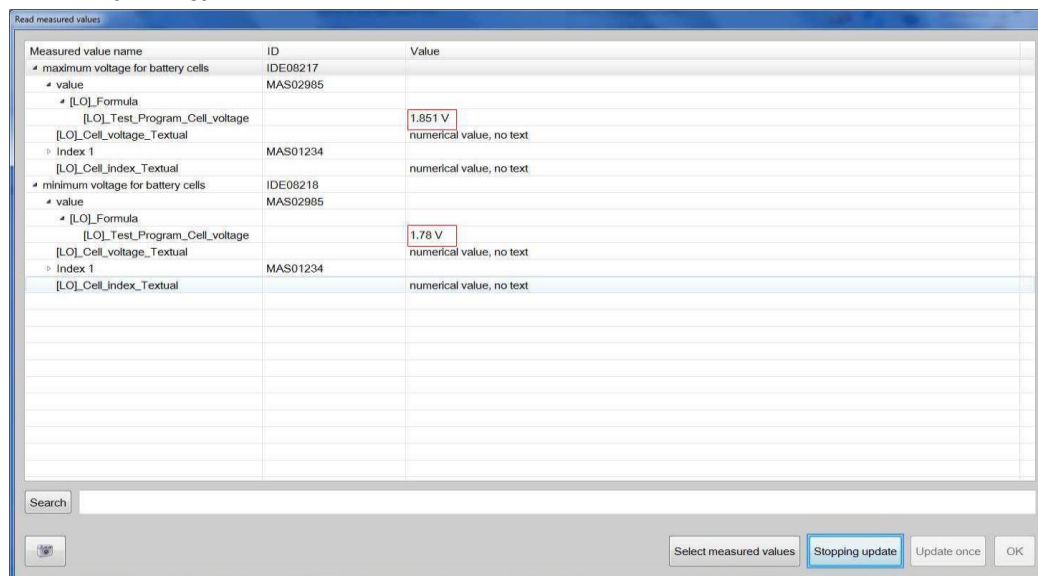
Figure 3

7) Read the following MVB's to check the difference between the **highest cell voltage** and the **lowest cell voltage** (Figure 3)

- If there is a difference of **0.5v** or more between the **highest** cell voltage and **lowest** cell voltage and the fault code '**P0B2500: Hybrid/EV Battery "A" Voltage low**' is stored in address **21-Battery Energy Control Module 2** - Referring to the applicable Rep.Gr 27 - Replace the super capacitor
