SERVICE ACTION: OBC REPLACEMENT (SA307)

| | GROUP<br><b>ELE</b> | MODEL<br><b>2016MY<br/>Soul EV (PS EV)</b> |
| | NUMBER<br><b>138</b> | DATE<br><b>September 2017</b> |
| TECHNICAL SERVICE BULLETIN | | |

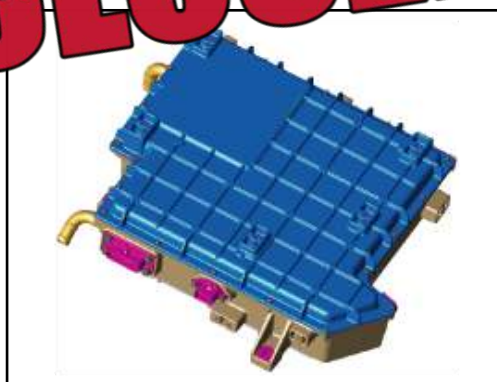
This bulletin provides the procedure to replace the On-Board Charger (OBC) on some 2016MY Soul EV (PS EV) vehicles, produced from January 16, 2015, to the end of September 2015, which may exhibit a malfunction indicator light (MIL) or Diagnostic Trouble Code (DTC) P1CF5 or P1CF6 due to a battery charge delay with the OBC. This is not a safety-related issue. No repairs are required if the vehicle is not affected. Before performing this procedure, verify that the vehicle is included in the list of affected VINs.

| DTC | Description |
| P1CF5 | BRID Check |
| P1CF6 | WSE Check |
