# SERVICE ACTION: OBC UPDATE, INSPECTION AND/OR REPLACEMENT (SA306)

GROUP  
ELEMODEL  
2015-17MY  
Soul EV (PS EV)NUMBER  
137DATE  
October 2017

## TECHNICAL SERVICE BULLETIN

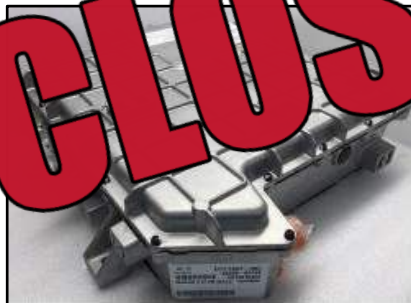
This bulletin provides the procedure to update, inspect, and if necessary, replace the On-Board Charger (OBC) on some 2015-17MY Soul EV (PS EV) vehicles, produced from January 1, 2014 through January 15, 2017, which may exhibit a Malfunction Indicator Lamp (MIL) and DTCs P1CF1 through P1CF6. This may be due to a battery charge delay. To address this concern, follow the procedure outlined in this bulletin. Refer to the list of affected vehicles to verify that the vehicle is included in the list of affected vehicles.

P1CF1 – HV DC Interlock Fault  
P1CF2 – HV DC Charge  
P1CF3 – HV DC Open Fault  
P1CF4 – HV DC Temperature  
P1CF5 – HV DC Link Stable  
P1CF6 – HV DC Not Detected (EVSE or OBC)
