| <b>HYUNDAI</b><br><b>Technical Service Bulletin</b> | GROUP<br><b>EV Systems</b> | NUMBER<br><b>24-EV-001H</b> |
| | DATE<br><b>MARCH 2024</b> | MODEL(S)<br><b>IONIQ PLUG-IN HYBRID (AE PHEV)</b> |
| <b>SUBJECT:</b> ECU SOFTWARE UPDATE FOR DTC U1341 | | |

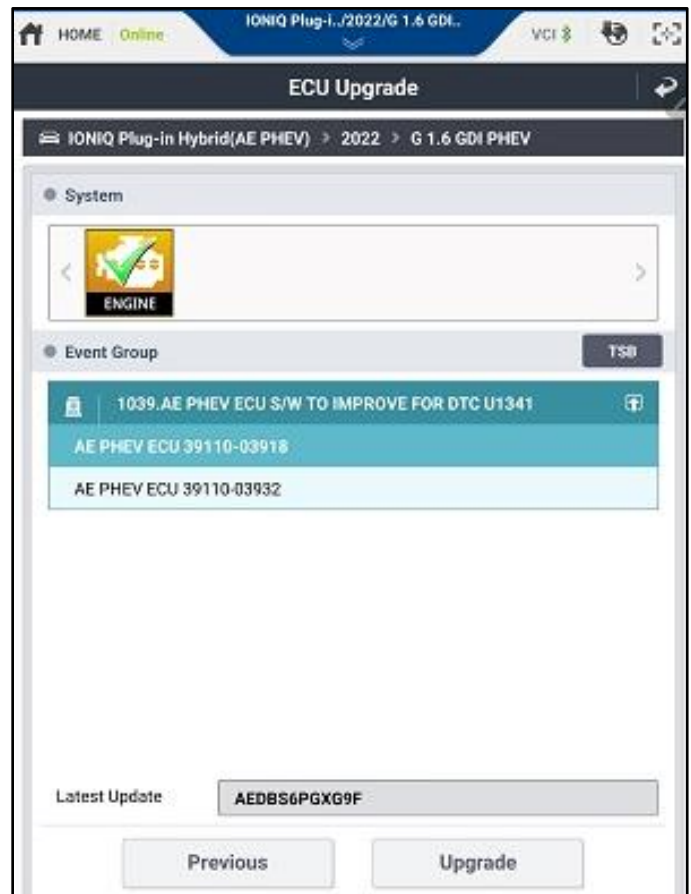
1. Perform the ECU update in Auto Mode.

Use the **ID Check** to verify the ROM ID before updating the software.

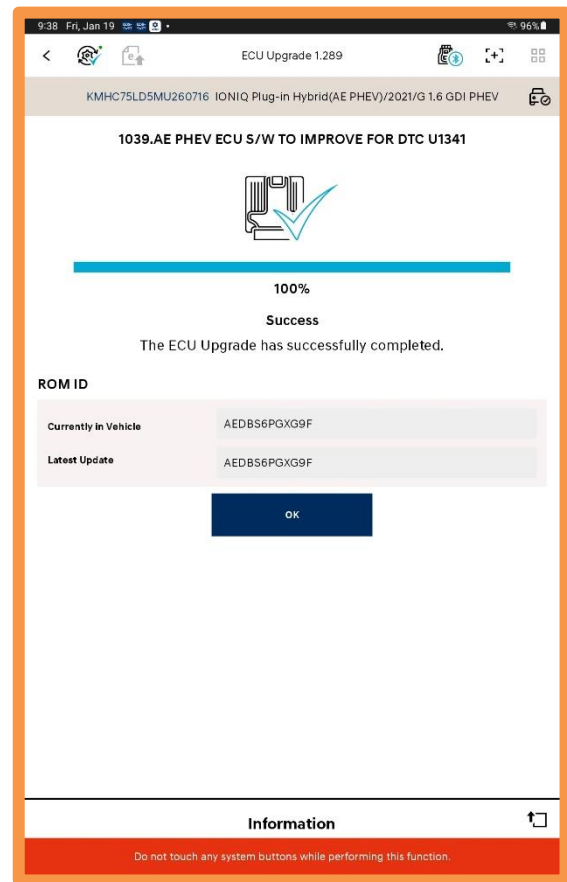
2.

Take a screenshot of the “ECU update complete” screen using your tablet and upload to STUI.
