## SERVICE BULLETIN

**APPLICABILITY:** 2022MY Forester

**NUMBER:** 07-209-22R

**SUBJECT:** EyeSight® Reprogramming  
DTC B28A6 Internal Stereo Camera  
Communication 1

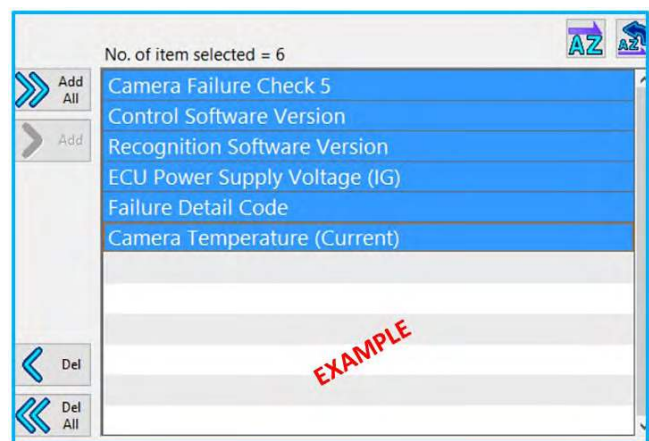
**STEP 1:** Confirm the EyeSight® Stereo Camera assembly is suitable for reprogramming. Using the Data Monitor feature within SSM, select the following signal items.

1. Camera Failure 5
2. Control Software Version
3. Recognition Software Version
4. ECU power Supply Voltage (IG)
5. Failure Detail Code
6. Camera Temperature

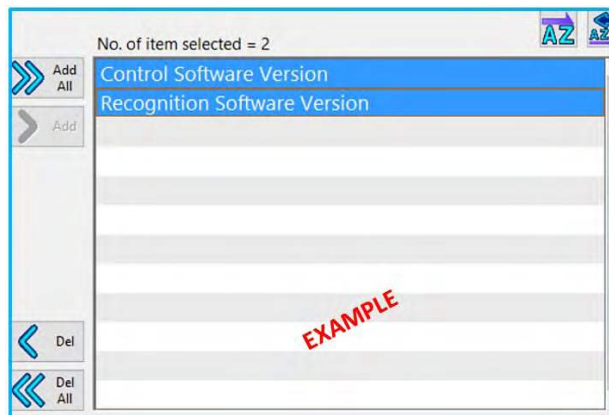
**STEP 1:** Confirm the EyeSight® Stereo Camera assembly reprogramming has been performed **SUCCESSFULLY**. Using the Data Monitor feature within SSM, select the following signal items.

7. Control Software Version
8. Recognition Software Version
