## SERVICE BULLETIN

**APPLICABILITY:** 2014-18MY Forester

**NUMBER:** 17-19-24

**SUBJECT:** DTC B1760 Occupant Detection Sensor Mat /  
Diagnosis & Repair Procedures

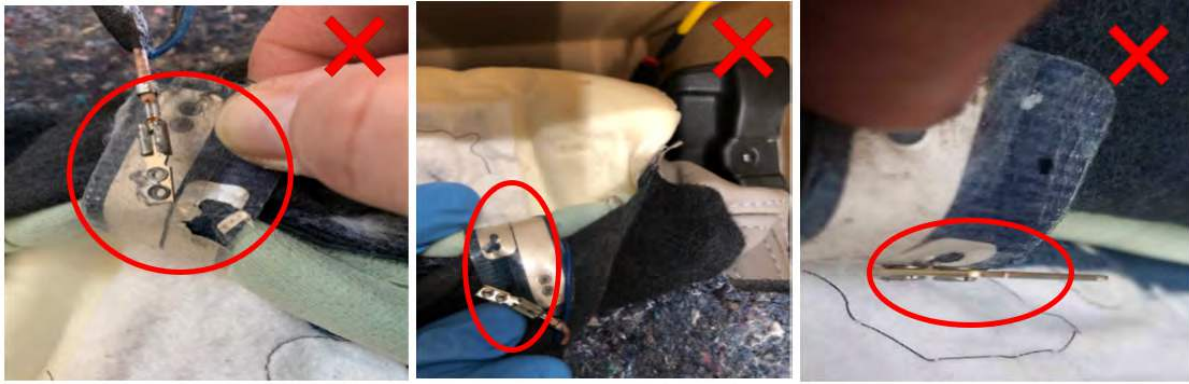
- Because the female connectors on the harness have strong clamping power, supporting the male connectors as described is mandatory to prevent any excessive bending of the sensor mat connectors and **CRITICAL** to preventing sensor mat damage as shown in the photos below.

These three photos are examples of a sensor mat connection point damaged due to overly-aggressive disassembly. This **MUST** be avoided.

- It is also **IMPERATIVE** to prevent sensor mat damage, always **FIRMLY** squeeze the riveted connection point between a thumb and forefinger when disconnecting **AND** reconnecting the harness from / to the sensor mat's flat, male spade connectors.

- **NEVER** bend or twist the sensor mat connection point, especially while disconnecting or reconnecting the harness connectors as doing so will damage it.

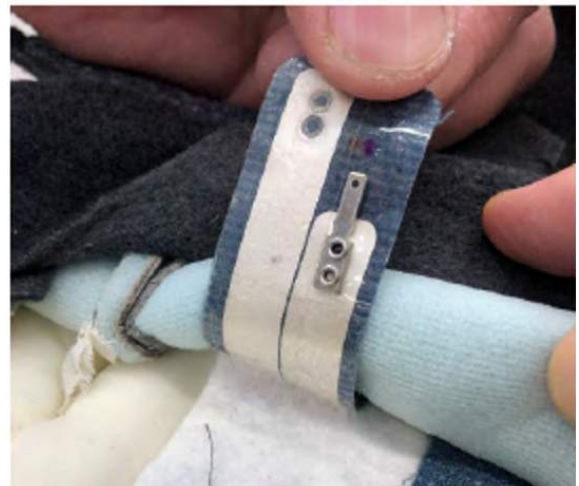
**STEP 8:** **IMPORTANT:** Before connecting the new harness, inspect the tail and sensor mat connectors to confirm they are tight on the 2 metal bands of the mat. Inspect closely for any breakages, cracks or other damages to the visible components of the sensor mat. If any damage is identified, the complete seat cushion assembly must be replaced as the sensor mat is not a serviceable component.

**REMINDER:** If a replacement is necessary, always order the most up-to-date seat cushion assembly part number for the VIN being repaired.
