## Technical product information

| <b>Topic</b> | Bentayga V8 Kovomo - DTC P227900 evident within the engine control unit 0001 |
| <b>Brand</b> | Bentley |
| <b>Transaction No.</b> | 2071575/3 |

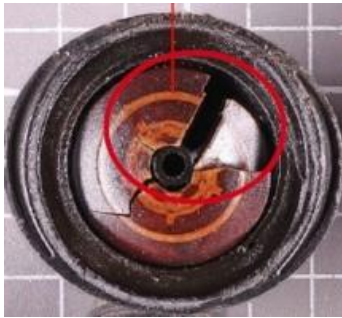
Figure 1

The issue described is due to a split breather diaphragm in one or both of the turbocharger full load pipes (Figure 1)

**The diaphragm of the bank 1 turbocharger full load pipe is located at the end of the pipe and can be easily located however the diaphragm of the bank 2 turbocharger full load pipe is installed within the pipe and therefore will not be visible**

Hint: the breather diaphragm could be split/damaged or missing

**Hint:** The diaphragm of the A,B and E suffix parts is orange (Figure 1)

1) Referring to Rep.Gr 21 - Replace the bank 1 (right) and bank 2 (left) turbocharger full load pipes

The operative should remove any debris belonging to the original diaphragm before fitting the new replacement pipes

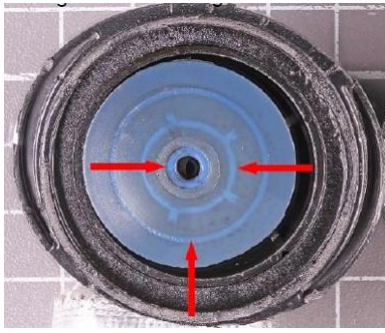
Figure 2

**Hint:** The diaphragm of 0P2 103 210G and 0P2 103 211H are blue (Figure 2)

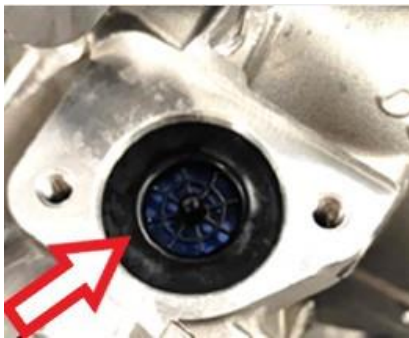
Figure 3

Production improvement was performed by fitting the diaphragm directly into the housing of the bank 1 and bank 2 turbochargers on all VINs post SJAAM2ZV3MC039237 (Figure 3)

VINs with this design are **not** subject to extended warranty

In the event the issue is evident post the suggested VIN the operative should raise a technical DISS query and await feedback before conducting any further work

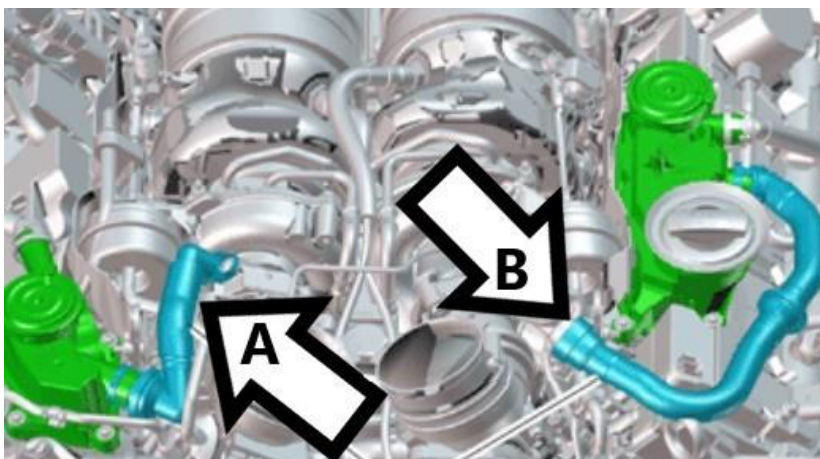
Figure 4

- Point A - Is the bank 1 (right) turbocharger full load pipe
- Point B - Is the bank 2 (left) turbocharger full load pipe

**Note:** when conducting the instructions within this TPI please ensure the bank 1 and bank 2 turbocharger full load pipes are replaced in pairs (during the same workshop visit)
