# Technical product information

| <b>Topic</b> | New Continental GT and GTC - Window drop glass operation |
| <b>Transaction No.</b> | 2070497/8 |

Retailer glass reset procedure for GT/GTC

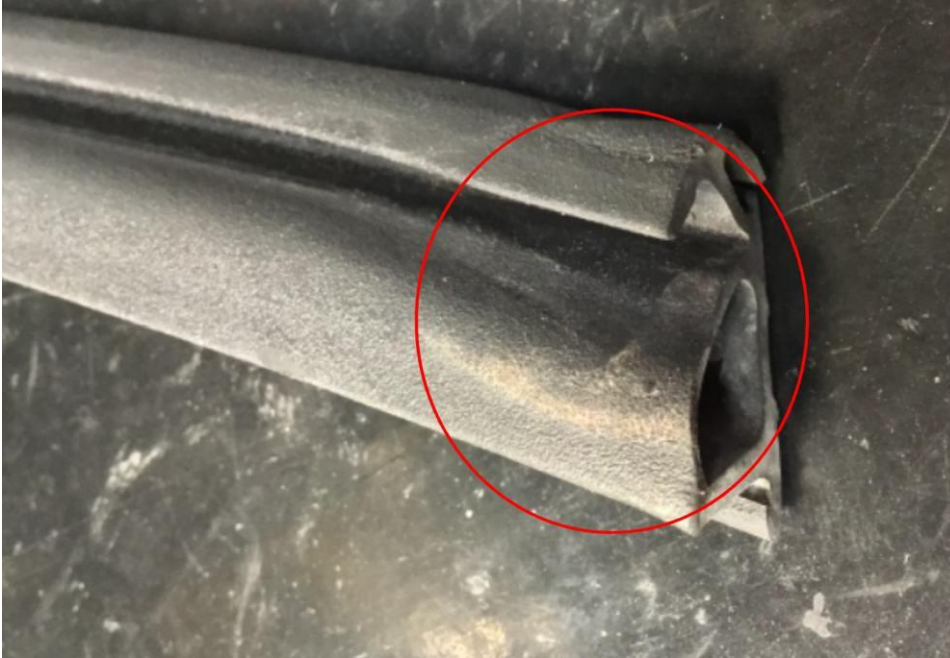
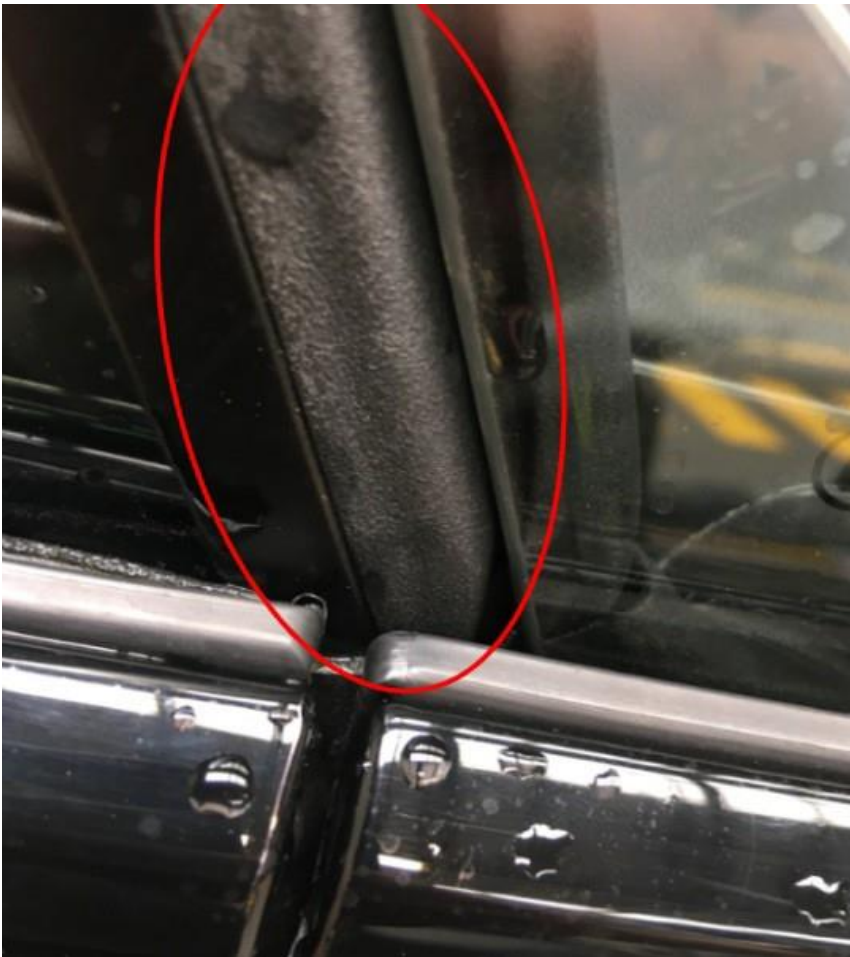
- Damage
- Splits
- Tears
- Misalignment
- Incorrectly fitted / located
- Drop glass seal deformation (see Figures 7 and 8 as examples)

**NOTE:** Any issues found with the window seals must be rectified before conducting the remaining steps

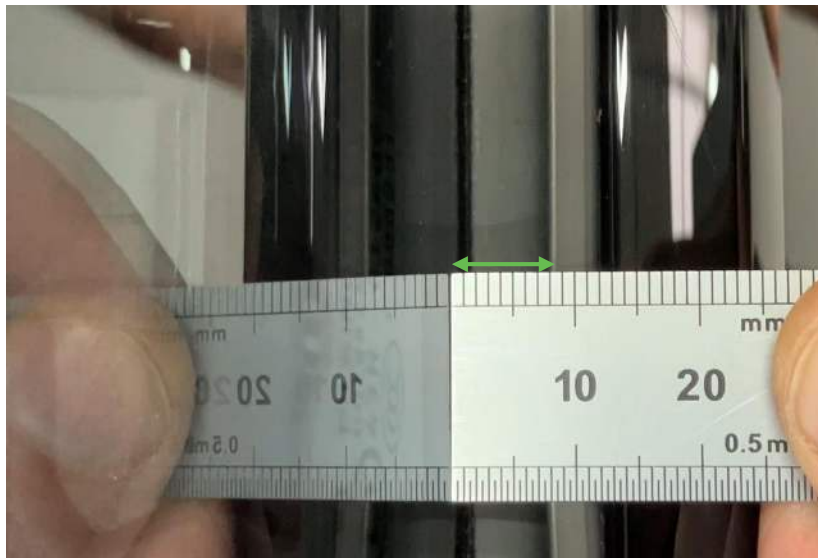
RHF window, front window closed, rear window open. Note gap
