# Service Bulletin

Bulletin No.: 24-NA-064

**Subject:** Malfunction Indicator Lamp (MIL) Illuminated - DTCs P0324 and/or P0116 Set — ECM Software Update

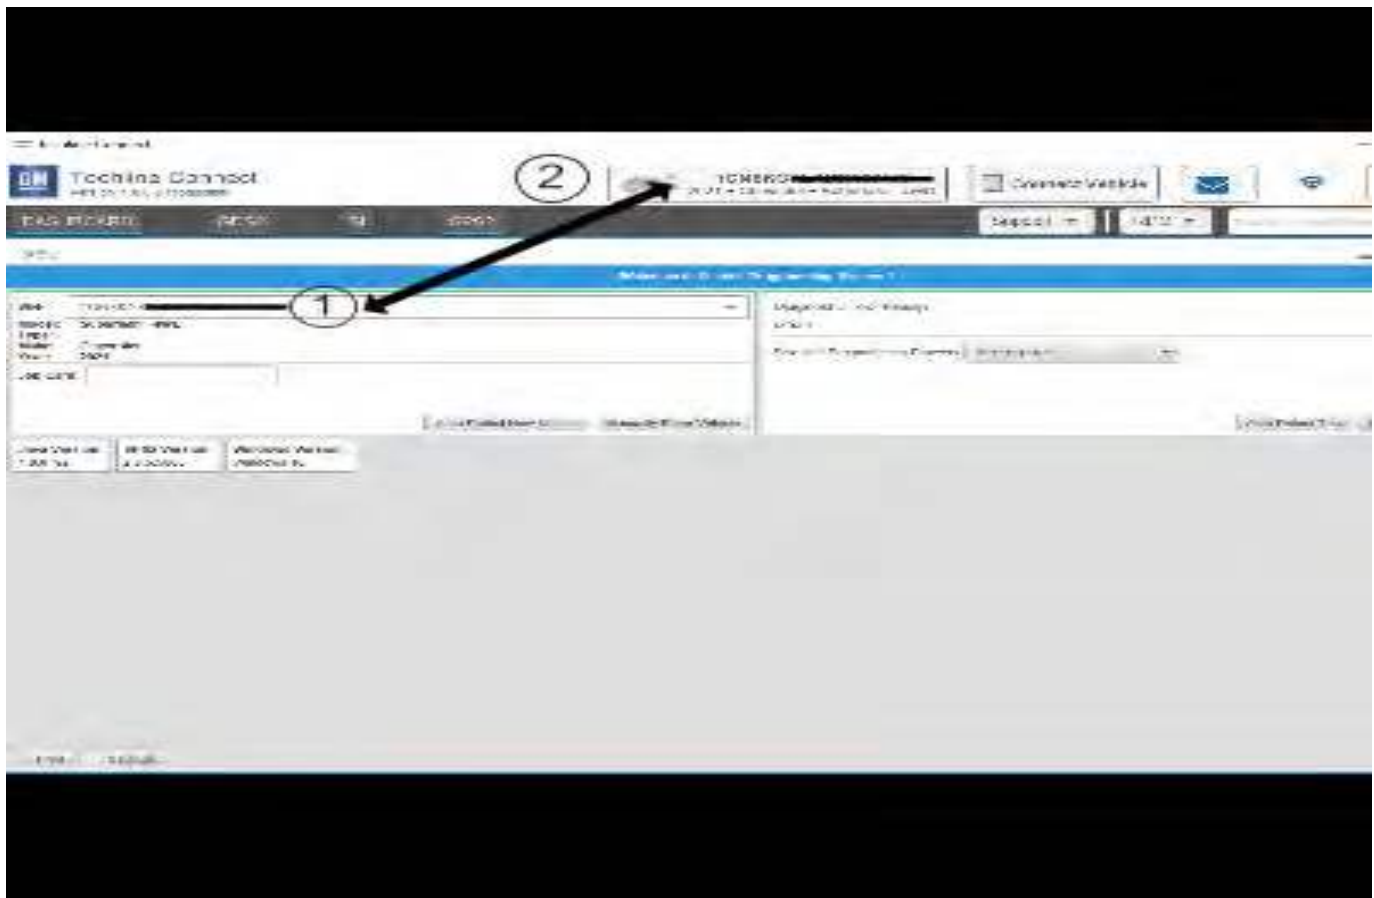
5743643

Caution: Be sure the VIN selected in the drop down menu (1) is the same as the vehicle connected (2) before beginning programming.

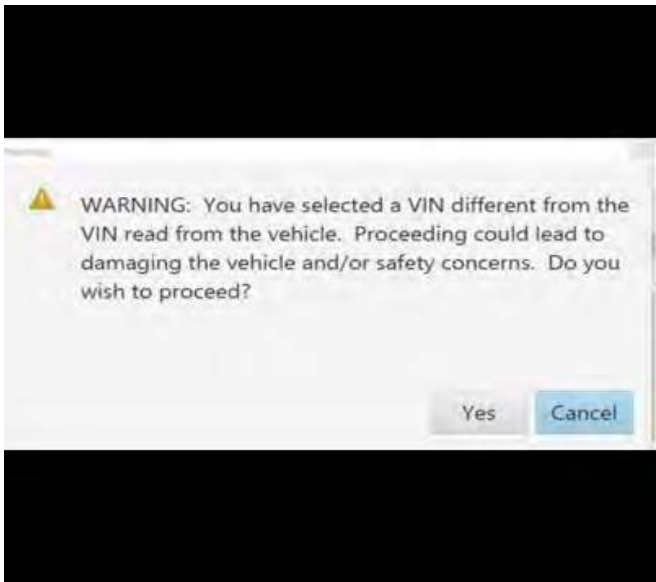
5877000

Important: If the vehicle VIN DOES NOT match, the message below will be shown

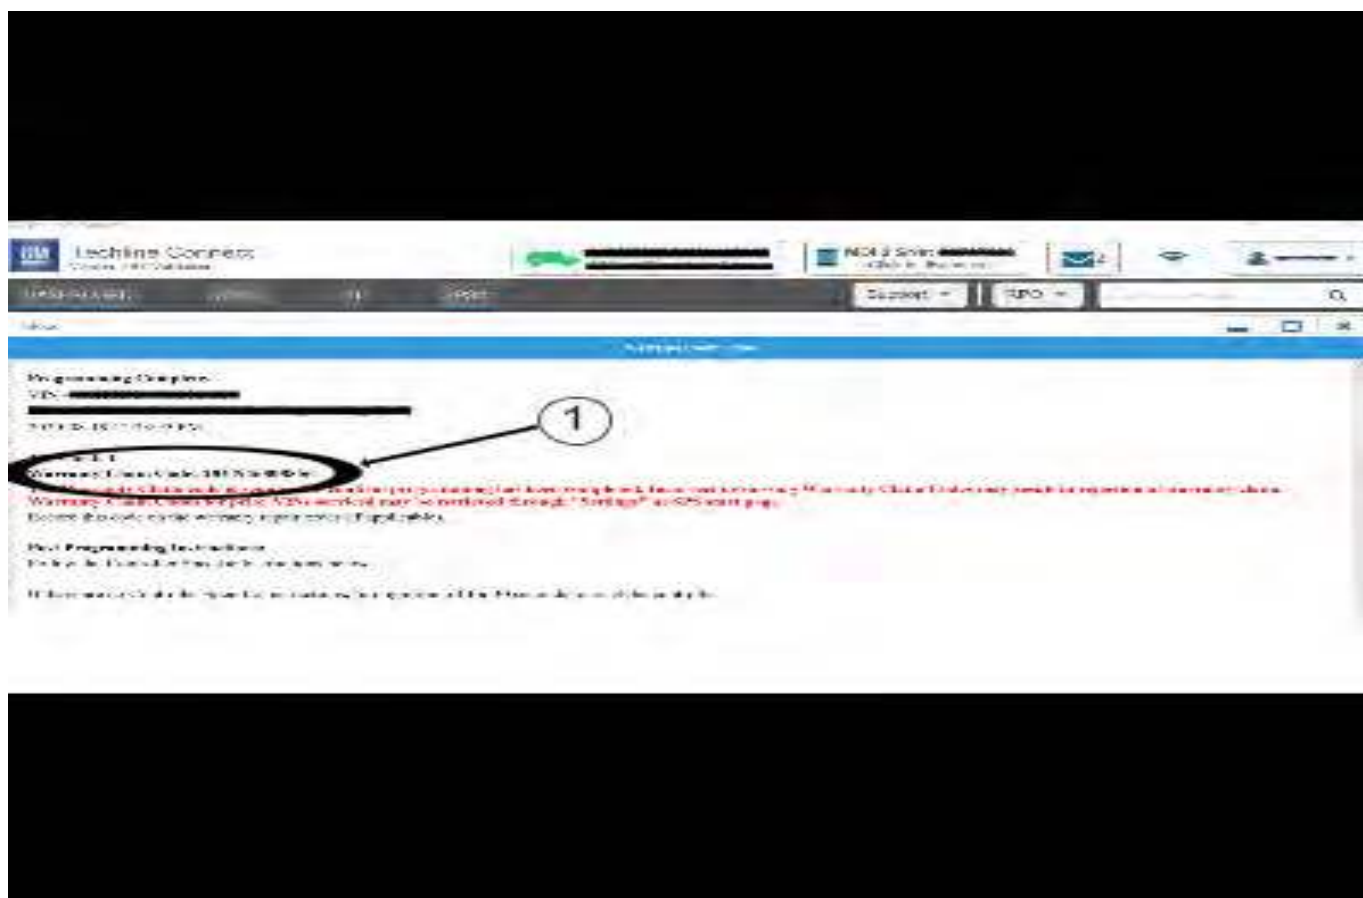
5644478

Important: To avoid warranty transaction rejections, you **MUST** record the warranty claim code provided on the Warranty Claim Code (WCC) screen shown above on the job card. Refer to callout 1 above for the location of the WCC on the screen.

2. Record SPS Warranty Claim Code on job card for warranty transaction submission.

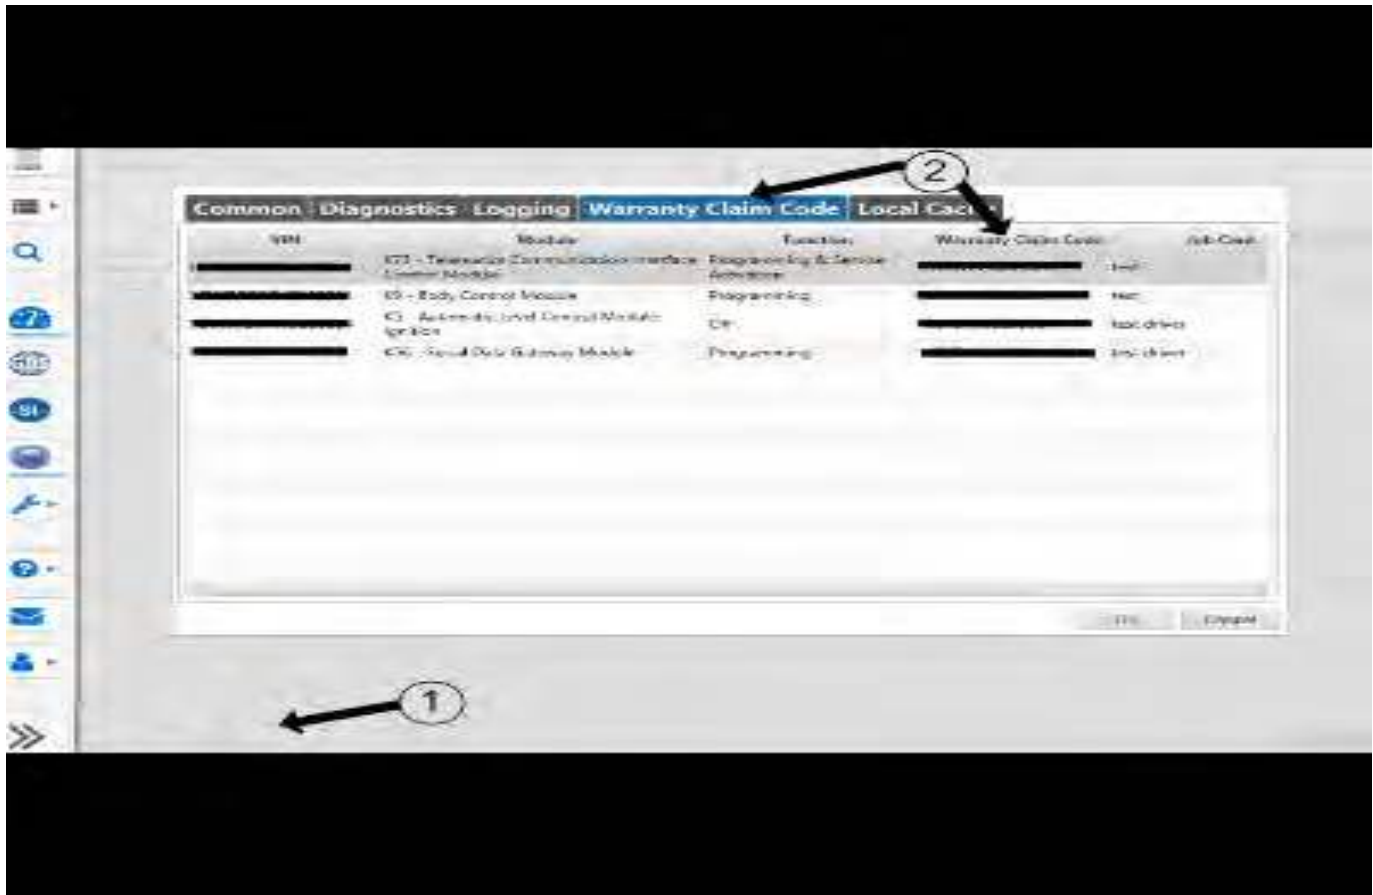
6125774

If the Warranty Claim Code was not recorded on the Job Card, the code can be retrieved in the SPS2 system as follows:

1. Open TLC on the computer used to program the vehicle.
2. Select and start SPS2.
3. Select Settings (1).
4. Select the Warranty Claim Code tab (2).
