**April 12, 2024**

Version 4

## **Warranty Extension: 2017-18 CR-V: Software Update with A/C Control Unit Replacement; DTC P0300, P0301, P0302, P0303, P0304, or P0172; Whirling Noise from Engine**

**Supersedes 19-032, dated June 18, 2019, to revise the information.**

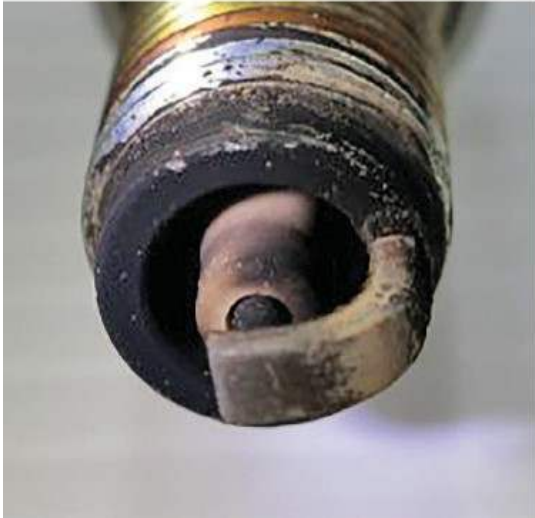
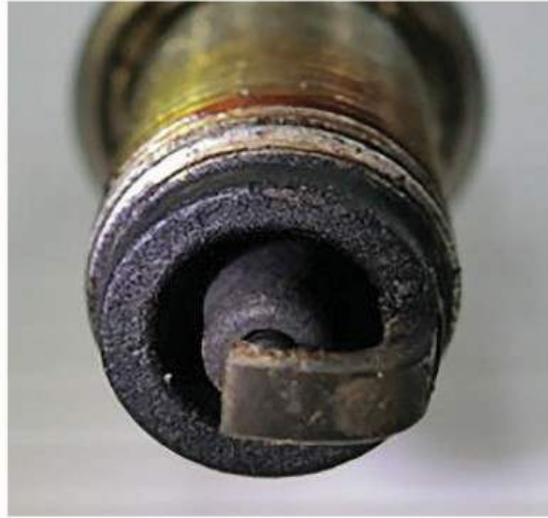
1. In some cases, the DTCs may return. If this happens, inspect the spark plugs.

- If the spark plugs are OK, the procedure is complete. Continue with normal troubleshooting.
  - If the spark plugs are fouled, go to step 2.
2. Replace the spark plugs per service information and check for stored DTCs.

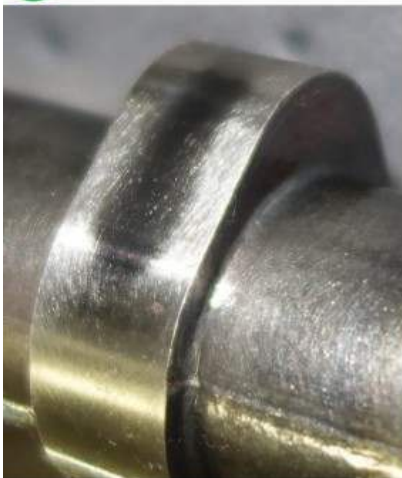
**GOOD**

- If the camshafts appear similar to the no good photo, go to step 8.
  - If the camshafts appear similar to the good photo, this bulletin does not apply. Continue with normal system troubleshooting.
8. Take a photo of the cam lobe, then follow the directions in the parts catalog when ordering the necessary parts.

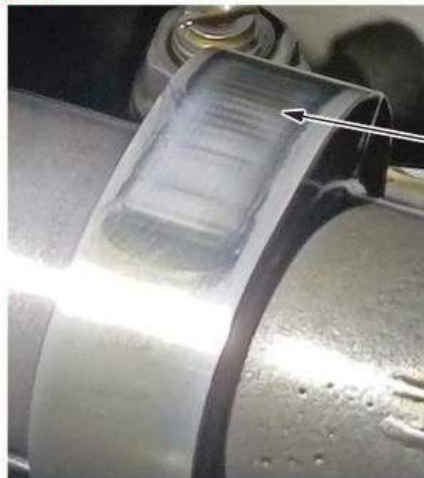
**NO GOOD**

The cam surface has ridges and a "cloudy" appearance.

Please send photos of failed camshafts to [PART\\_RELEASE@AHM.HONDA.COM](mailto:PART_RELEASE@AHM.HONDA.COM) to receive approval and release parts.
