2021-2024MY  
Multiple Models

108 (Rev 1, 4/25/2024)

## TECHNICAL SERVICE BULLETIN

SUBJECT: 4WD COUPLING ACTUATOR ASSEMBLY REPLACEMENT

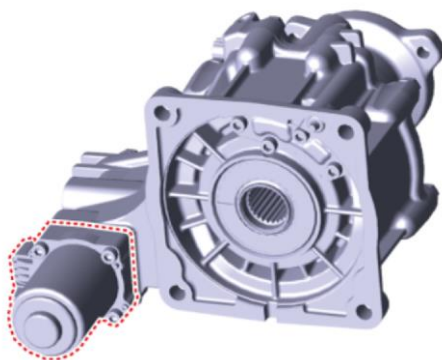
This bulletin provides information to replace the AWD coupling actuator assembly on some 2021-2024MY Kia AWD models listed on page 4. The affected vehicles may exhibit an inoperative AWD system (also referred to as 4WD) capability concern which may be caused by abnormal wear of the motor brushes inside the actuator assembly. This condition will cause the warning lamps on the instrument cluster to illuminate with stored DTC(s) P195800 and/or P19600. Follow the procedure outlined in this publication to inspect and, if necessary, replace the AWD coupling actuator assembly on the applicable vehicles.

P195800 - 4WD Torque Error

P196000 - 4WD Bleeding Pressure Error

1. Confirm an inoperative AWD/4WD condition is present with stored DTC(s) P195800 and/or P196000.
  - If DTC(s) is/are not stored, then this TSB does not apply.
