## SERVICE BULLETIN

**APPLICABILITY:** 2024MY Crosstrek & Impreza

**NUMBER:** 09-118-24

**SUBJECT:** DTCs P2404 & P0087 / Reprogramming Files

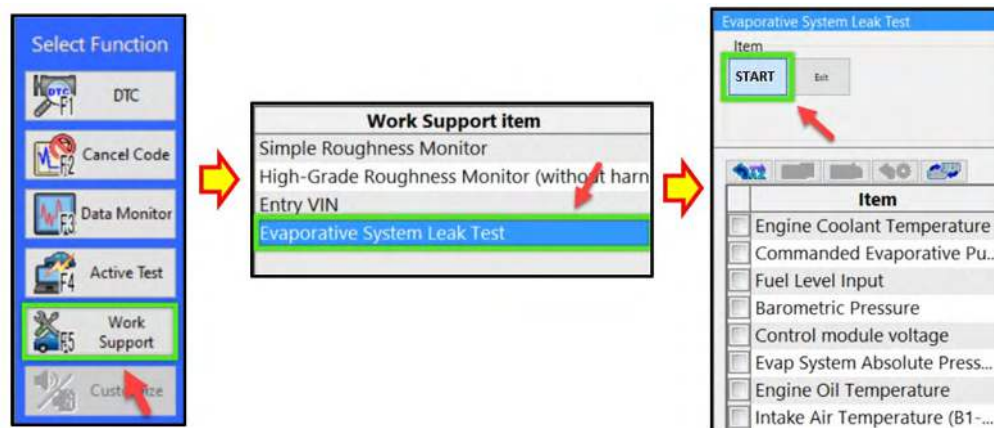
**STEP 6:** Connect the vehicle to a recommended power supply. See **APPENDIX A** for additional information regarding power supply. Using SSM, perform the Evaporative System Leak Test. Collect and save all data.

Once the evaporative system leak test is complete, check the DTCs and examine the vacuum value results. Record the value shown in the row labeled MID: \$3C, TID: \$C4, and Scaling ID: \$FE. This value should be lower than -0.26 PSI.
