# Service Bulletin

Bulletin No.: 22-NA-203

**Subject:** Check Engine Lamp Illuminated on Driver Information Center (DIC) with DTC P0451 Set

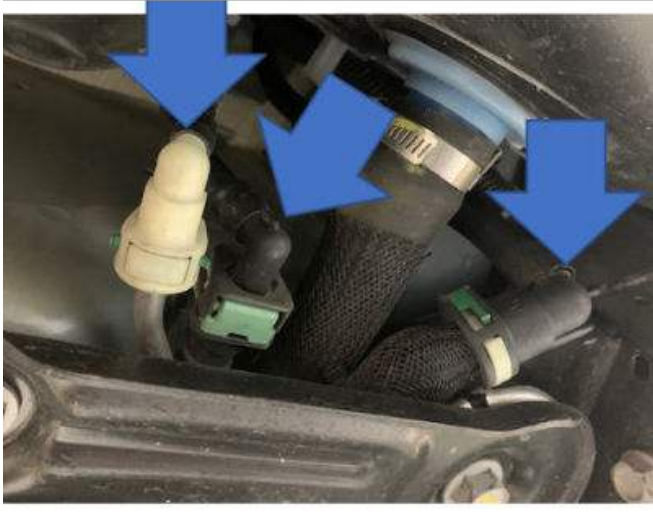
6175877

| <b>Cause</b> | Liquid fuel can enter vapor lines following a customer fuel overfill. If a customer goes beyond three clicks at the fuel station fill, liquid fuel could enter the vapor line through the recirculation line. The liquid fuel can block the line and cause issues with the fuel tank pressor sensor readings. |

1. Raise the vehicle.
2. Disconnect the 3 vapor lines near the gas tank.
