# Technical Service Bulletin

**96 Lane change assist: side assist and exit warning system: unavailable. Sensor view restricted (DTC C12AA00)**

91 24 01 2073683/1 April 16, 2024.

| Model(s) | Year | VIN Range | Vehicle-Specific Equipment |
|---|---|---|---|
| RS 6 | 2021 - 2024 | All | Not Applicable |

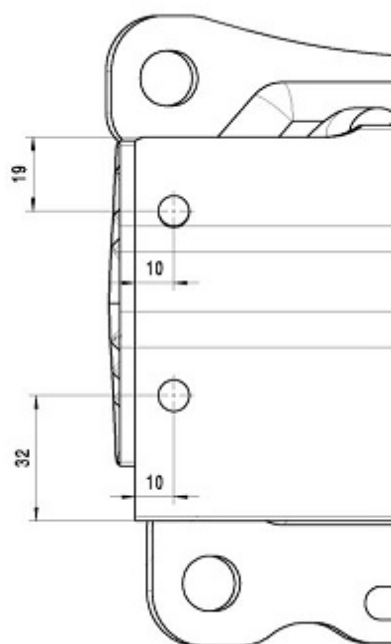
*Figure 1: Illustration showing positioning of holes for spreader rivets.*

In order to secure the covers, two holes (8 mm diameter) must be drilled on each side (left and right) of the bumper cover, as shown in the image below:

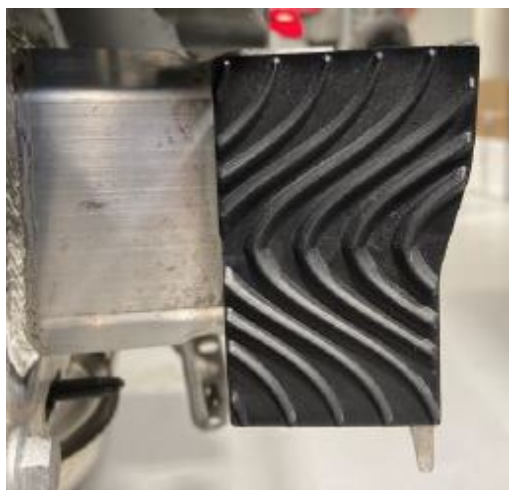
*Figure 2: Cover mounted on bumper carrier (left side).*

Cover the holes and openings on both sides of the bumper carrier. To do so, please use the following covers:

- 4K0 807 245 / 4K0 807 246

Please use the following spreader rivet to secure the covers on the bumper carrier:

- N 905 584 01 (2x per side)
