# Technical Service Bulletin

## 91 No diagnostics communication to the telematics control module (ConBox); DTC U142100

91 24 05 2070942/3 April 26, 2024. Supersedes Technical Service Bulletin Group 91 number 23-36 dated October 26, 2023 for reasons listed below.

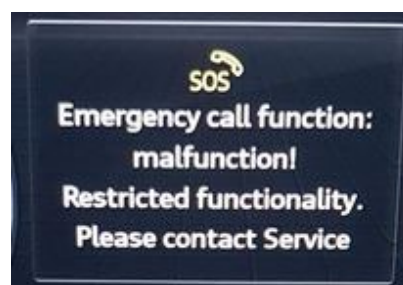
- An SOS Warning might be displayed in the instrument cluster (Figure 1).

**Figure 1.** Emergency call malfunction warning.

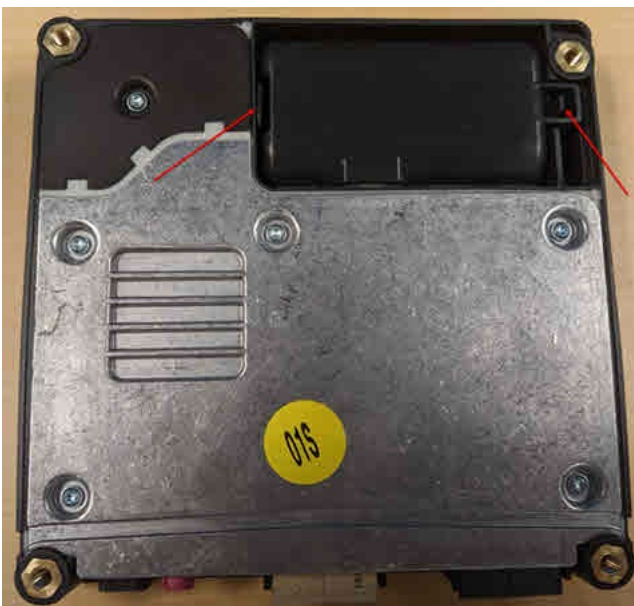
*Figure 2. Backup battery compartment location.*

2. Open the battery compartment of the control module for the emergency call module and communication unit, -J949- (address word 0075), and disconnect the backup battery (Figures 2 - 3).

3. Wait approximately one minute, then reinstall the backup battery back into the control module for the emergency call module and communication unit, -J949- (address word 0075).
4. Reinstall the control module for the emergency call module and communication unit, -J949- (address word 0075) back into the vehicle.
5. If ODIS **still cannot** connect to the control module for the emergency call module and communication unit, -J949- (address word 0075), then follow the ODIS test plan and replace the control module for the emergency call module and communication unit with the part specified in ETKA.

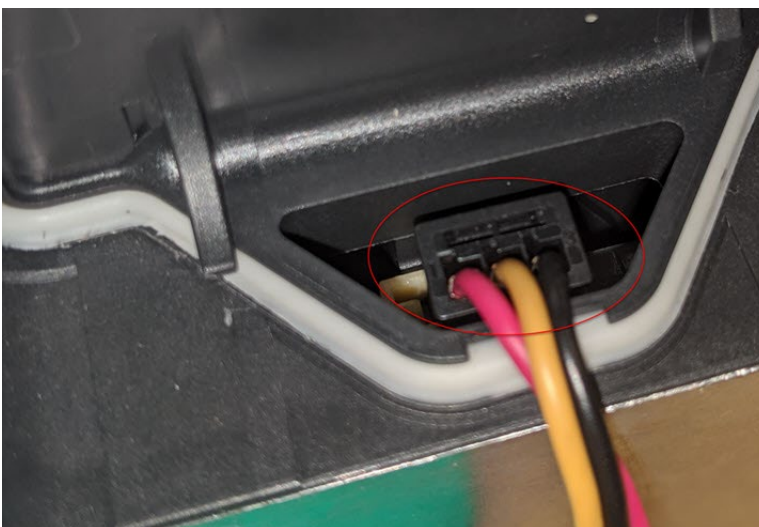
*Figure 3. Backup battery connector (no release mechanism).*
