Service Alert

| Subject:<br><br>MAZDA CONNECT INTERMITTENT AUDIO NO SOUND AND/OR<br>STATIC NOISE FROM SPEAKERS | Service Alert No.: SA-021/24 |
| | Last Issued : 04/09/2024 |

2020-2024 CX-30  
2019-2024 Mazda3

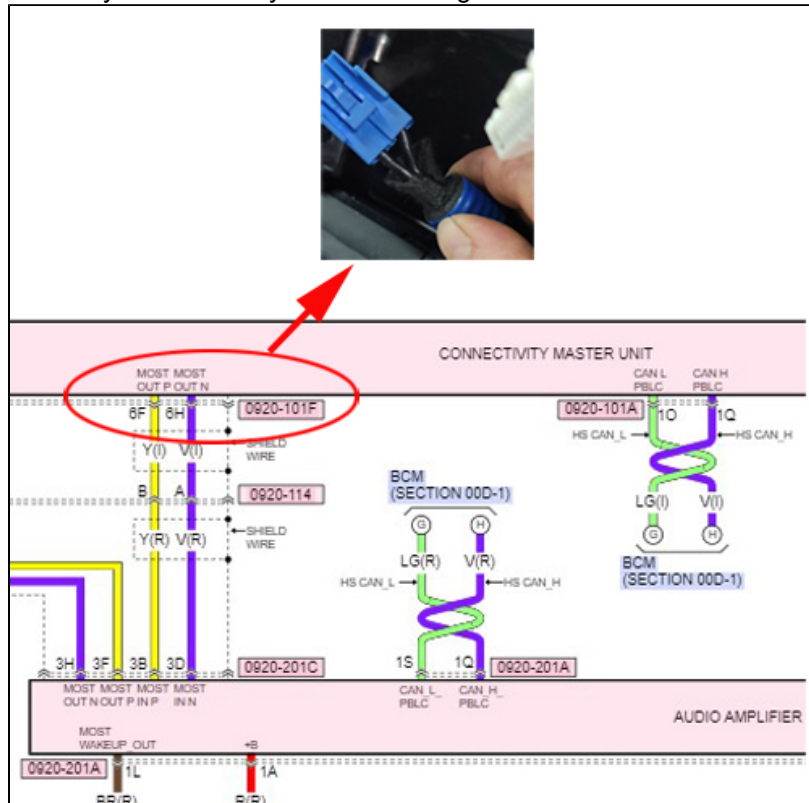
This may be caused by PIN 6F backing out at the CMU connector 0920-101F.

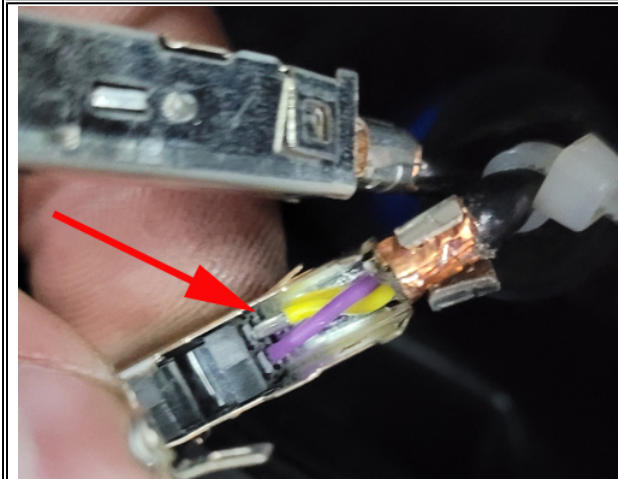
PIN 6F is backed out

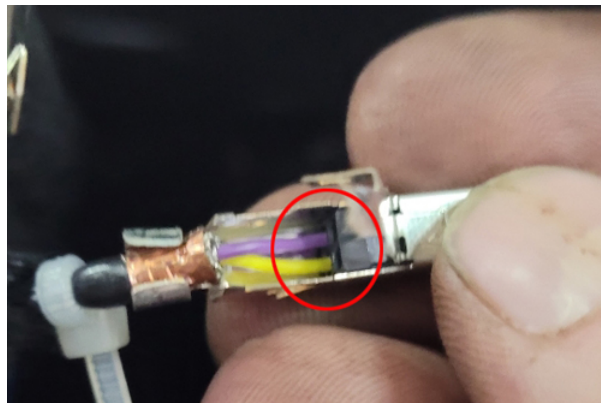
PIN 6F is untwisted and repaired

5. Untwist pins 6F and 6H (straighten) and reinstall them into connector 0920-101F.
